Appendix F

Cost Estimates

F1 Contractor estimates for harbour entrance structures

RHDHV have been commissioned by Coastal Partnership East for East Suffolk Council to undertake a study into the current condition of the defences at Southwold harbour and potential options to improve conditions and safeguard the future use of the harbour.

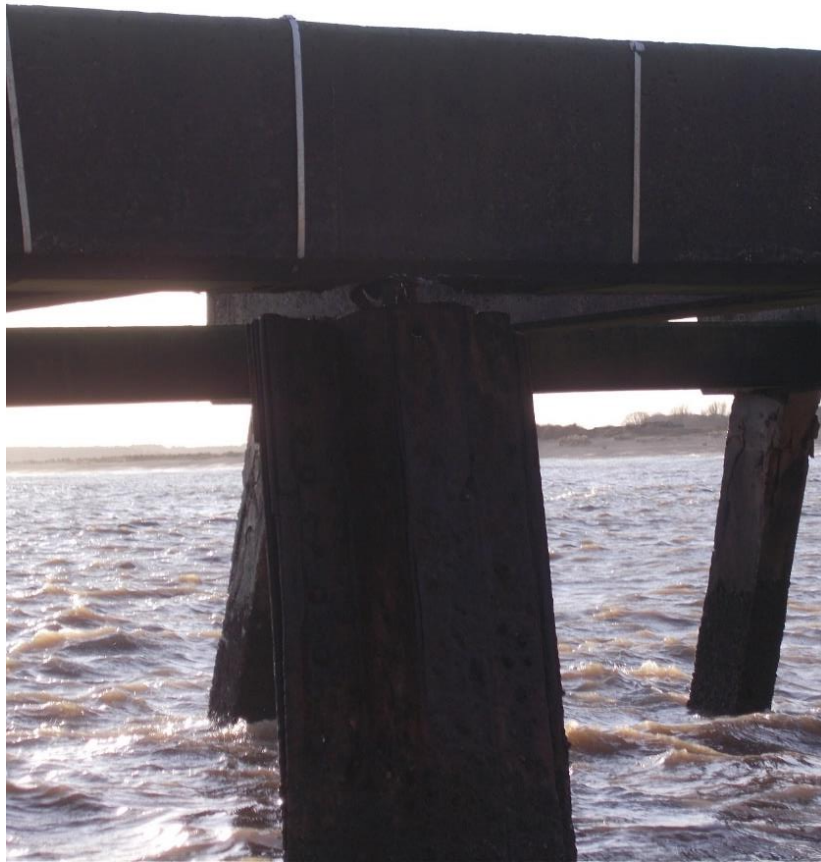
Figure 2-4 - Box Pile 8 failure

One of the box piles around the harbour mouth (number 8 counting the seaward end inland) is not supporting the beam above it. Closer inspection suggests that this pile is likely to have been struck by a vessel resulting in a dent at the low tide waterline. This damage is also causing the top beam to be cantilevered off the rear piles and may be subject to failure in a storm surge as above.

Box pile number 8 (Figure 2-4) has been damaged, possibly hit by a vessel at some point, and is no longer supporting the beam above which is simply cantilevered off the raking piles behind and the adjacent box piles. (Figure 2-5).

The condition of the structure and the predicted sources of failure are essentially unchanged from the reports from the 1990s. The condition of most of the existing concrete structure is unlikely to have changed much since that time. It is therefore considered likely to last another 15-20 years if the unsupported and cantilevered sections are repaired.

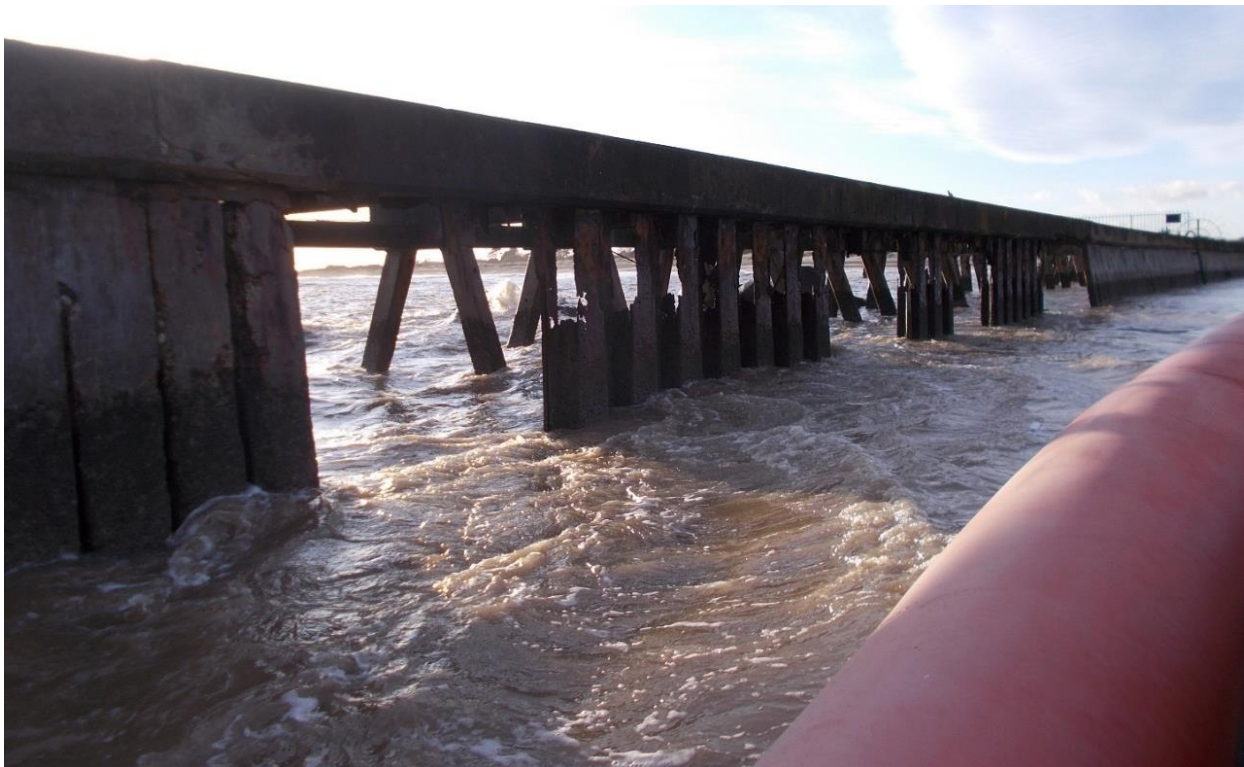
Figure 2-5 - Length C corroded steel sheet piles and unsupported front beam.

The sheet steel piles in Length C extend above low water into the splash zone. Consequently they have suffered from significant corrosion, and are supporting little to none of the front beam. This beam is cantilevered off the piles behind and would appear to be the most 'at risk' part of the structure. In the event of a storm surge event this beam is liable to be driven upwards, which could lead to the crossmembers or rear piles failing and a length of this front beam collapsing into the harbour.

A section of planks has been replaced with steel sheet piles (Length C) however these have corroded severely (Figure 2-6). This front beam section is no longer supported properly and is cantilevered off the rear raking piles. The damage to this structure in the past appears to have been slowed with mounds of rock that have been used to block openings in the pier face from the rear (Figure 2-6).

Length C has essentially failed and could collapse within the next 5 years. Failure could risk damage to adjacent parts of the structure. This section should be repaired as soon as possible.

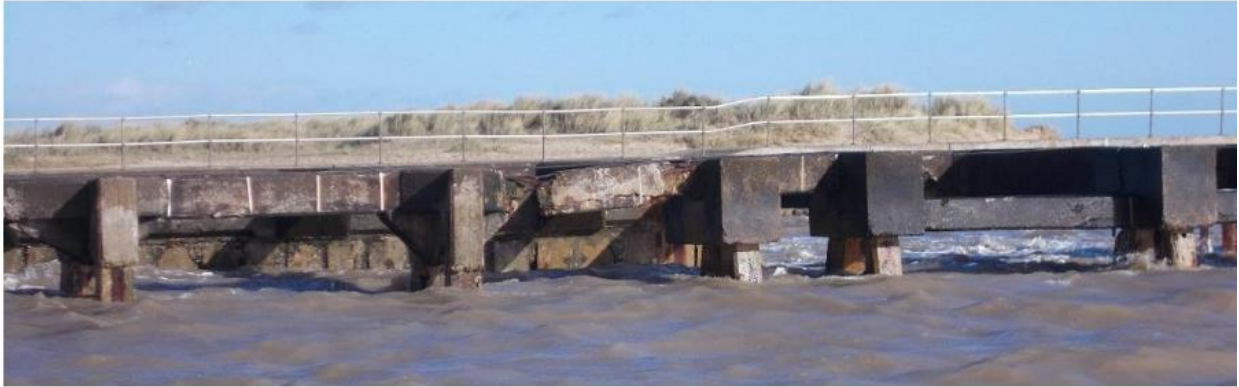
Figure 2-6 - 35-36 rear longitudinal beam failure

A rear longitudinal beam at piles 35-36 has failed completely (Figure 2-6).

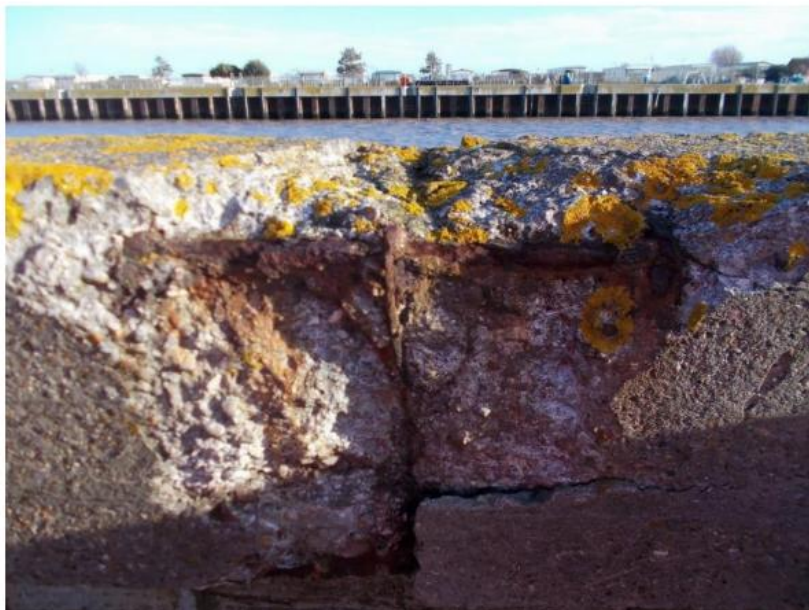
Figure 2-8 - Exposed rebar and failure of front beam at piles 115-116

Potential failure has occurred in the front beam at piles 115-116 (Figure 2-8)

Reinforced concrete can be patched or replaced at those locations where the rebar is exposed (approximately 20% of the structure). However, this may not be cost effective as it would not improve structural stability.

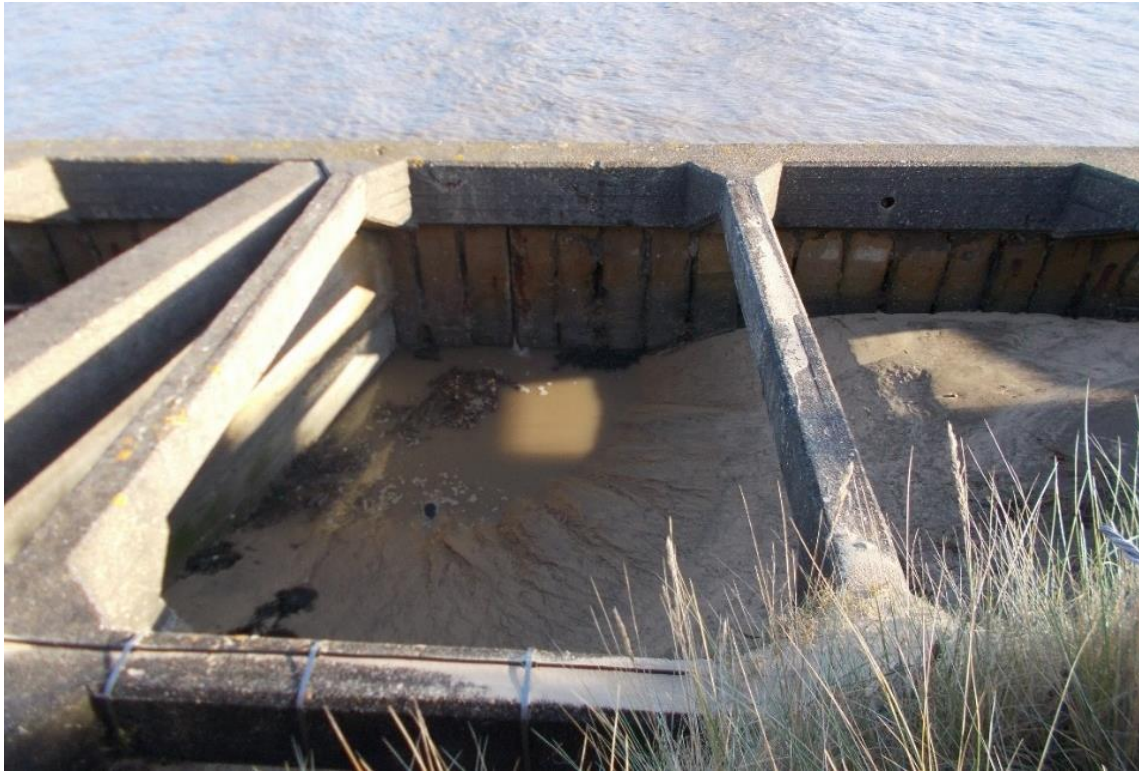
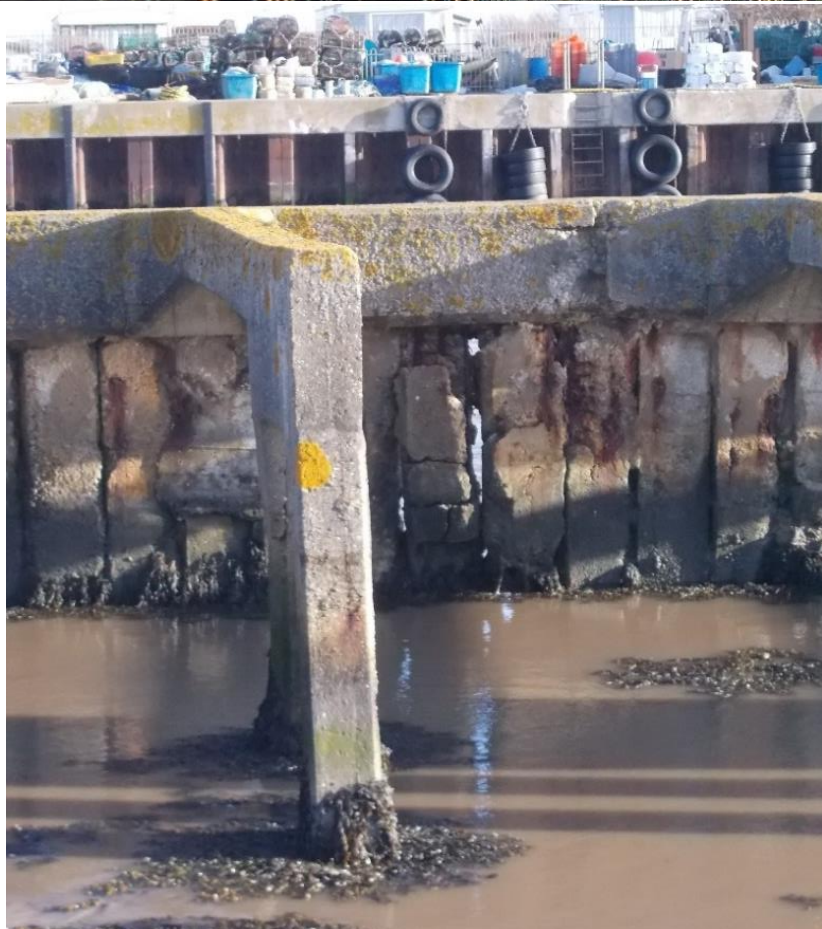
Figure 2-9 - Scour holes from failed front planks

A joint has begun to fail / a crack has formed on the front beam between piles 121 and 122 (Figure 2-9).

If necessary, considering the aims of the scheme, scour holes could be filled after the gaps in the planks and piles have been repaired.
