## **Southwold Harbour Study**

### Project Report

Client: East Suffolk Council

Reference: PB9485-ZZ-XX-RP-Z-0001

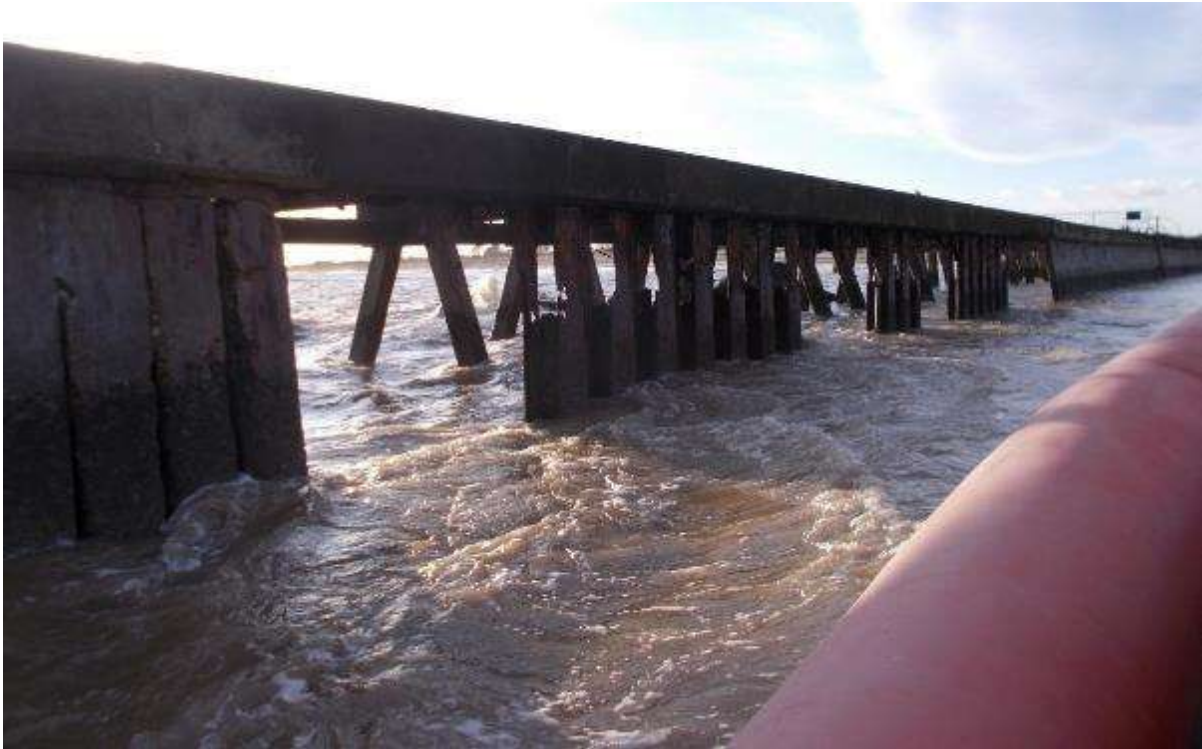
Figure 4-5: Length C corroded steel sheet piles and unsupported front beam.

- The sheet steel piles in Length C extend into the splash zone and have suffered from significant corrosion, providing limited support to the front beam, which is cantilevered off the piles behind and as such is the most 'at risk' part of the structure (**Figure 4-5**). During a storm surge event this beam is liable to be driven upwards, which could lead to the crossmembers or rear piles failing and a length of this front beam collapsing into the harbour.

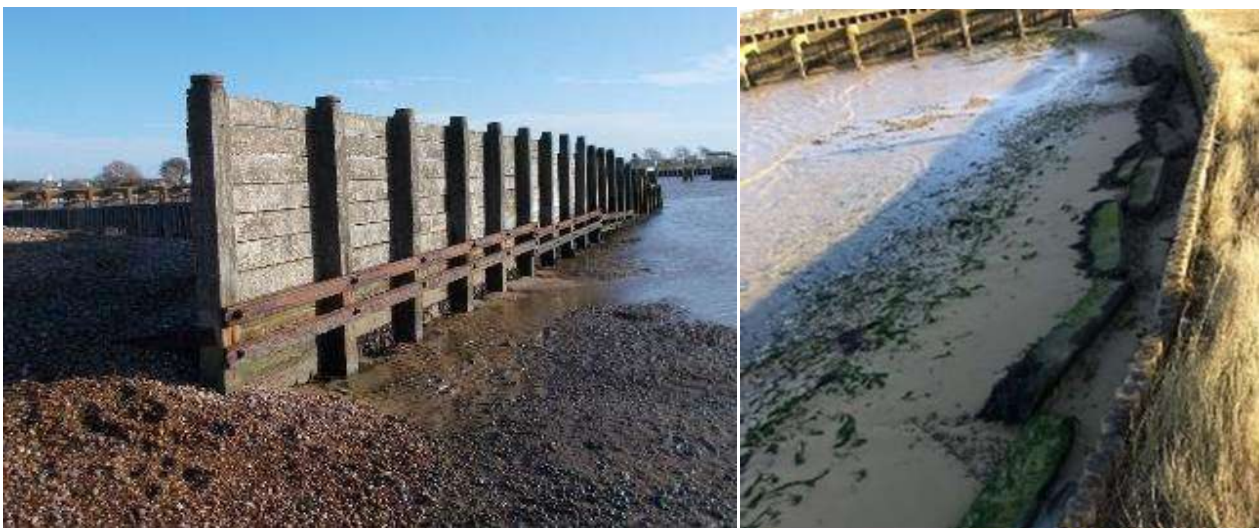
Figure 4-8: Timber groyne and wall at Dunwich Creek

The timber piled wall may influence wave reflection in the harbour, potentially limiting accretion of the spending beach, and the beneficial effects of this beach on wave energy dissipation.

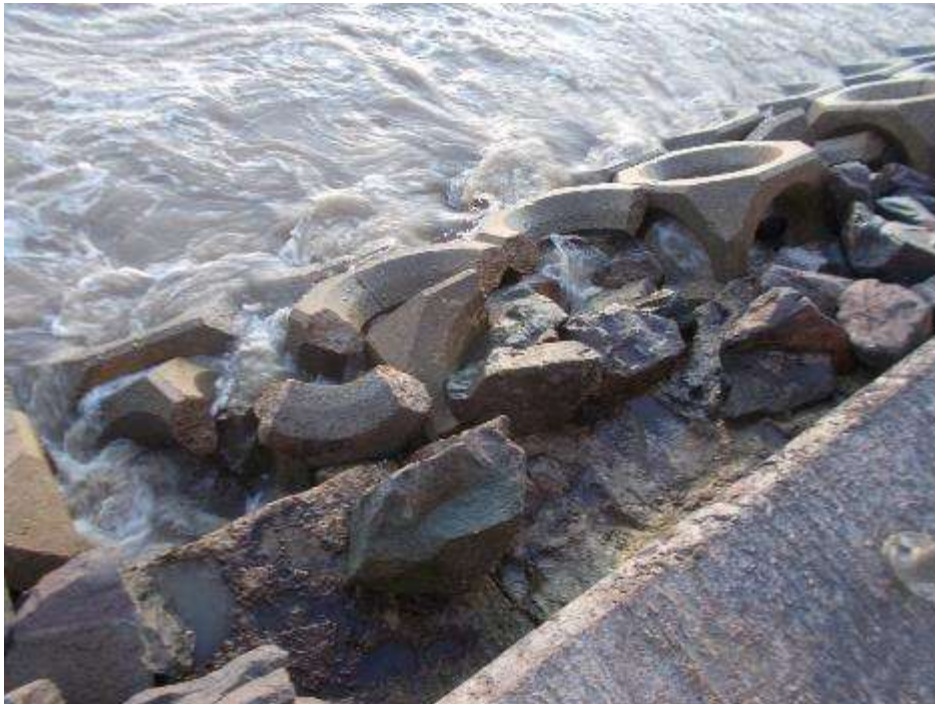
*Figure 4-13: Failed blocks near east end of concrete block revetment*

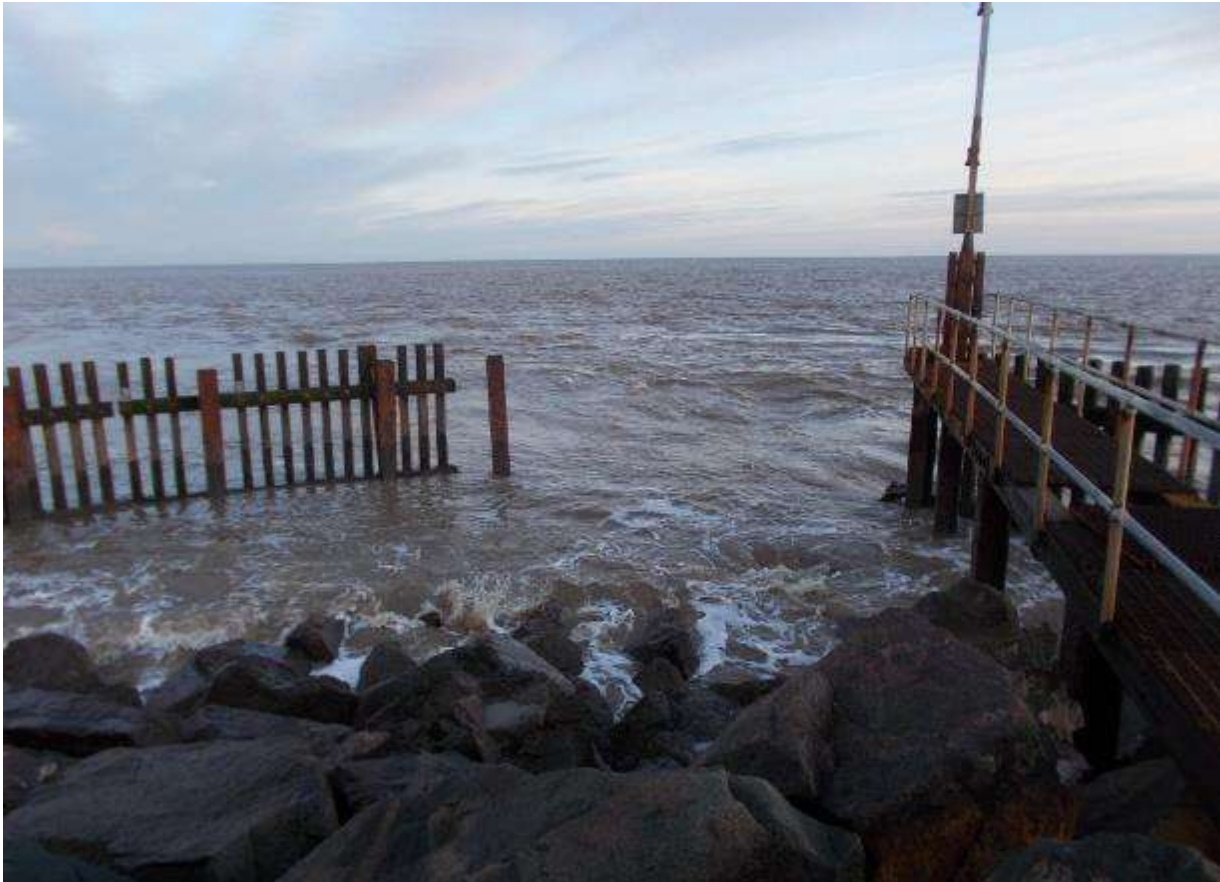
Figure 4-14: Rock armour, navigational light and damaged timber fendering

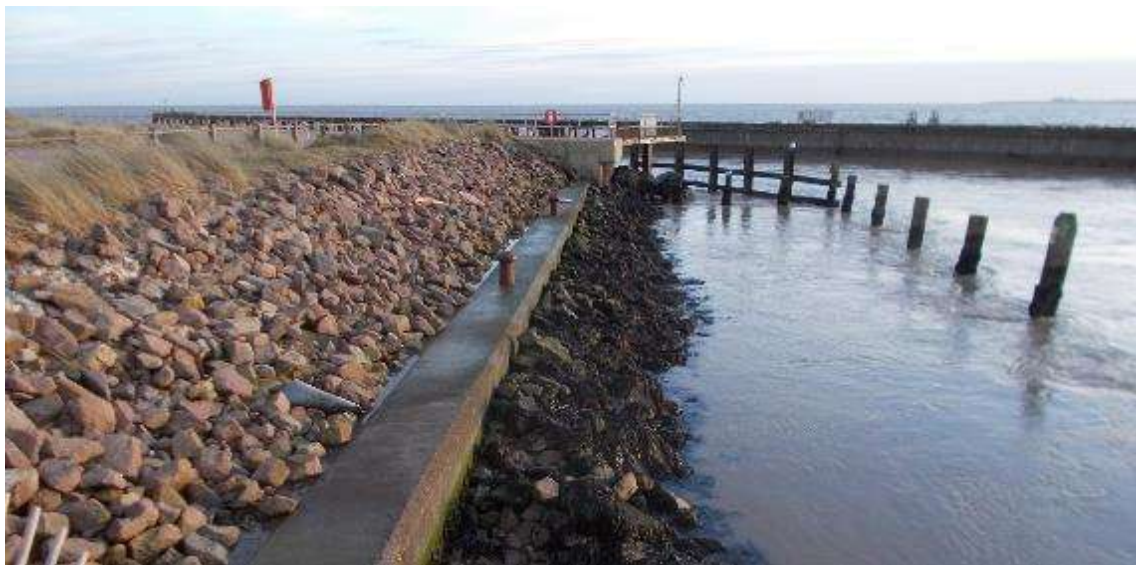
Figure 4-16: Current condition of Knuckle

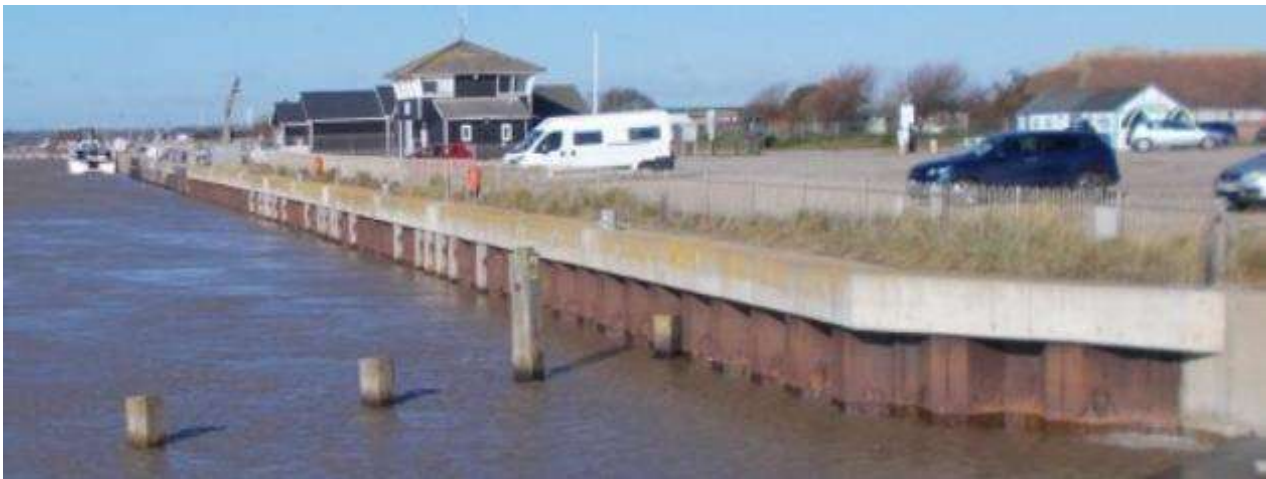
Figure 4-18: Current condition of North Wall

This structure was built less than 10 years ago. It is still very good condition (**Figure 4-18**) and would be expected to have another 50 years of life or more.

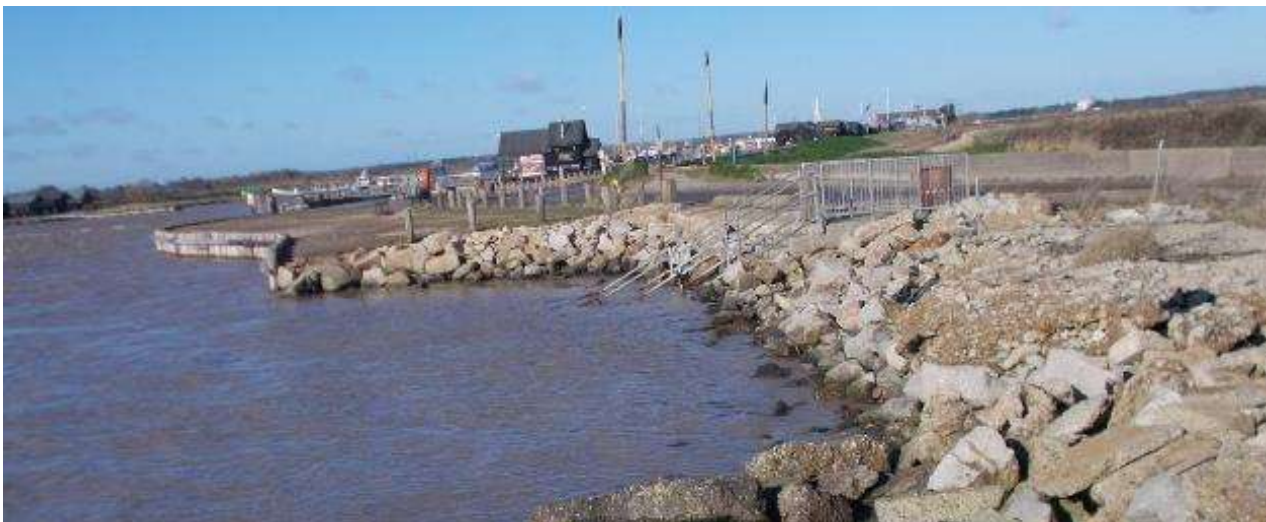
Figure 4-19: Rock revetment West of North Wall

At the west end of the new piled wall there is a short length of the old sheet piled wall, with a 20m length of rock revetment to the west of this (Figure 4-19). These are in moderate condition, but are not considered to be at risk of failure within the next 20 years.

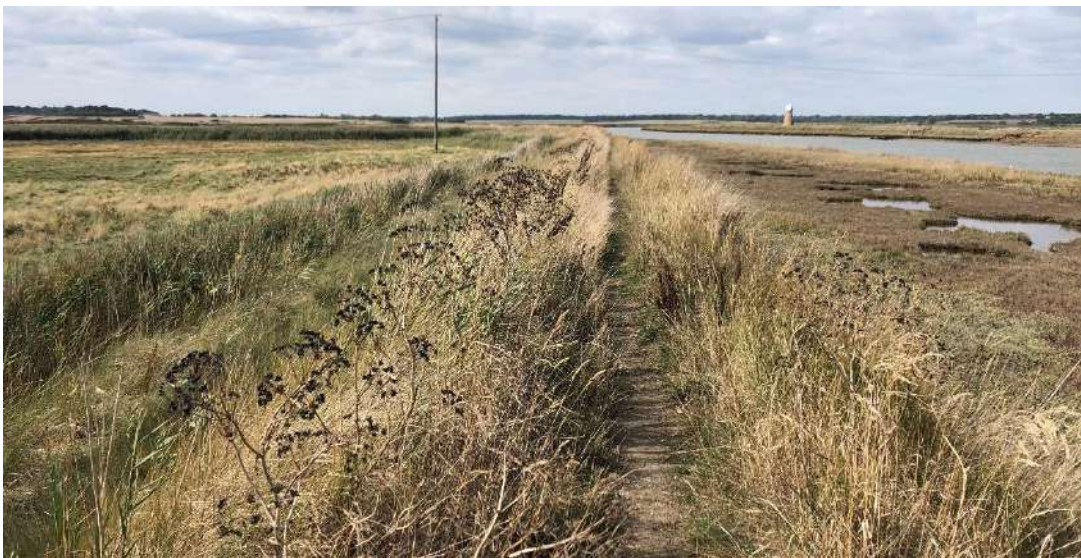
Figure 4-21: Embankment to Tinker's Marsh

The estuary flood embankments are very narrow, with a crest width that is typically less than 2m and side slopes of between 1.0 and 2.0. The photograph in **Figure 4-21** gives an example of the condition of the embankments to Tinker's Marsh.
