Southwold Harbour Study

Site Inspection Report

Client: Coastal Partnership East for East Suffolk Council

Reference: PB9485-RHD-ZZ-XX-RP-Z-0001

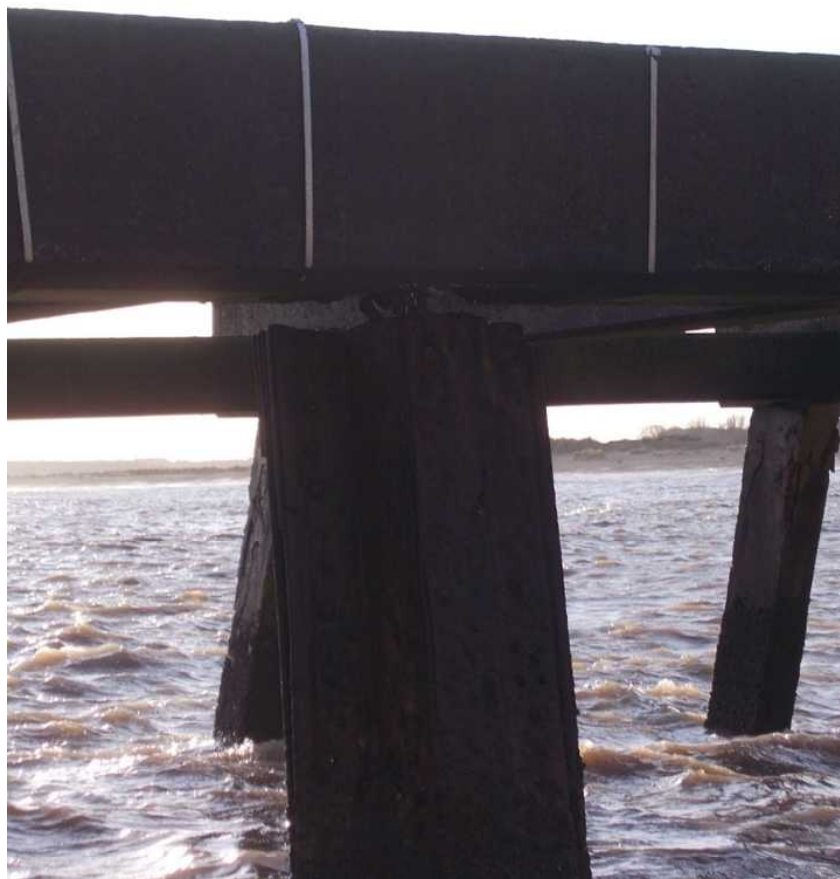
One of the box piles around the harbour mouth (number 8 counting the seaward end inland) is not supporting the beam above it. Closer inspection suggests that this pile is likely to have been struck by a vessel resulting in a dent at the low tide waterline. This damage is also causing the top beam to be cantilevered off the rear piles and may be subject to failure in a storm surge as above.

Box pile number 8 (**Figure A01**) has been damaged, possibly hit by a vessel at some point, and is no longer supporting the beam above which is simply cantilevered off the raking piles behind and the adjacent box piles. (Figure 6).

Figure 6 - Box Pile 8 failure

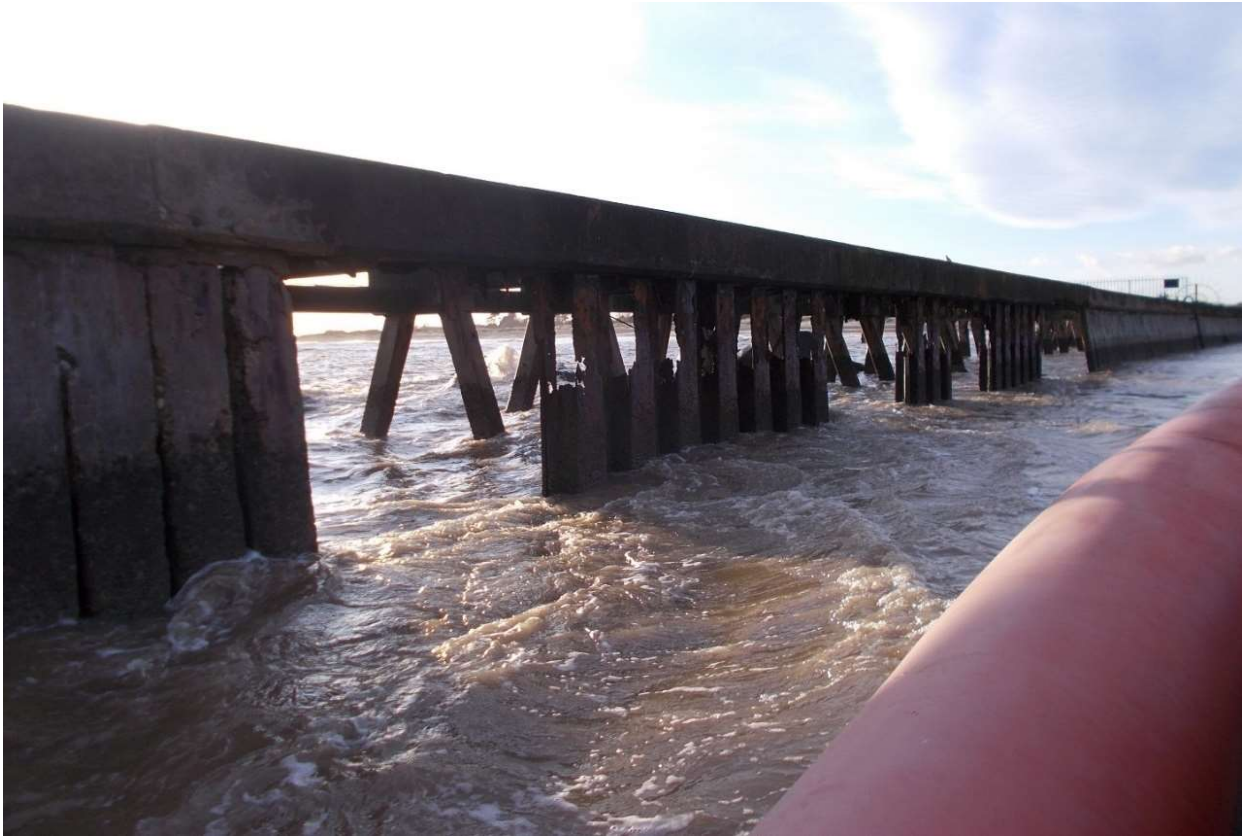
The sheet steel piles in Length C extend above low water into the splash zone. Consequently they have suffered from significant corrosion, and are supporting little to none of the front beam. This beam is cantilevered off the piles behind and would appear to be the most 'at risk' part of the structure. In the event of a storm surge event this beam is liable to be driven upwards, which could lead to the crossmembers or rear piles failing and a length of this front beam collapsing into the harbour.

A section of planks has been replaced with steel sheet piles (Length C) however these have corroded severely (Figure 7). This front beam section is no longer supported properly and is cantilevered off the rear raking piles. The damage to this structure in the past appears to have been slowed with mounds of rock that have been used to block openings in the pier face from the rear (**Figure A02**).

Figure 7 - Length C corroded steel sheet piles and unsupported front beam.

Length C has essentially failed and could collapse within the next 5 years. Failure could risk damage to adjacent parts of the structure. This section should be repaired as soon as possible.

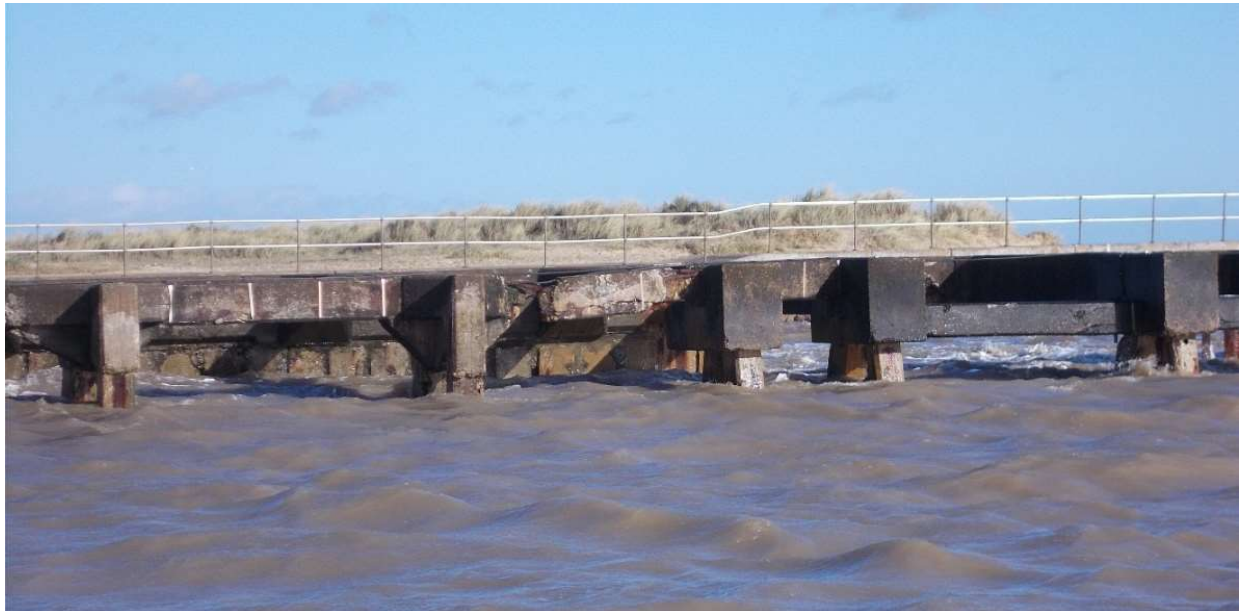
A rear longitudinal beam at piles 35-36 (**Figure A02**) has failed completely (Figure 8).

Figure 8 - 35-36 rear longitudinal beam failure

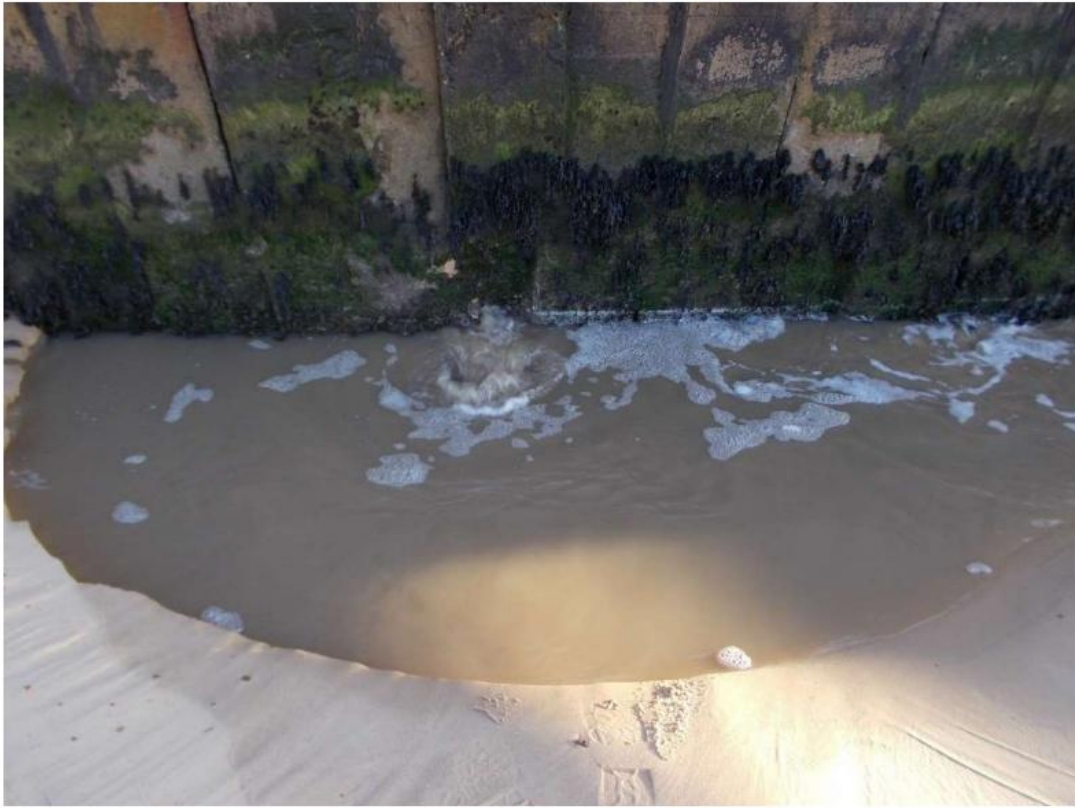
Figure 9 - Scour Hole in South beach at piles 66-67

If necessary considering the aims of the scheme, scour holes could be filled after the gaps in the planks and piles have been repaired.

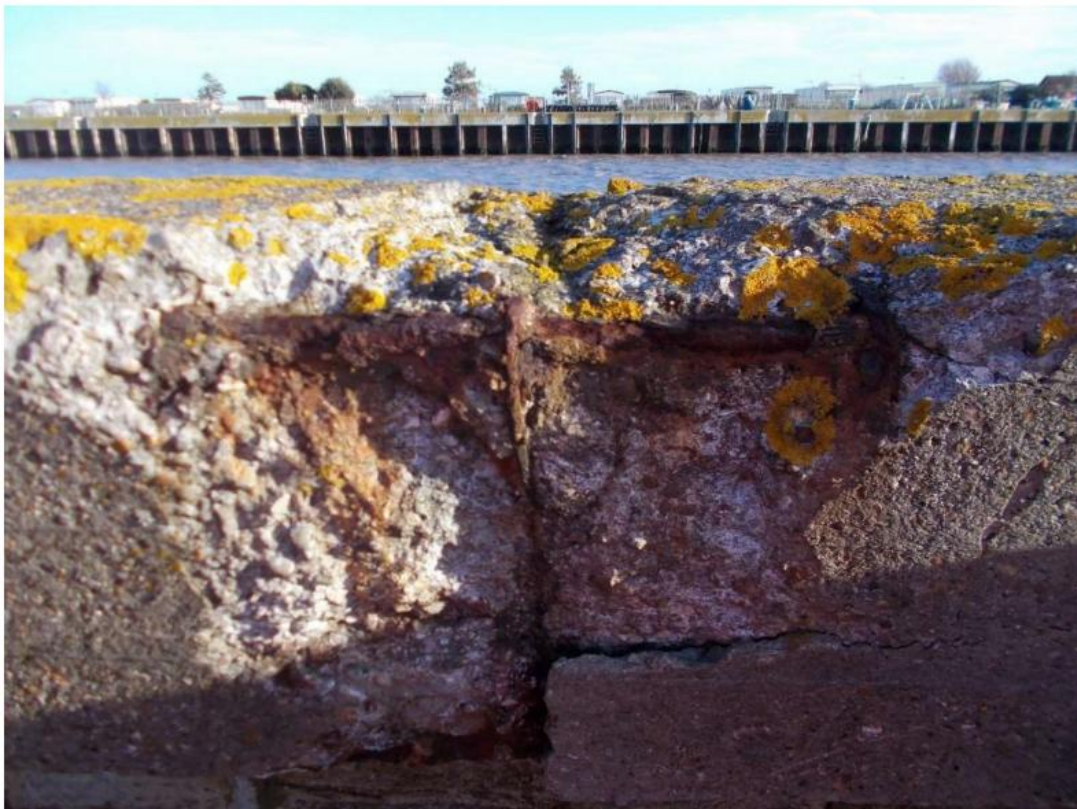
Potential failure has occurred in the front beam at piles 115-116 (Figure 10, See location in **Figure A05**)

Figure 10 - Exposed rebar and failure of front beam at piles 115-116

Reinforced concrete can be patched or replaced at those locations where the rebar is exposed. However, this may not be cost effective as it would not improve structural stability.

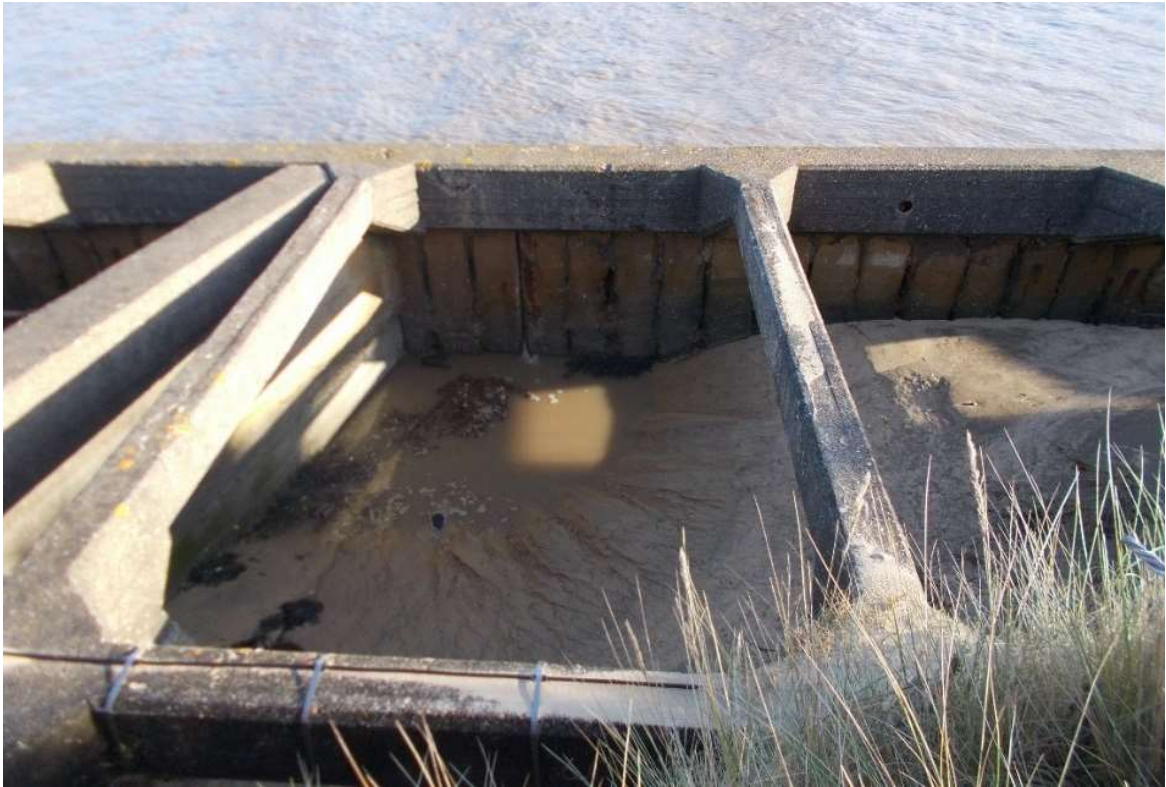
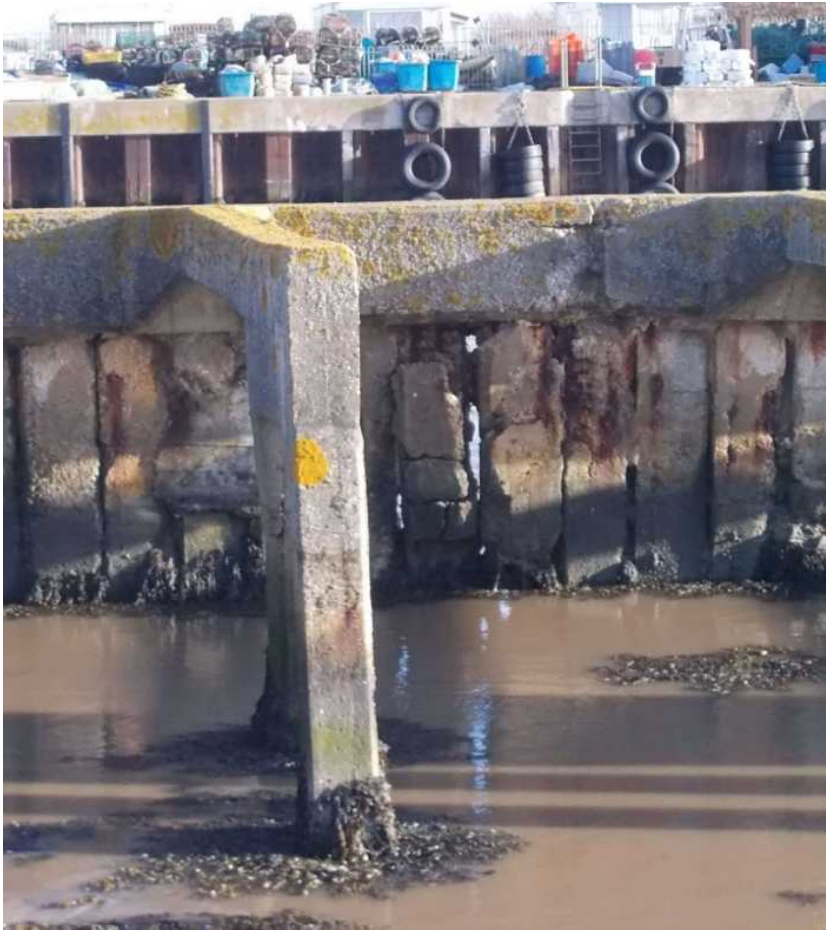
Figure 11 - Scour holes from failed front planks

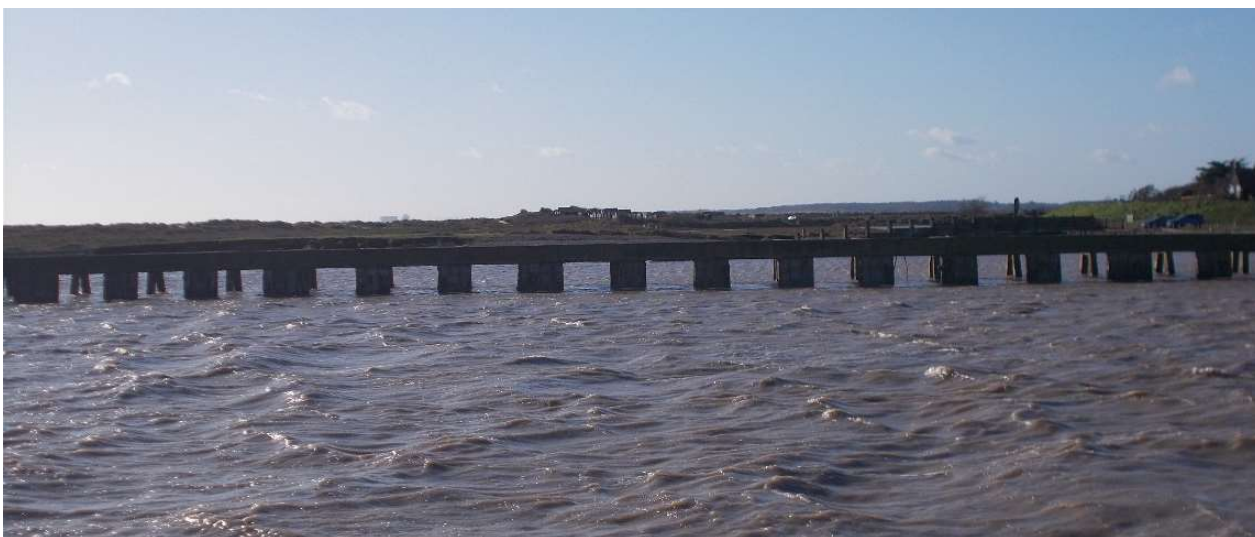
The wall has had windows cut in the North face that would otherwise enclose Walberwick Quay (Figure 13). The toes of the planks remain in situ serving to retain built up sediment in the quay (Figure 14).

Figure 13 - Length of wall with windows cut in planks

The windows cut in the concrete planks should not be filled as the reflected wave energy would cause problems for harbour users. It is recommended that the lower sections of the cut planks are left in situ to support the build-up of sediment inside Walberswick Quay and prevent it from collapsing out into the harbour channel.

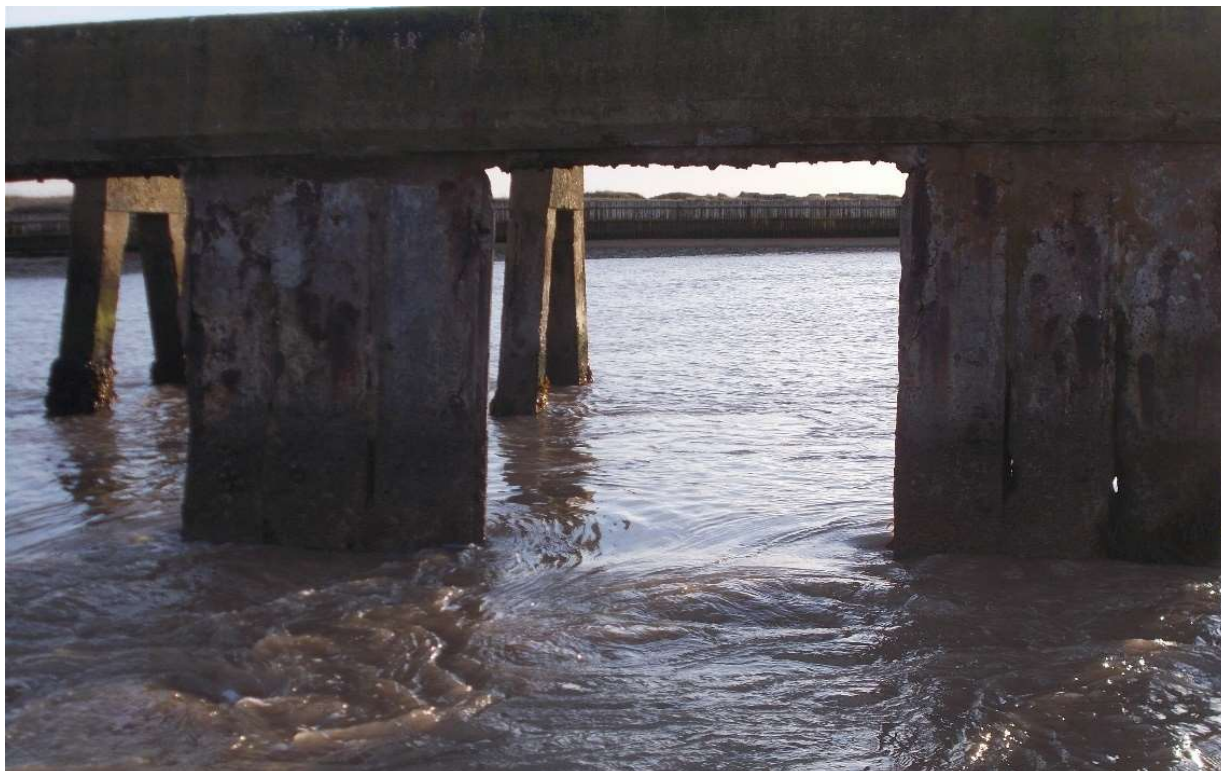
Figure 14 - Planks with cut out panels along South Training Wall

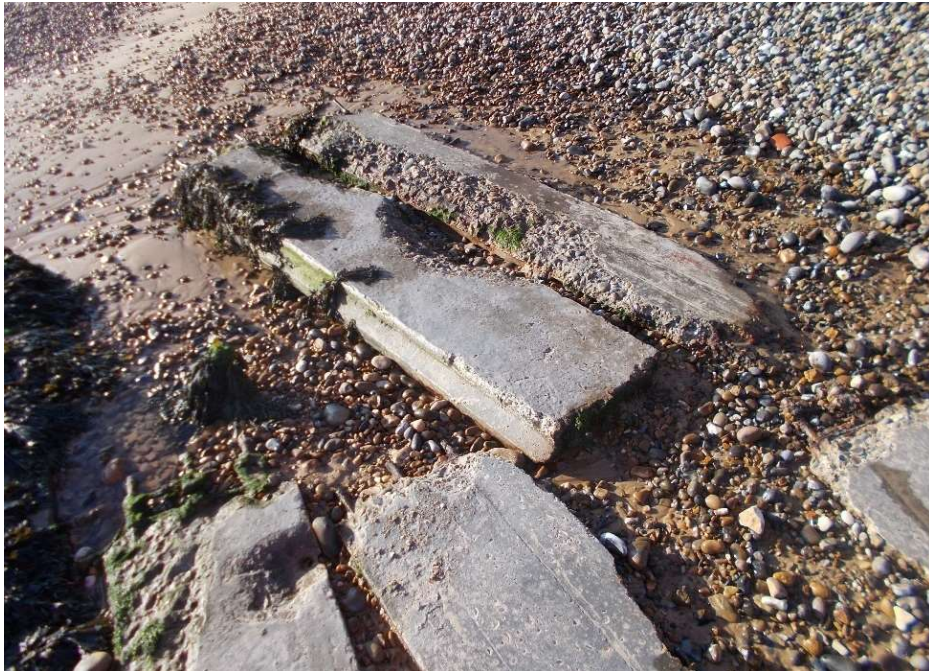
The remains of the cut out concrete planks were found on the West beach (Figure 18).

Figure 18 – Remains of upper lengths of cut planks from South Training Wall

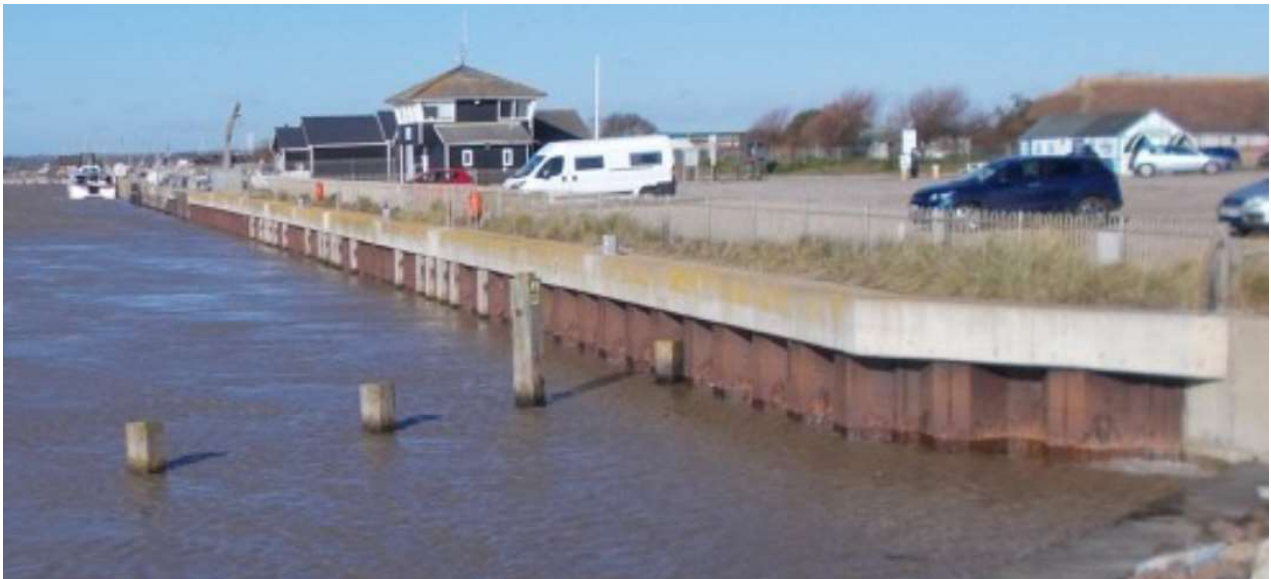
Figure 22 - Current condition of North Wall

This new wall is still in very good condition, and would be expected to have another 50 years of life or more. In structural terms, no further actions currently need to be taken.

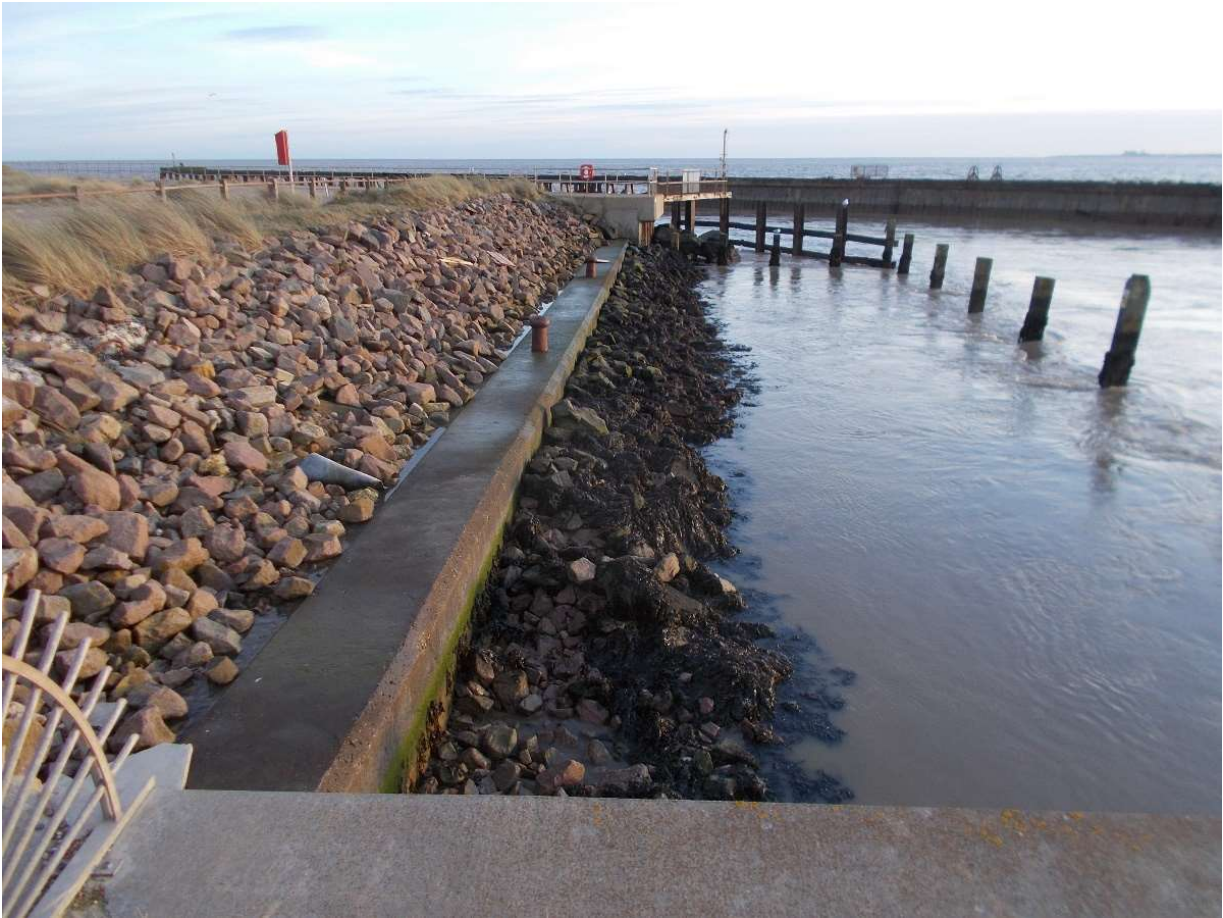
The revetment is in a good condition. The concrete toe beam is also in good condition and is continuing to support the revetment. Although the gabion cages are failing the wall has bedded into the surrounding ground and seems to be very solid.

Although the gabion cages are failing this is not considered to be a significant issue as their purpose has been served. The Knuckle is expected to have at least another 20 years of life. No actions currently need to be taken.

Figure 27 - Current condition of Knuckle

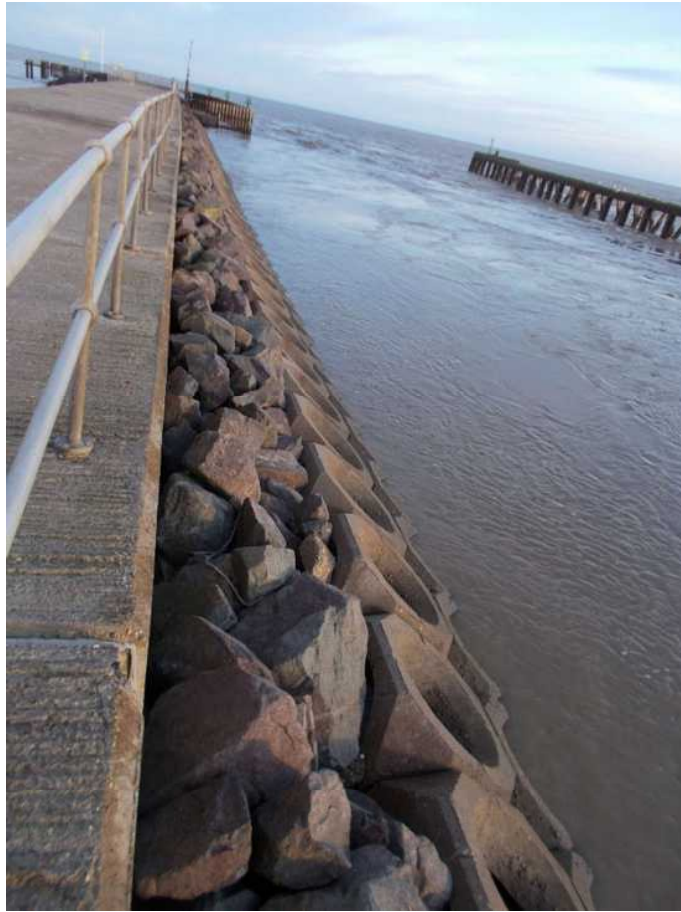
The SHED concrete block revetment runs most of the length of the North Pier (Figure 31). This has sustained some damage since construction in 1990 (Figure 32).

Figure 32 - SHED concrete blocks with rock fill

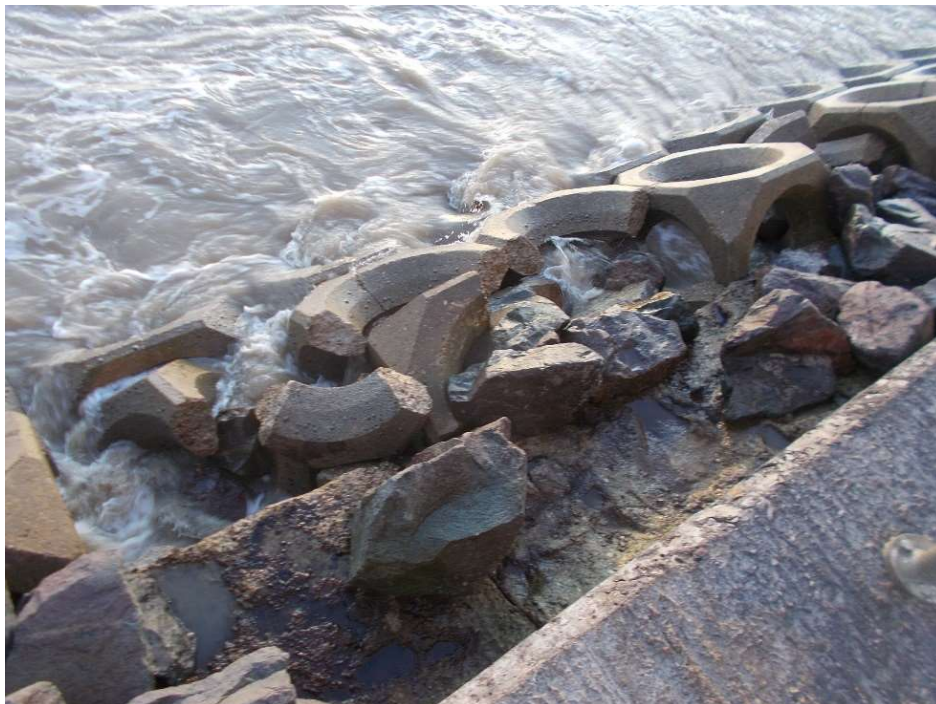
Some of the blocks have cracked and failed completely at the eastern end of the SHED concrete block revetment.

Figure 33 - Failed blocks near east end of concrete block revetment

The failed concrete blocks at the eastern end of the SHED concrete block revetment could be replaced.

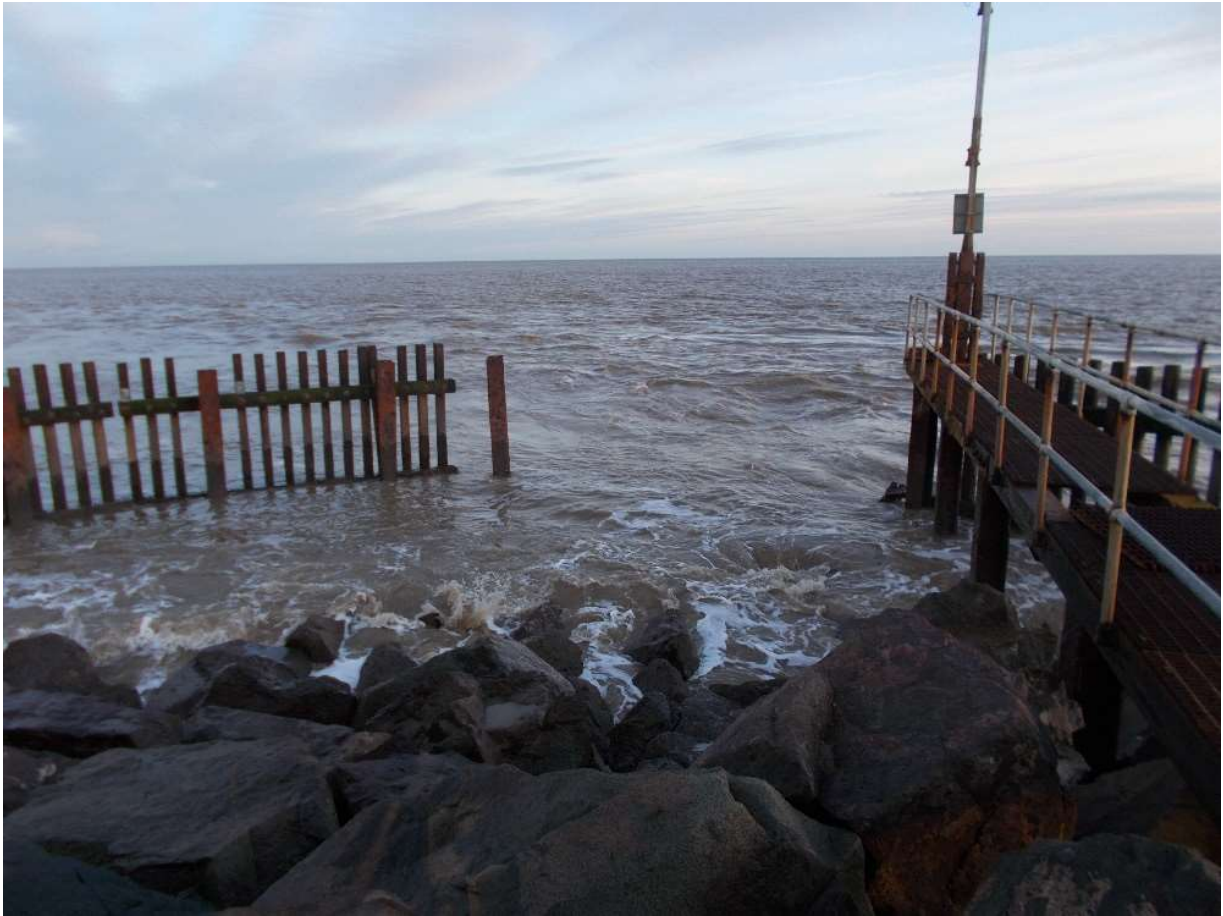
The timber fendering is damaged and a length of it is missing (Figure 34). The eastern-most length is missing the lower crossbeam and the vertical timber columns are only restrained at the top allowing them to move with the waves.

Figure 34 - Rock armour, navigational light and damaged timber fendering

The loose timber fendering should be replaced but might be wise to keep an access gap in this to allow access if needed in case someone becomes trapped behind it (Figure 34).

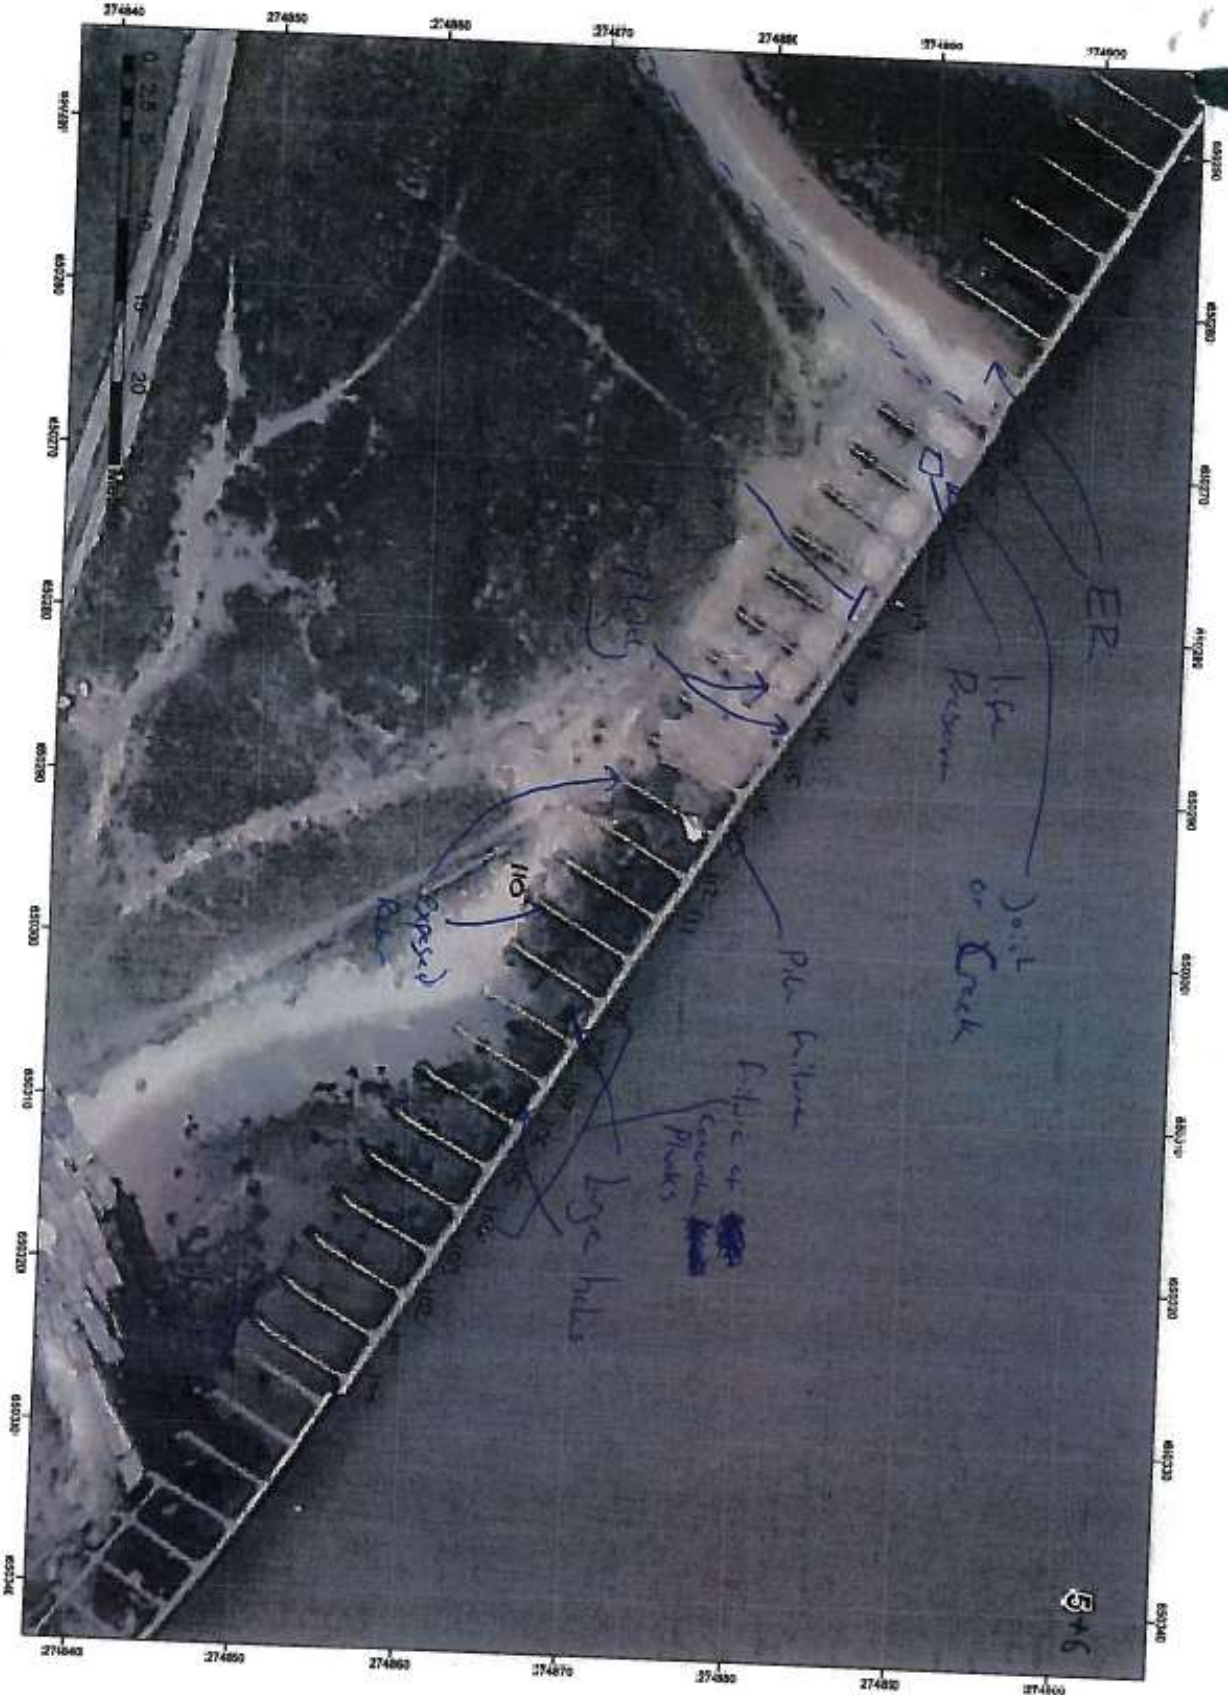
Figure A05 South Pier

A joint has begun to fail / a crack has formed on the front beam between piles 121 and 122 (**Figure A05**).
