Item: 9

DC/21/5574/LBC

Repair & Refurbishment of Existing Pedestrian
Bridge

Jubilee Bridge, The Ravine, Lowestoft, Suffolk

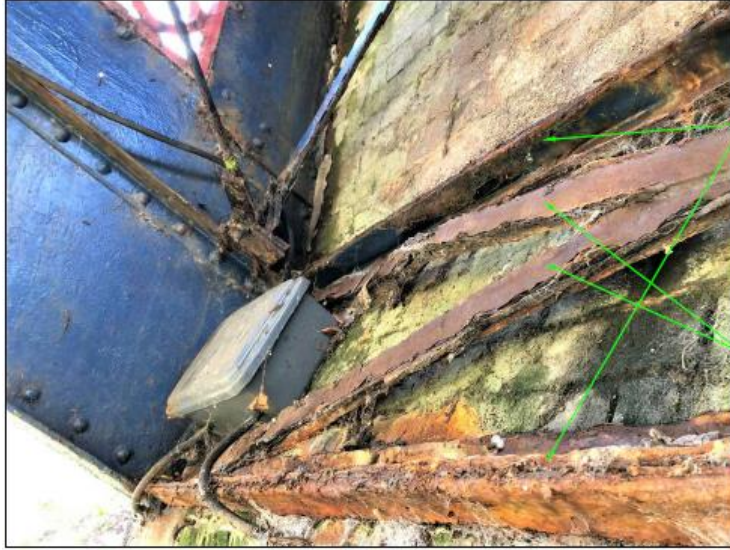
SEVERELY CORRODED AND DELAMINATED WROUGHT IRON ANGLE SECTION CROSS-MEMBERS. TO BE REPLACED WITH NEW FABRICATED S275J0 MILD STEEL MEMBERS TO MATCH SIZE AND GEOMETRY OF ORIGINAL MEMBERS WITH NEW END FIXINGS.

SEVERELY CORRODED AND DELAMINATED WROUGHT IRON FLAT BAR CROSSED DIAGONAL BRACING MEMBERS. TO BE REMOVED AND REPLACED WITH NEW FABRICATED S275J0 MILD STEEL MEMBERS TO MATCH SIZE AND GEOMETRY OF ORIGINAL MEMBERS WITH NEW END FIXINGS.

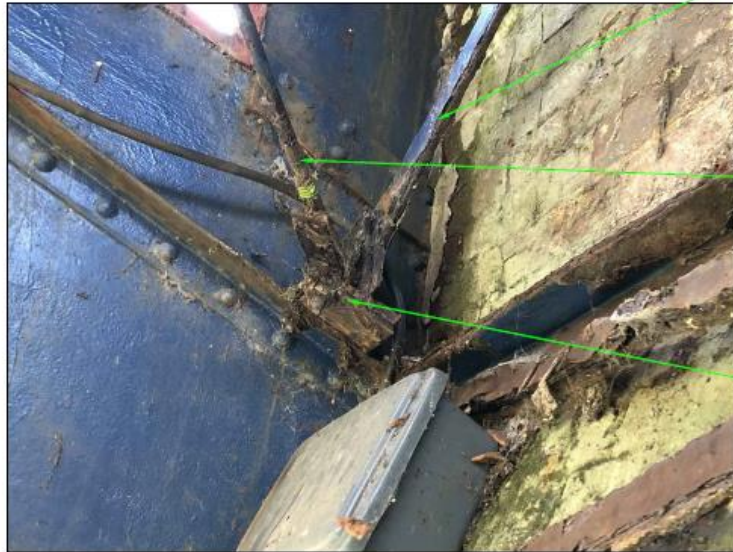
SEVERELY CORRODED AND DELAMINATED WROUGHT IRON FLAT BAR CROSSED DIAGONAL BRACING MEMBERS. TO BE REMOVED AND REPLACED WITH NEW FABRICATED S275J0 MILD STEEL MEMBERS TO MATCH SIZE AND GEOMETRY OF ORIGINAL MEMBERS WITH NEW END FIXINGS.

SEVERELY CORRODED PLAN BRACING ROD MEMBERS SHOWING SIGNIFICANT NECKING TO ENDS OF MEMBERS. TO BE REMOVED AND REPLACED WITH NEW FABRICATED S275J0 MILD STEEL MEMBERS TO MATCH SIZE AND GEOMETRY OF ORIGINAL MEMBERS WITH NEW END FIXINGS.

SEVERELY CORRODED AND DELAMINATION WROUGHT IRON PLAN BRACING TO PRINCIPAL BRIDGE BEAM CONNECTION PLATE. TO BE REMOVED AND REPLACED WITH NEW FABRICATED S275J0 MILD STEEL MEMBERS TO MATCH SIZE AND GEOMETRY OF ORIGINAL MEMBERS WITH NEW END FIXINGS.

PHOTOGRAPHS SHOWING SEVERE CORROSION AND DELAMINATION TO VERTICAL AND PLAN BRACING MEMBERS CLOSE TO SOUTHERN BRIDGE ABUTMENT

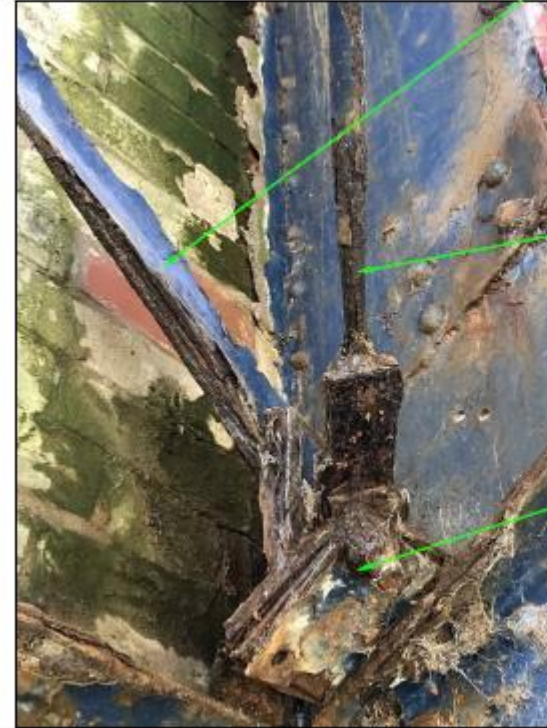
SEVERELY CORRODED AND DELAMINATED WROUGHT IRON FLAT BAR CROSSED DIAGONAL BRACING MEMBERS. TO BE REMOVED AND REPLACED WITH NEW FABRICATED S275J0 MILD STEEL MEMBERS TO MATCH SIZE AND GEOMETRY OF ORIGINAL MEMBERS WITH NEW END FIXINGS.

SEVERELY CORRODED PLAN BRACING ROD MEMBERS SHOWING SIGNIFICANT NECKING TO ENDS OF MEMBERS. TO BE REMOVED AND REPLACED WITH NEW FABRICATED S275J0 MILD STEEL MEMBERS TO MATCH SIZE AND GEOMETRY OF ORIGINAL MEMBERS WITH NEW END FIXINGS.

SEVERELY CORRODED AND DELAMINATED WROUGHT IRON PLAN BRACING TO PRINCIPAL BRIDGE BEAM CONNECTION PLATE. TO BE REMOVED AND REPLACED WITH NEW FABRICATED S275J0 MILD STEEL MEMBERS TO MATCH SIZE AND GEOMETRY OF ORIGINAL MEMBERS WITH NEW END FIXINGS.

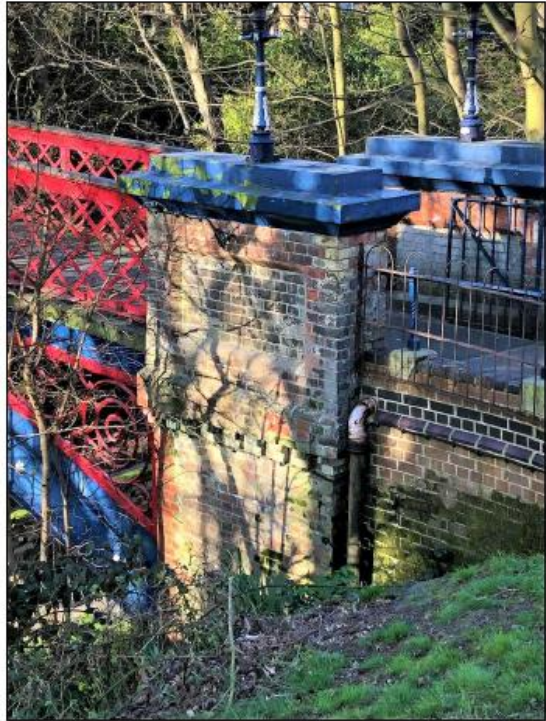
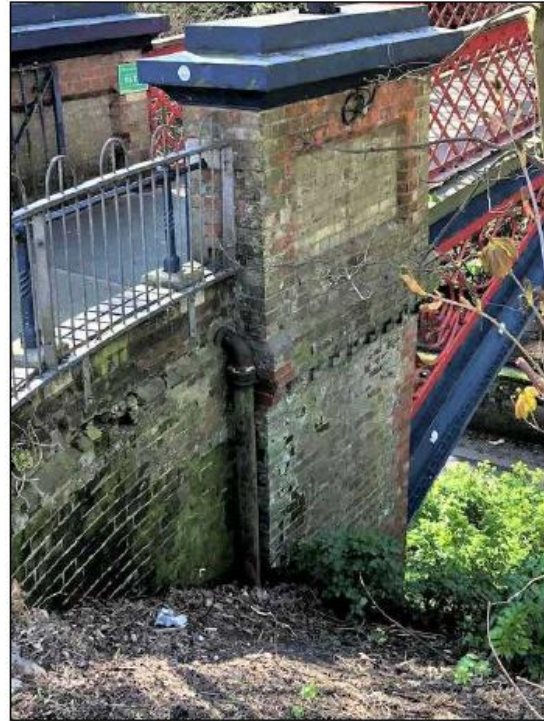
DAMAGED AND DEFECTIVE SURFACE WATER DRAINAGE RAINWATER DOWNPIPES AND CONNECTIONS WITH GULLY POTS ON NORTHERN BRIDGE ABUTMENT

TO BE REPLACED WITH NEW 100mm Ø CAST IRON RAINWATER DOWNPIPES WITH NEW
CONNECTIONS TO NEWLY INSTALLED uPVC GULLY POTS

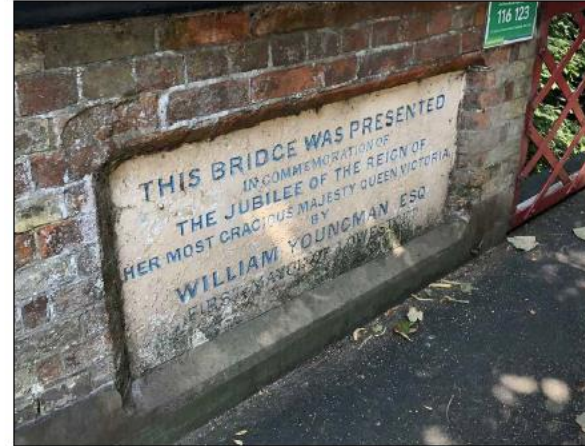
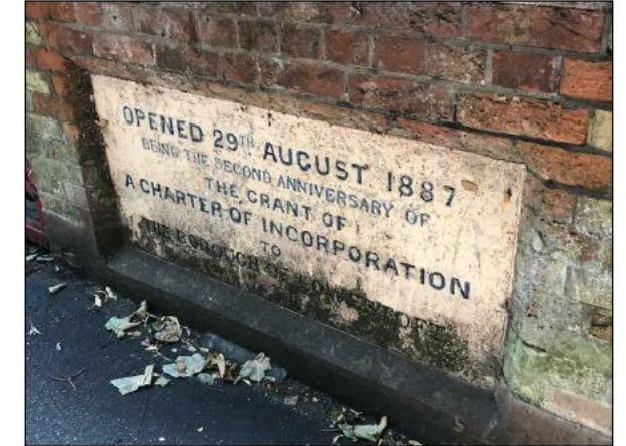
COMMEMORATIVE CARVED STONE PLACARDS ON SOUTHERN BRIDGE ABUTMENT PIERS

TO BE CLEANED AND RE-PAINTED WITH CARVED LETTERING RE-PAINTED BLUE AS EXISTING
(BELIEVED TO BE SAND-STONE)

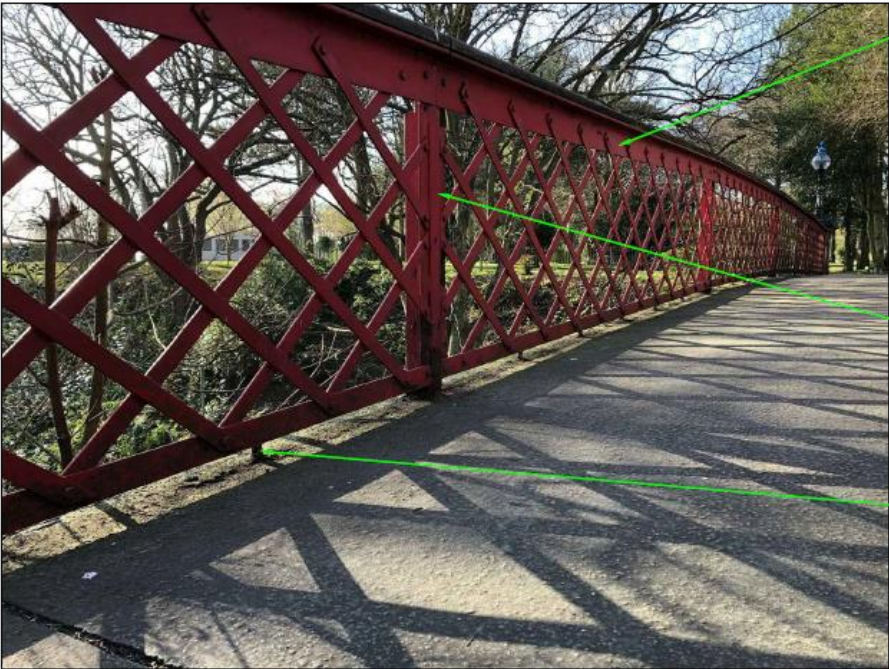
EXISTING NON-ORIGINAL FABRICATED MILD STEEL LATTICE TYPE HAND RAIL INFILL PANELS (10 No. TOTAL, 5 No. PER SIDE) WITH BOLTED CONNECTIONS WITH SUPPORTING MASONRY BRIDGE ABUTMENTS AND FABRICATED MILD STEEL BALUSTERS. REFER TO DRAWING No. 20223_EX03 FOR DETAILS.

EXISTING NON-ORIGINAL FABRICATED MILD STEEL BALUSTERS SUPPORTING HAND RAIL INFILL PANELS. REFER TO DRAWING No. 20223_EX03 FOR DETAILS.

BOLTED CONNECTIONS (AND SPACER TUBES) SECURING BOTTOM CHORD ANGLE SECTION OF HAND RAIL INFILL PANELS TO CONCRETE BRIDGE DECK TO PROVIDING INTERMEDIATE LATERAL RESTRAINT AND VERTICAL SUPPORT.

WHEN REFURBISHED HAND RAIL PANELS ARE REPLACED PROVIDE NEW GALVANISED M12 Gr 8.8 RESIN ANCHORED FIXINGS (STUD, WASHER, NUTS & SPACERS) SECURED INTO CONCRETE USING HILT HIT-HY 200-A RESIN (OR SIMILAR EQUIVALENT) WITH MINIMUM 100mm EMBEDMENT INTO CONCRETE.

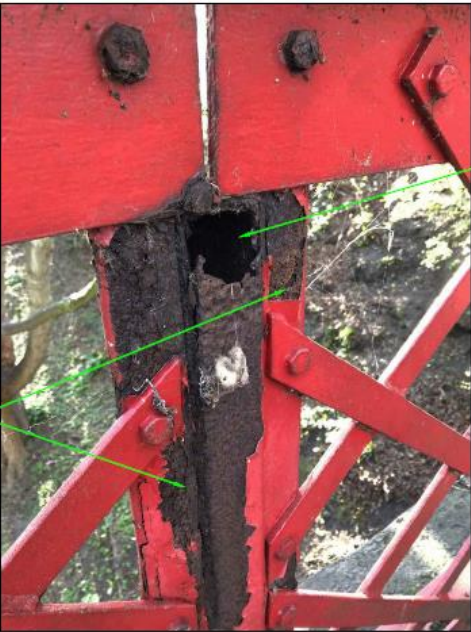
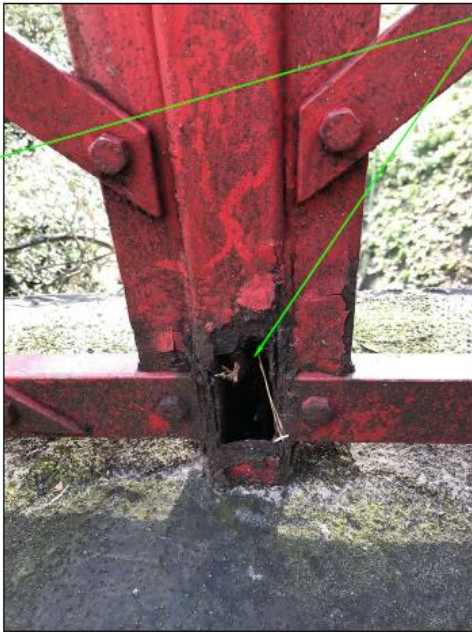
TYPICAL VIEWS SHOWING LEVELS OF SEVERE CORROSION, SECTION LOSS AND PERFORATION TO FABRICATED MILD STEEL HAND RAIL BALUSTER SECTIONS.

TYPICAL VIEWS SHOWING SEVERE LEVELS OF CORROSION AND SECTION LOSS PRESENT IN EXISTING FABRICATED MILD STEEL HAND RAIL BALUSTERS

ALL 8 No. HAND RAIL BALUSTERS ARE TO BE REPLACED WITH NEW ITEMS FABRICATED IN GRADE S275J0 STEEL AND GALVANISED PRIOR TO PAINTING. REFER TO DETAILING AND SPECIFICATION OF NEW HAND RAIL BALUSTERS ABOVE.

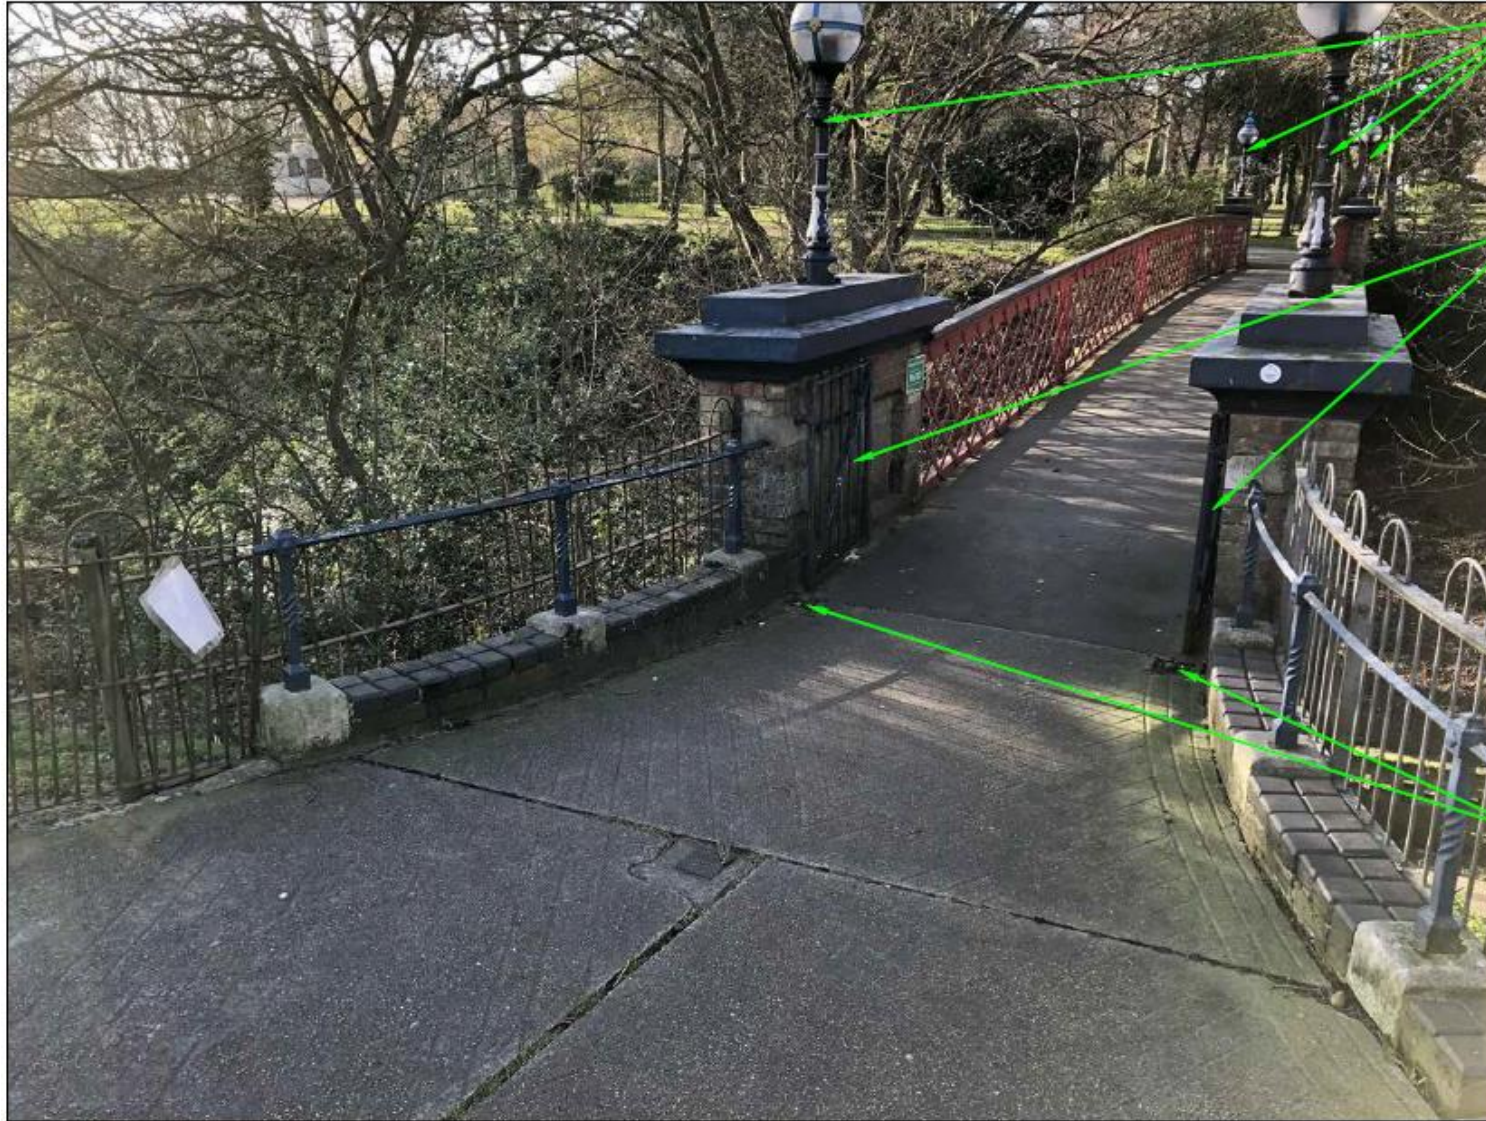
NORTHERN BRIDGE APPROACH FROM NORTH PARADE
SHOWING LOCATION OF ORIGINAL ACCESS GATES

ORIGINAL LANTERNS TO BE RESTORED AND RECOMMISSIONED.
4 No. IN TOTAL, 1 No. PER ABUTMENT PIER.

LOCATION OF ORIGINAL WROUGHT IRON ACCESS GATES TO BE REMOVED, BLAST CLEANED, REPAIRED AND REFITTED.

EXISTING DAMAGED SURFACE DRAINAGE GULLYS TO BE REMOVED AND REPLACED WITH NEW uPVC TRAPPED YARD GULLY POTS WITH GALVANISED STEEL GRATINGS CONNECTED TO NEW RAIN WATER DOWNPIPES.
CONCRETE PAVING TO MADE GOOD TO MATCH EXISTING ONCE GULLIES HAVE BEEN INSTALLED.
