# Southwold Harbour Management Committee

Members are invited to a **Meeting of the Southwold Harbour Management Committee**

| <b>6</b> | <b>Southwold Harbour Investment Plan Study and options for replacement of the South Pier ES/1600</b><br>To consider the report on the Southwold Harbour Investment Plan Study and options for replacement of the South Pier | <b>14 - 224</b> |

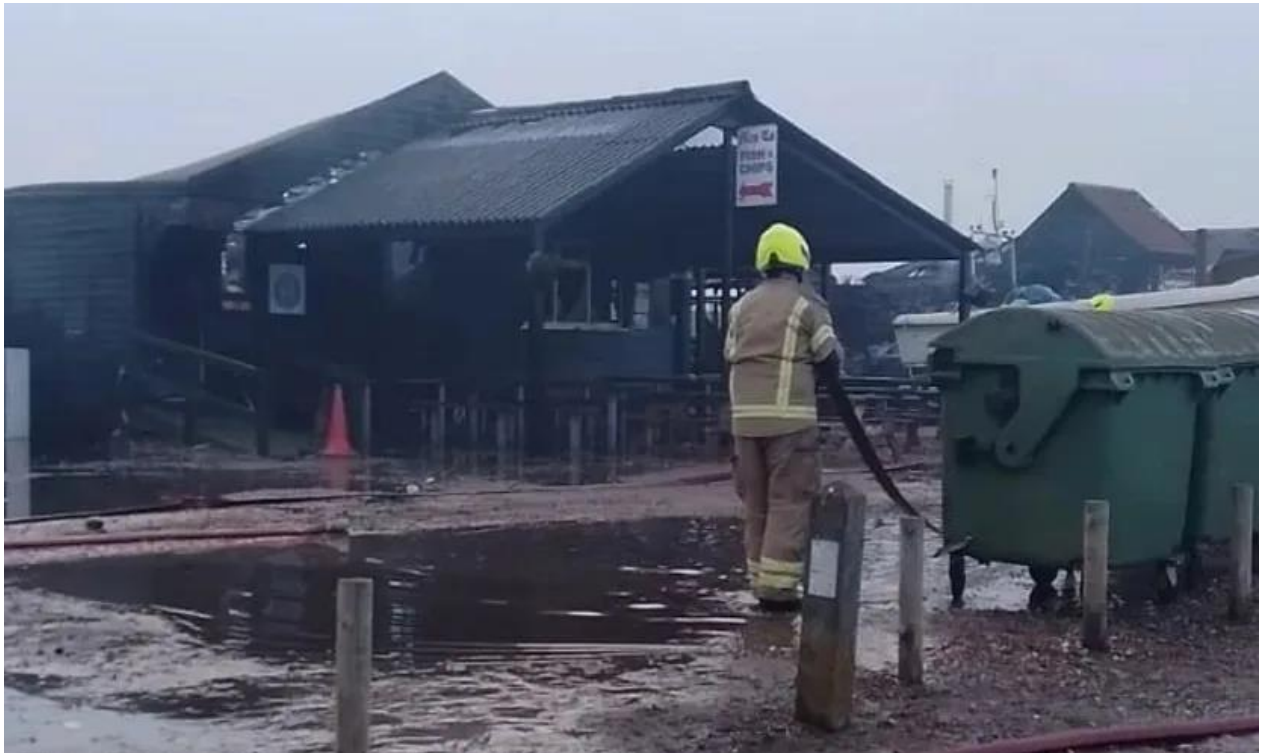
The fire was finally extinguished at around 0450. It is believed that the fire was caused by an electrical fault. There were no casualties.

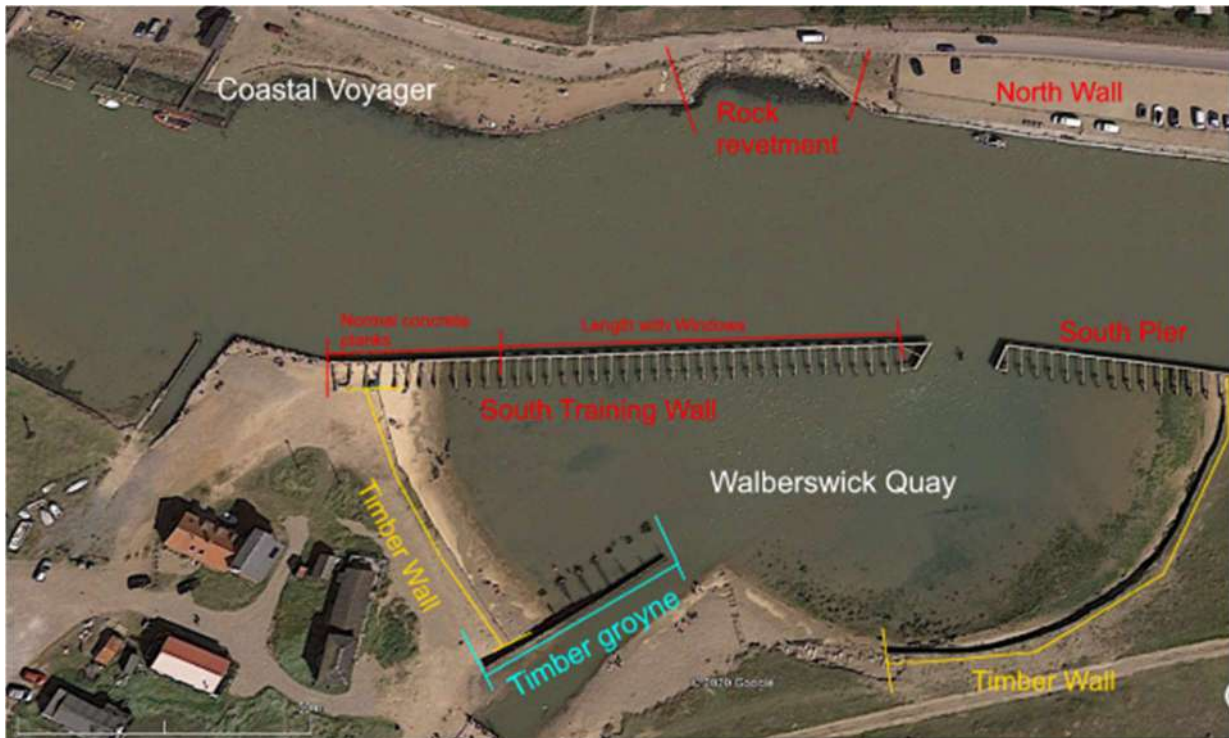
Figure 4-7: South Training Wall, Walberswick Quay

It is recommended that the lower sections of the cut concrete planks are left in situ to support the build-up of sediment inside Walberswick Quay and prevent it from collapsing out into the harbour channel.

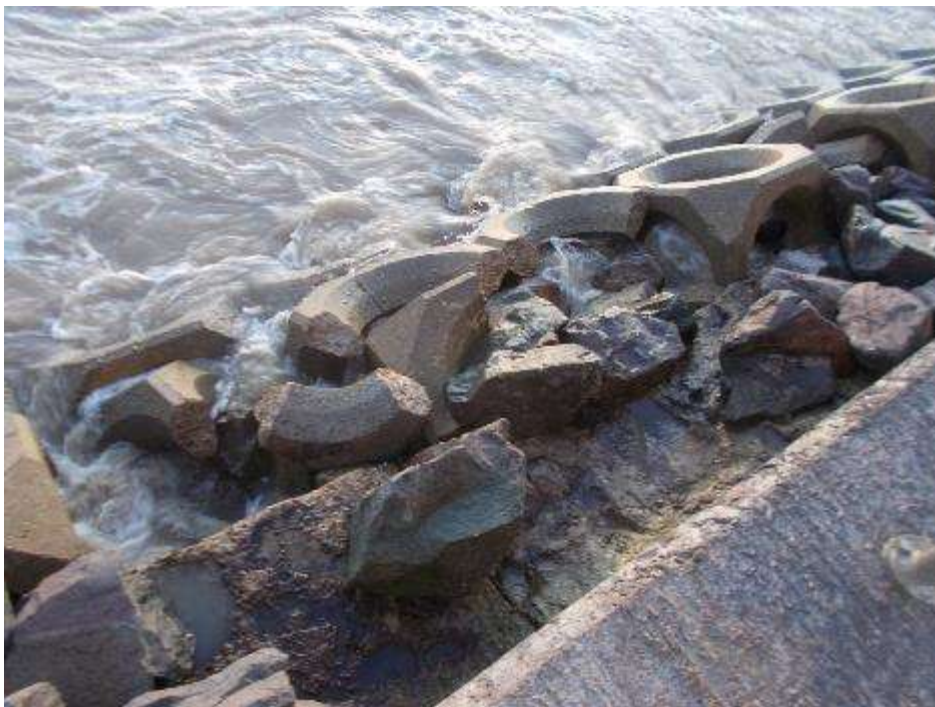
Figure 4-13: Failed blocks near east end of concrete block revetment

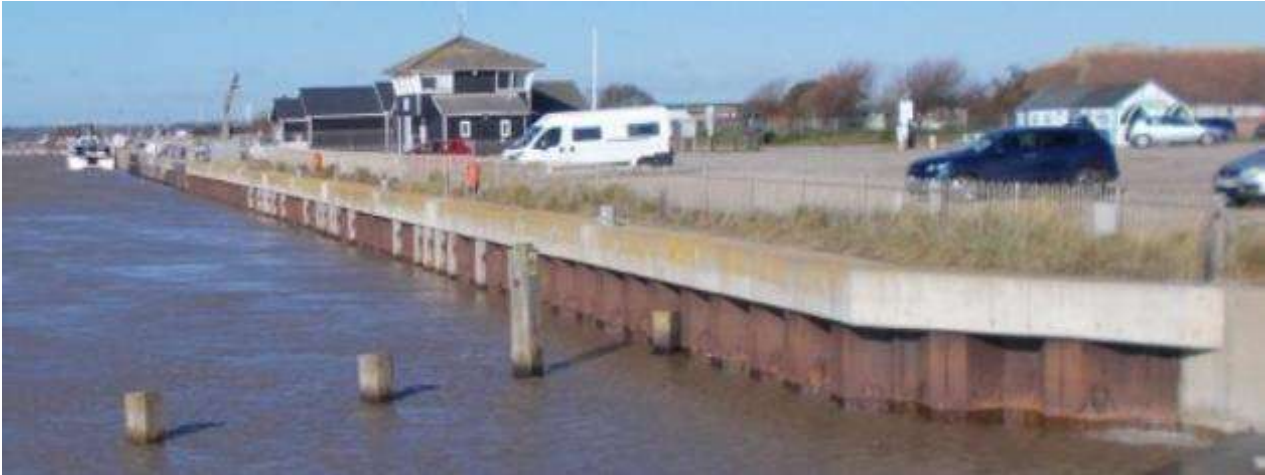
This structure was built less than 10 years ago. It is still very good condition (**Figure 4-18**) and would be expected to have another 50 years of life or more.

Figure 4-18: Current condition of North Wall

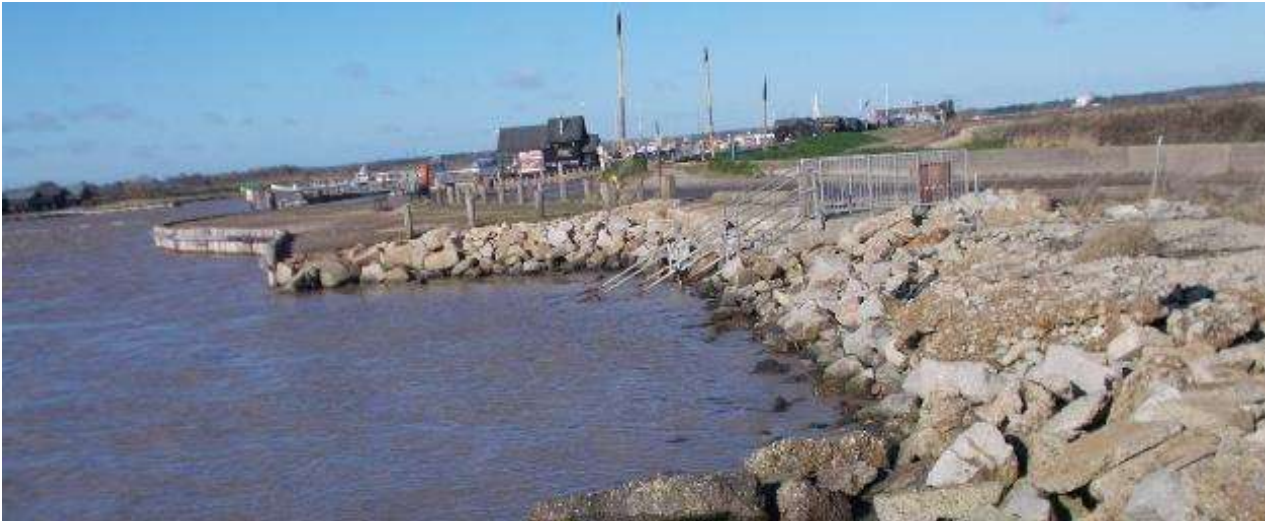
At the west end of the new piled wall there is a short length of the old sheet piled wall, with a 20m length of rock revetment to the west of this (Figure 4-19). These are in moderate condition, but are not considered to be at risk of failure within the next 20 years.

Figure 4-19: Rock revetment West of North Wall

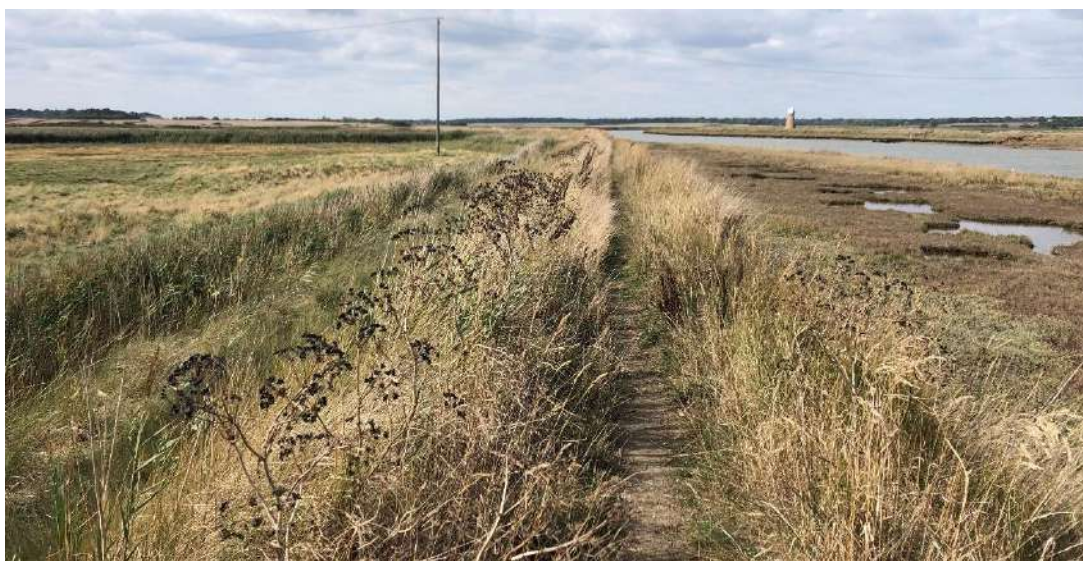
The estuary flood embankments are very narrow, with a crest width that is typically less than 2m and side slopes of between 1.0 and 2.0. The photograph in **Figure 4-21** gives an example of the condition of the embankments to Tinker's Marsh.

Figure 4-21: Embankment to Tinker's Marsh
