DC/21/5550/FUL

Erection of 21MW solar photovoltaic (PV) array

Address: Land at Park Farm, Loudham Hall Road, Loudham, Suffolk

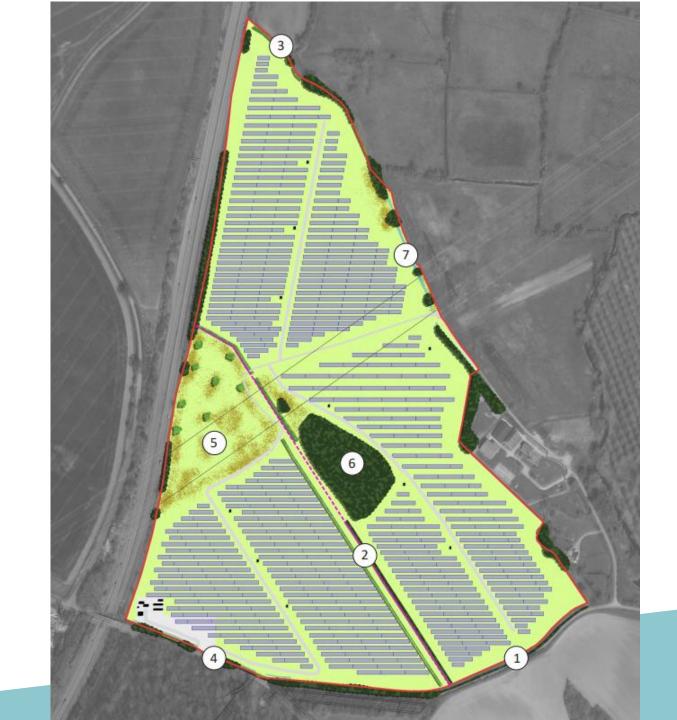
Landscape Masterplan

- 1. Retention of existing hedgerows and trees and allow to grow to a height of 3 to 4 m along the southern boundary (eastern section).
- 2. Proposed native hedge planting along the central part of the site along the PRoW. PRoW corridor extended to a width of 10m.
- 3. Re-establish native hedge planting along a proportion of the northern boundary (western and central section).
- 4. Lay existing hedge and plant up gaps of the southern boundary (western section).
- 5. Creation of a scrub with grassland habitat in the central section of the site.
- 6.Existing block of woodland excluded from the application area.
- 7. Existing ditches retained and enhanced for biodiversity.

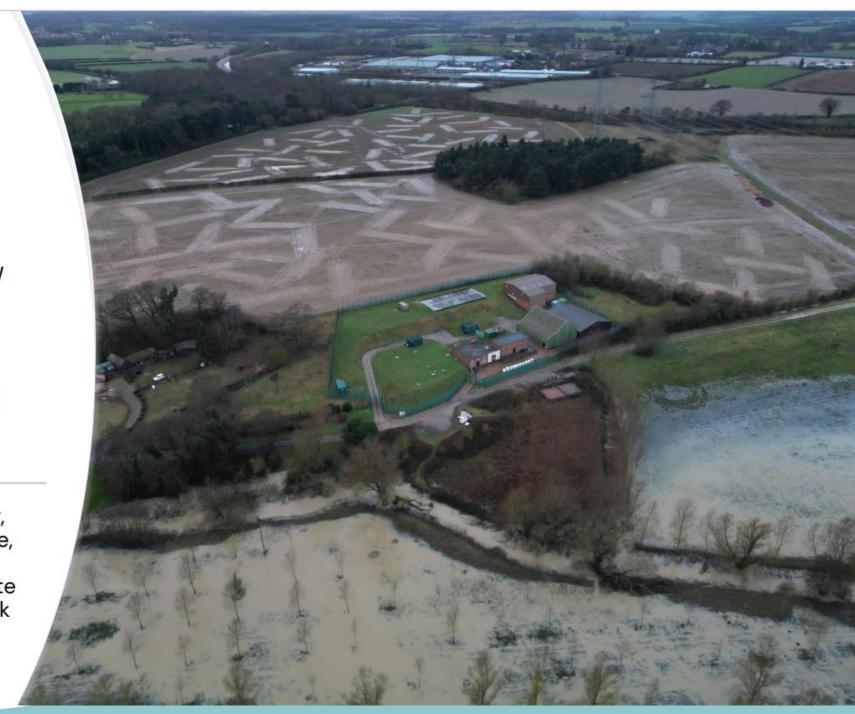
View over River Deben looking west

towards Anglian Water pumping facility, part of the Deben flood plain, valley side, block of conifer; within part of the proposed site. Also Loudham Hall Estate woodland belt, A12 in cutting and Suffolk Plant Centre (on B1438) glass and poly tunnel roofs in distance.

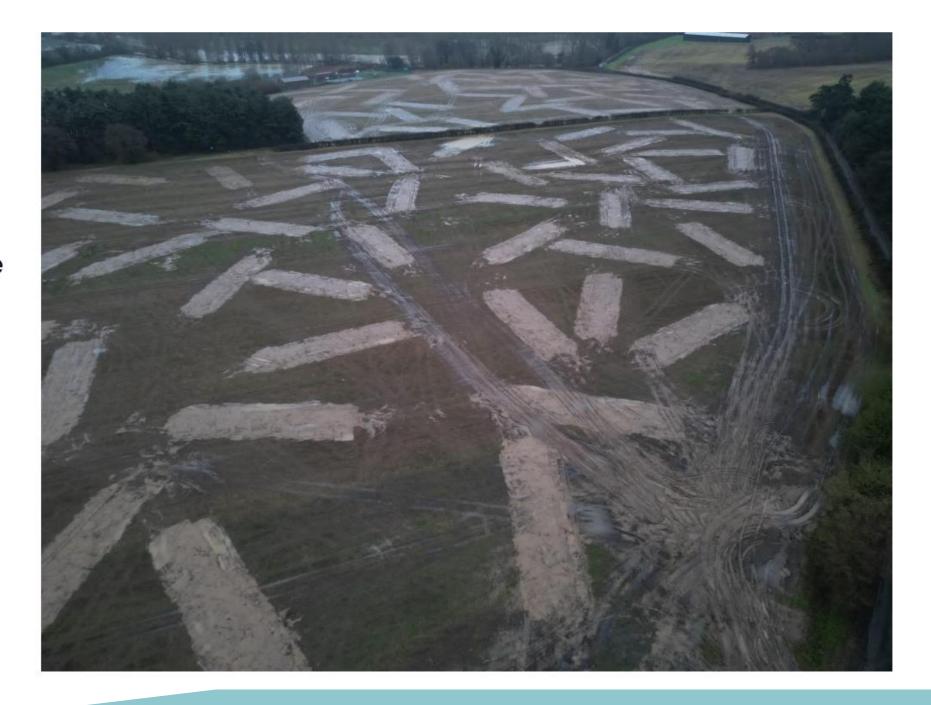
View taken over Loudham Hall Road, access to site, just east of the A12 bridge (approx.) looking northeast over the site area, valley sides and flood plain. Loudham Hall Road visible on the right of the image.

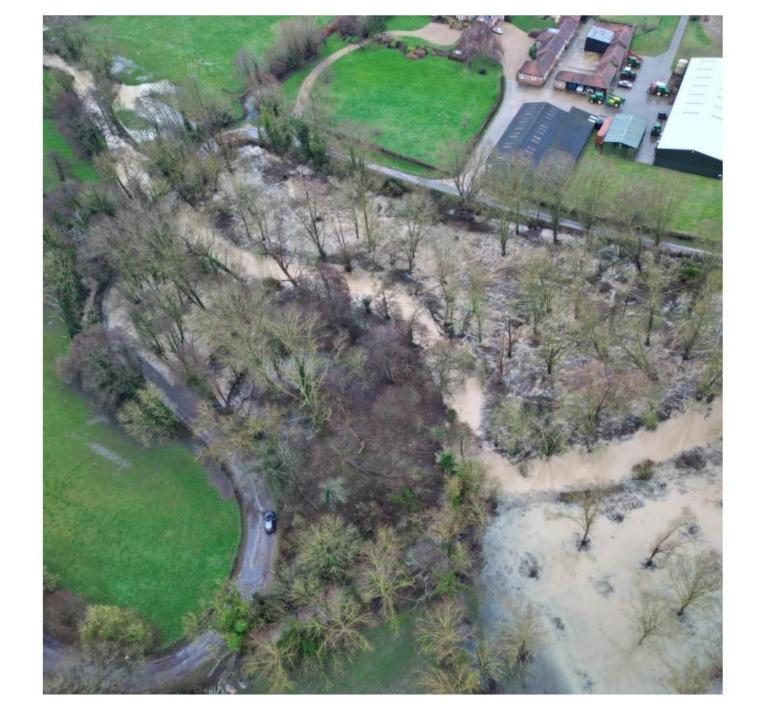
View over River Deben and Loudham Hall Road looking south, away from the site area. Showing the River Deben flood plain, and Park Farm on Loudham Hall Road.

Water levels rose again after 2nd January with overhead power cables fallen into flood and the road closed to traffic.

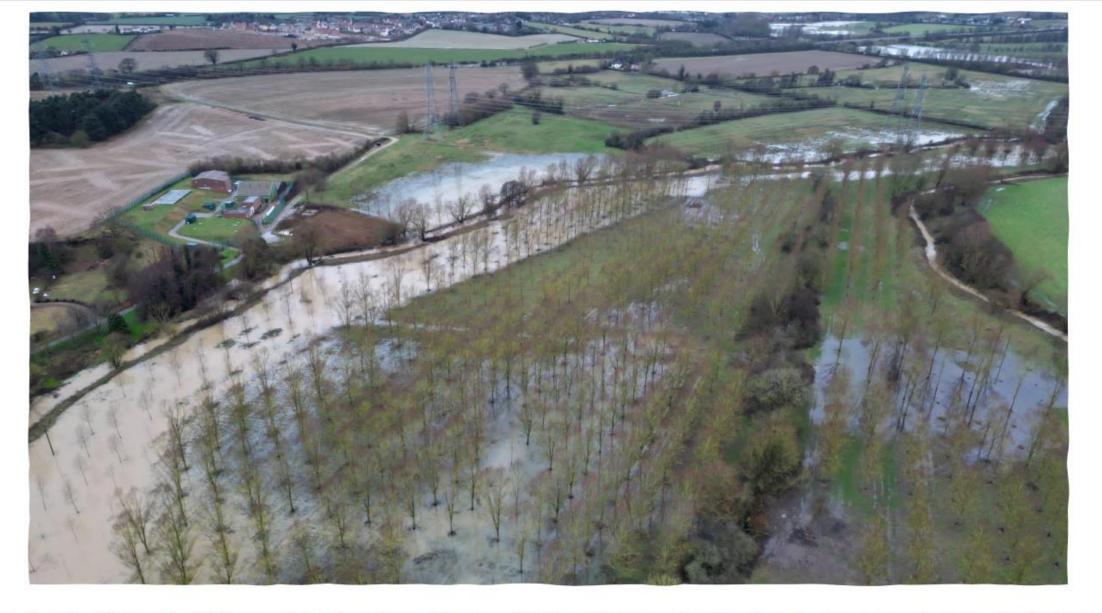
Above: (on Left) Sandpit House & land, valley side site fields, AW Pumping Station, lower part of proposed site area flooded, the wider flood plain + Cricket Bat willow, River Deben and grazing meadow (on Right)

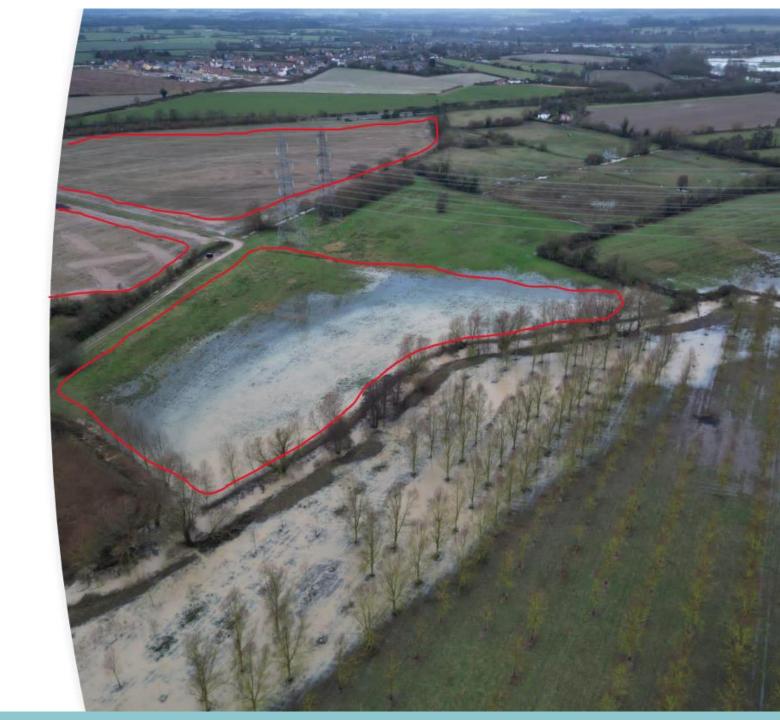
View taken over Park Farm (approx) looking northwest towards Wickham Market.

River Deben flood plain (floods each winter) with the lower part of the site field flooded last October to the current time.

Part of the site area denoted by a red line.

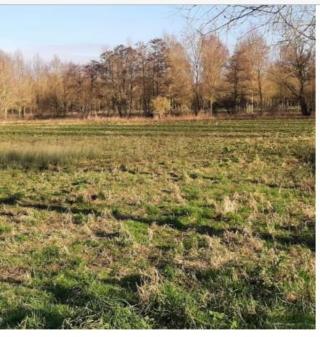
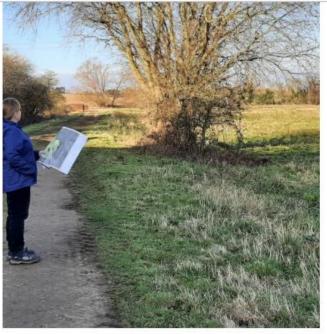
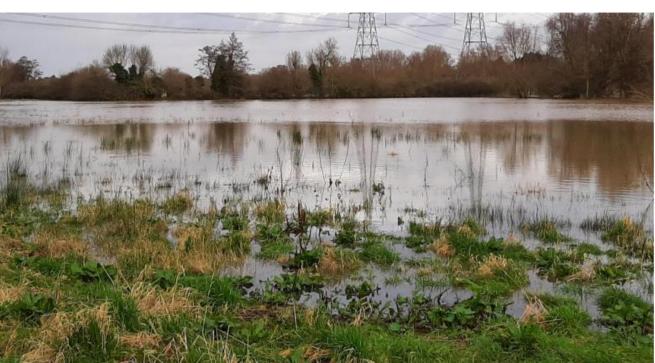
The lower eastern part of the proposed site located in the River Deben flood plain, this floods every year. Flooded much of the winter months since Storm Babet in October 2023.

Photo top left taken 13th January after the water level had receded: Meadow grassland and habitat for heron, egret, lapwing, geese and duck. Kingfisher, otter and water vole also frequent the River Deben and valley.

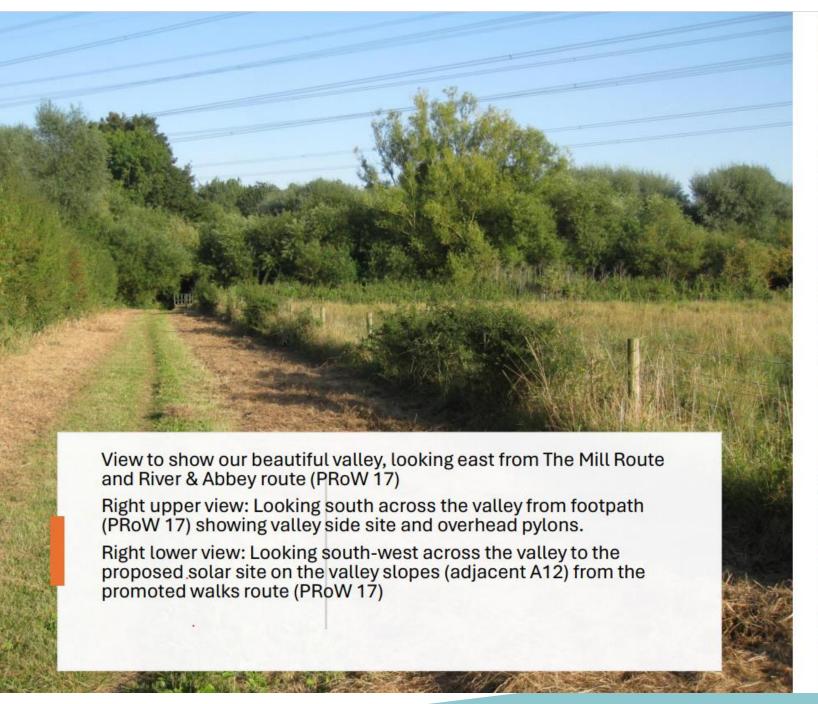
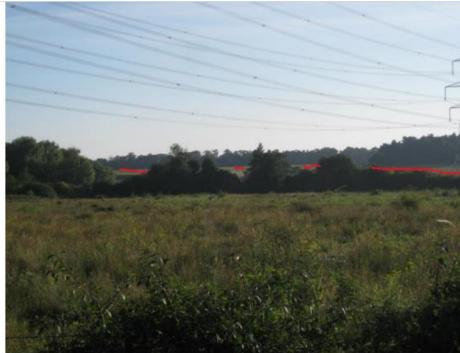
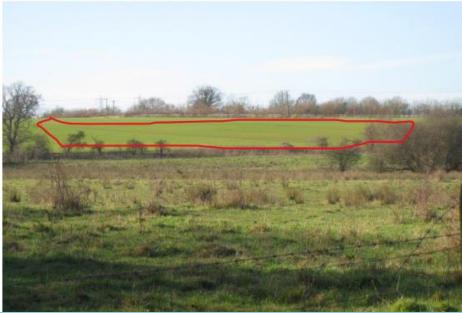
All photographs taken from the private track to Sandpit House and AW pumping station and farmland.

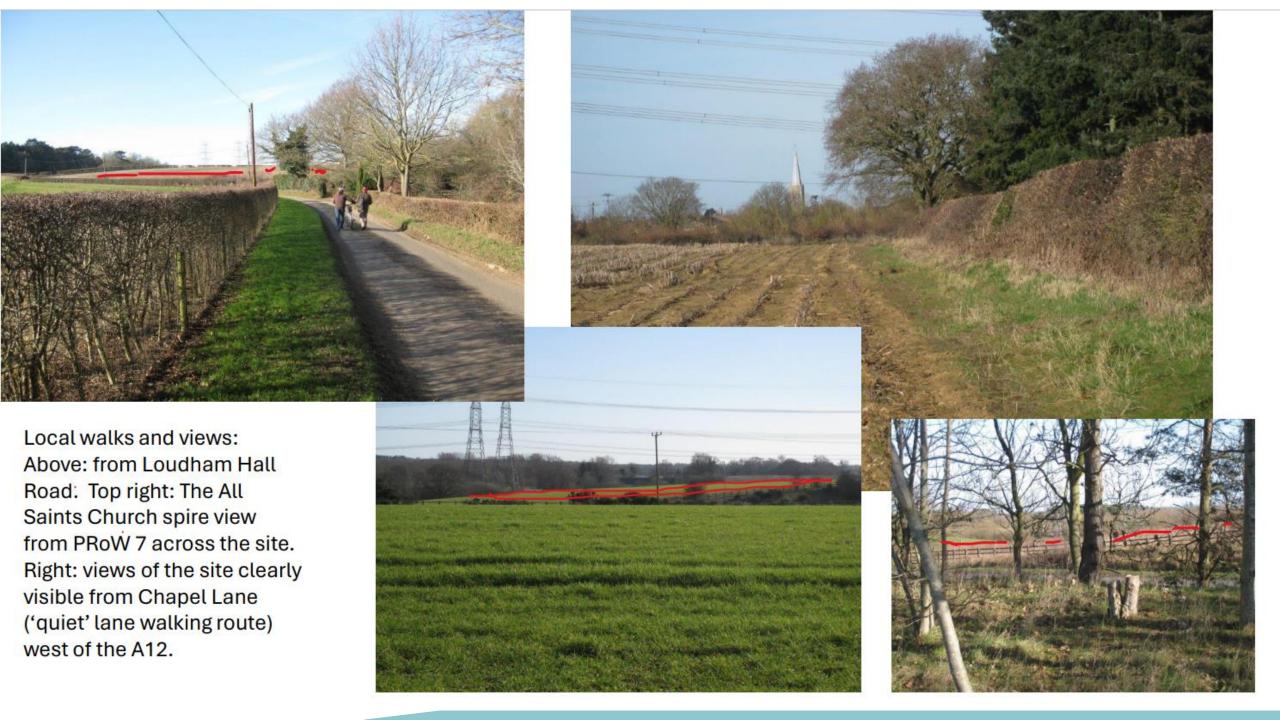
Views from Loudham Hall Road showing the south-west part of the site, the plateau and the valley side area located alongside the A12.
