Appendix F

Cost Estimates

F1 Contractor estimates for harbour entrance structures

RHDHV have been commissioned by Coastal Partnership East for East Suffolk Council to undertake a study into the current condition of the defences at Southwold harbour and potential options to improve conditions and safeguard the future use of the harbour.

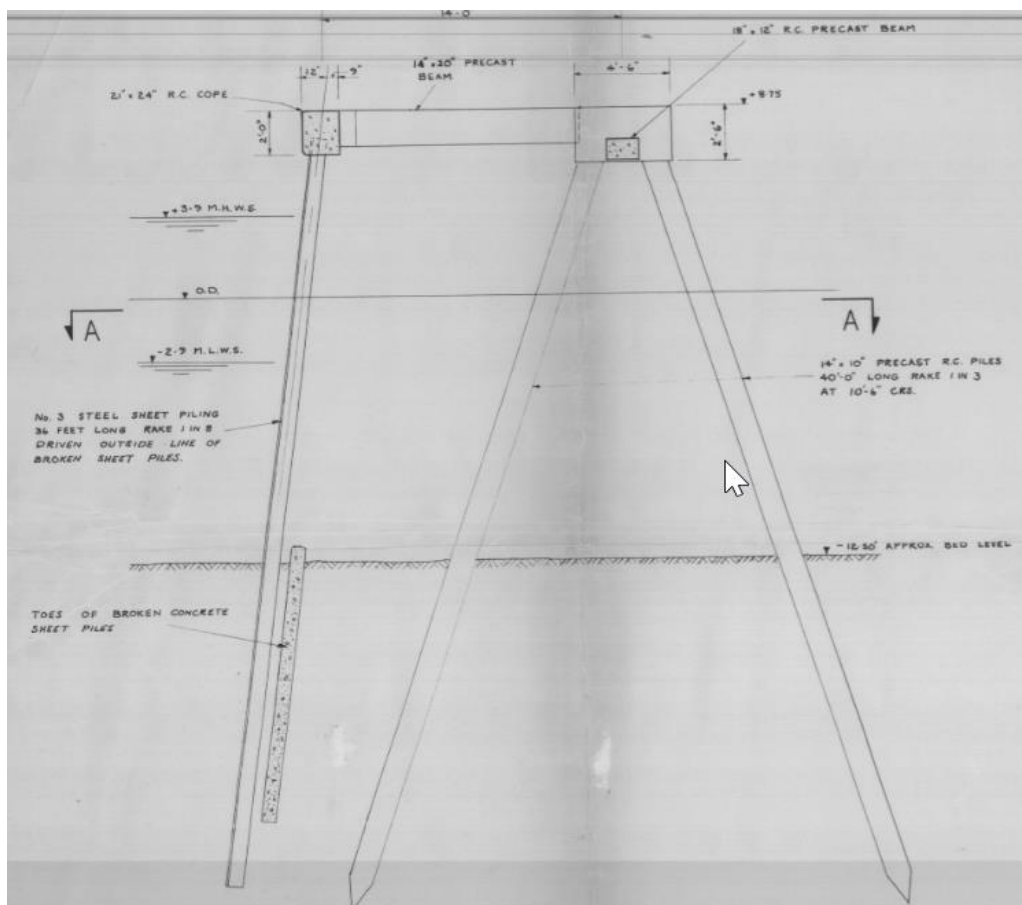
Figure 2-1 – Example cross-section of South Pier (Length C – dimensions and levels in feet and inches)

The South Pier is comprised of three or four different types of structure having undergone a number of repairs over the last 90 years. Fundamentally however, the South Pier consists of a 417m long continuous reinforced concrete structure with a face (on the north side of the Pier) of either reinforced concrete planks or steel sheet piling making up the harbour wall, supported by pairs of raking piles connected with concrete longitudinal and cross members. The nature and condition of this face varies depending on location. In places, the raking piles are surrounded by rock armour, intended to reduce scouring according to the 1990s design drawings. An example cross-section drawing of one part of the South pier is included in Figure 2-1.

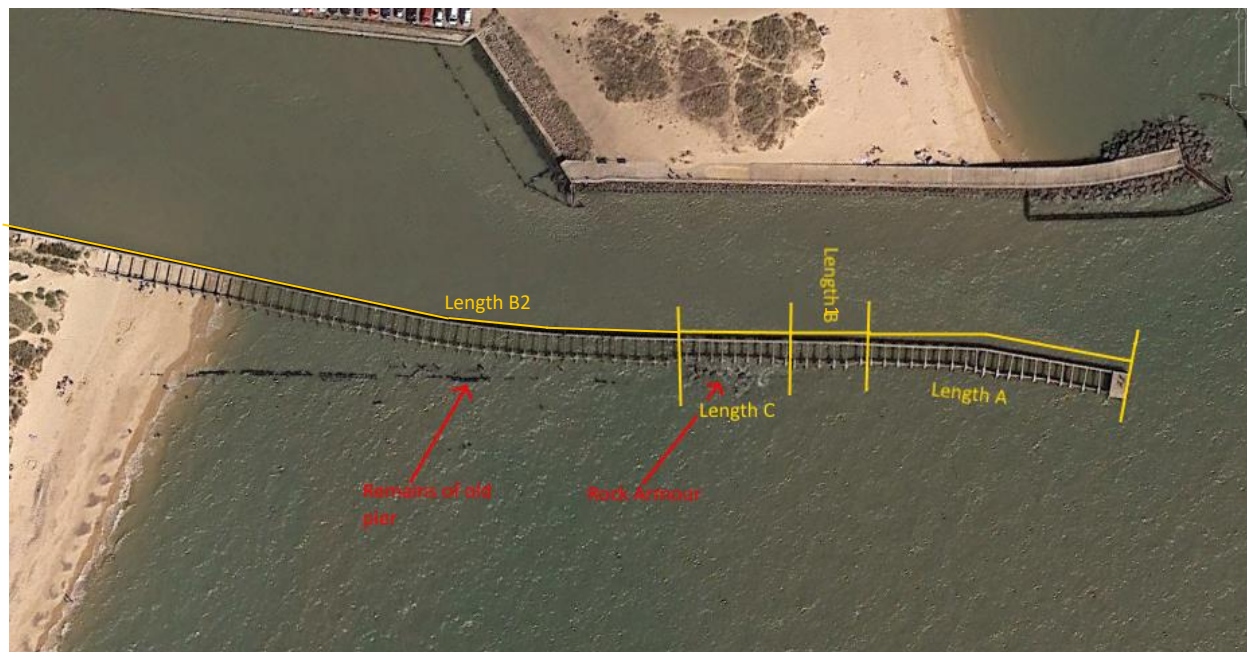
Figure 2-2 - Map of South Pier with marked Lengths A-C

The easternmost section of the pier, Length A (Figure 2-2), is made up of box piles at each crossmember interlocked with sheet piles driven in front of the concrete planks. The box piles are shown on historic drawings to be filled with concrete above the seabed level. The planks have been cut off at -0.3m AOD (Figure 4). The rear concrete beams to Length A have also been replaced at some point. The joints between these box piles and the crossmembers have been repaired in the past. An original length of the pier remains inland of these box piles (Length B), which is still in relatively good condition.

Length C, immediately inland of Length B, is made up of steel sheet piles driven in front of the concrete planks which had been cut off at -0.3m OD (Figure 2-2). Newer raking piles, beams and crossmembers have been added here too. This structure differs slightly from the original design in that the rear beams are below the cross members rather than in line with the cross beams.

Length B2 is the remainder of the structure inshore of Length C up to the entrance to Dunwich Creek, and is similar in construction to Length B.
