## **Southwold Harbour Study**

### Project Report

Client: East Suffolk Council

Reference: PB9485-ZZ-XX-RP-Z-0001

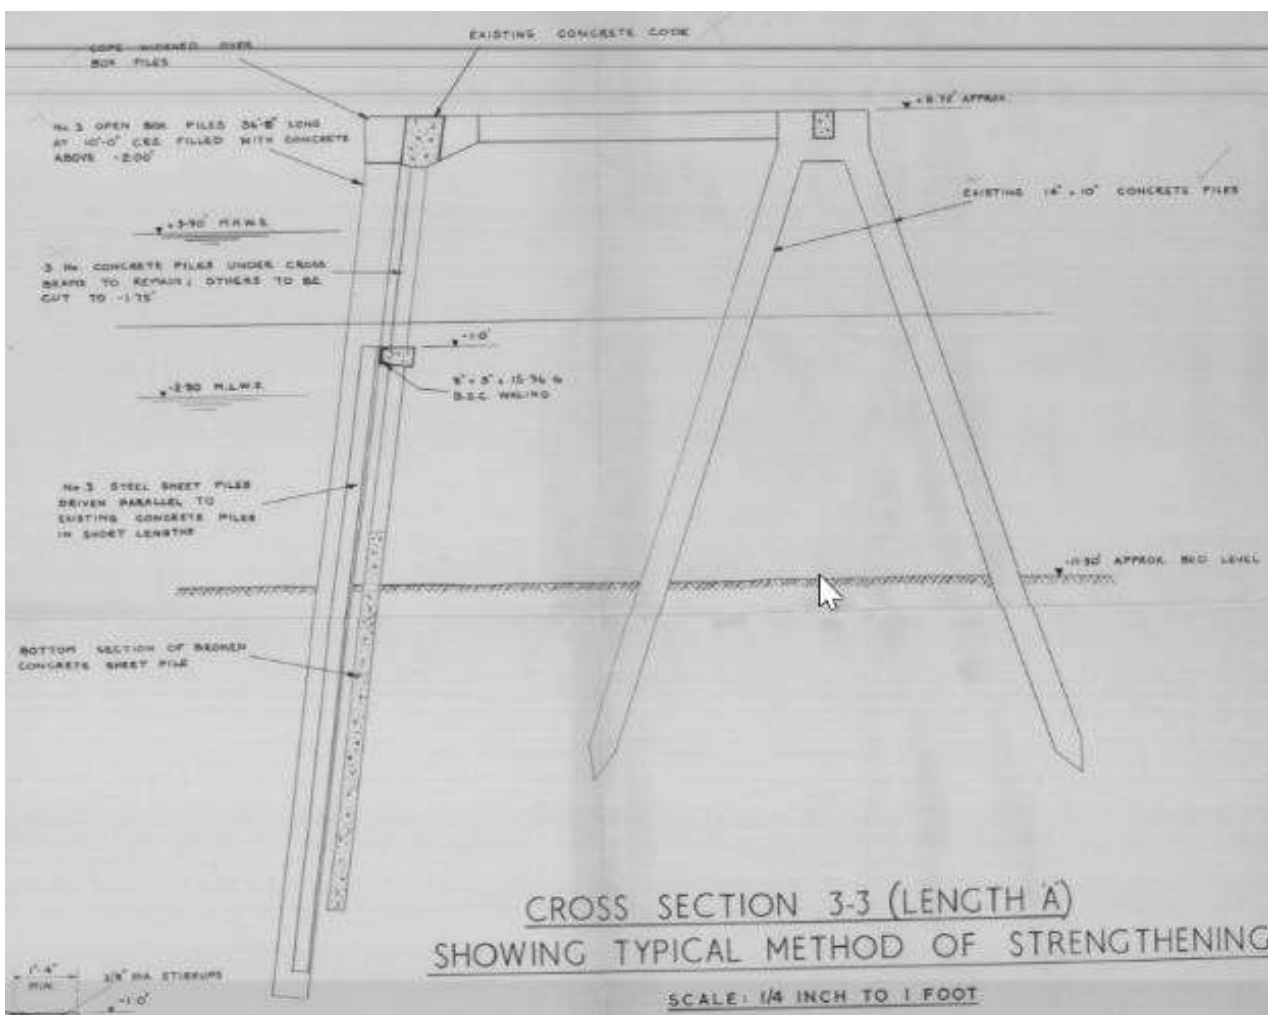
Figure 4-3: South Pier Length A, Section 3-3

The outermost section of the pier, Length A (**Figure 4-3**), comprises box piles at each crossmember interlocked with sheet piles driven in front of the original concrete planks. The box piles are understood to be filled with concrete above the seabed level. The concrete planks have been cut off at -1.0mODN, forming 'windows' in the structure, which were created to dissipate wave energy and allow tidal flow into the entrance channel from the south, to improve conditions for navigation. The rear concrete beams have been replaced at some point, and the joints between the box piles and the crossmembers have been repaired in the past.

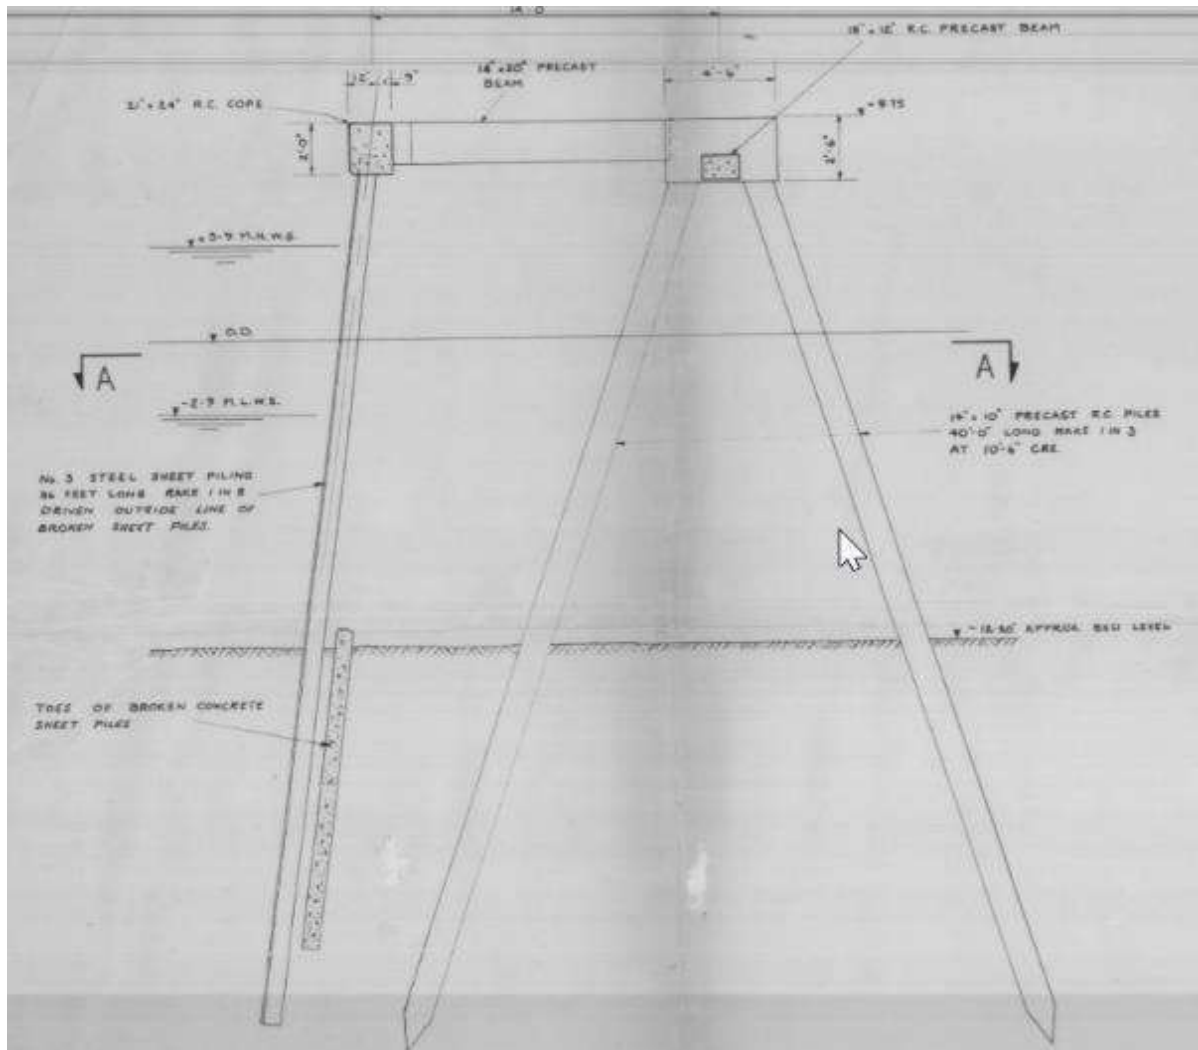
Figure 4-4: Example cross-section of South Pier (Length C)

Length C comprises steel sheet piles driven in front of the concrete planks which are again cut off at -1.0mODN (**Figure 4-4**). Newer raking piles, beams and crossmembers have been added to this part of the structure, which differs slightly from the original design in that the rear beams are below the cross members rather than in line with the cross beams.

- The sheet steel piles in Length C extend into the splash zone and have suffered from significant corrosion, providing limited support to the front beam, which is cantilevered off the piles behind and as such is the most 'at risk' part of the structure (**Figure 4-5**). During a storm surge event this beam is liable to be driven upwards, which could lead to the crossmembers or rear piles failing and a length of this front beam collapsing into the harbour.

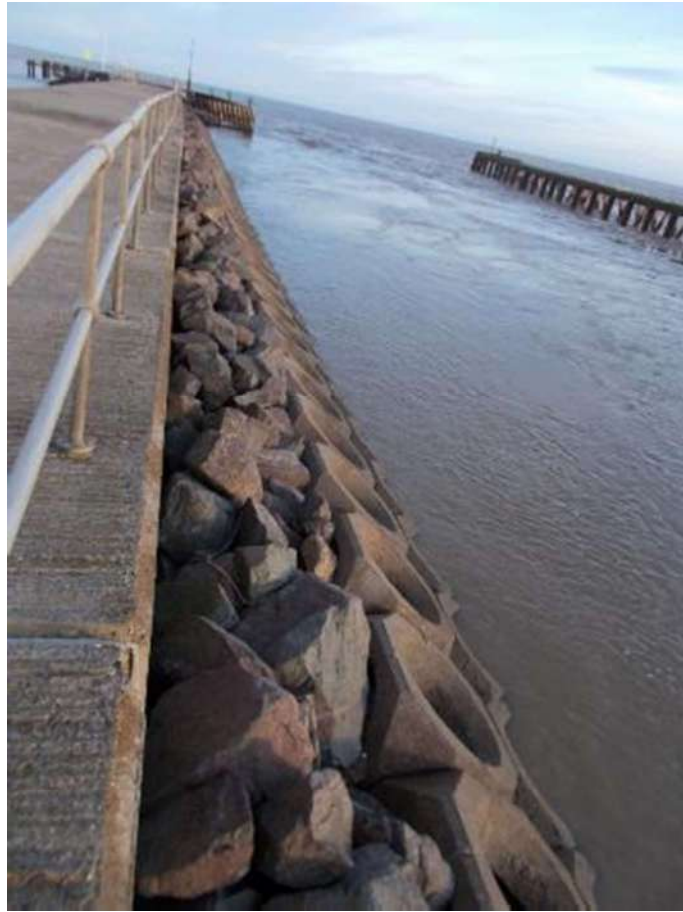
*Figure 4-12: SHED concrete blocks with rock fill*

The North Pier forms the northern side of the harbour entrance. This is comprised of a continuous concrete structure protected by a SHED concrete block revetment (**Figure 4-12**) along most of the length plus rock armour which forms a roundhead at the outer end of the pier. Timber fendering is installed around the seaward end of the pier, which is currently being replaced.

Overall the North Pier is considered to have a remaining life of at least 20 years, assuming no further erosion of the channel bed, and if the South Pier remains in place. Improvements to the South Pier could extend the life of the North Pier, particularly if the failed concrete blocks at the eastern end of the North Pier SHED revetment were also replaced.

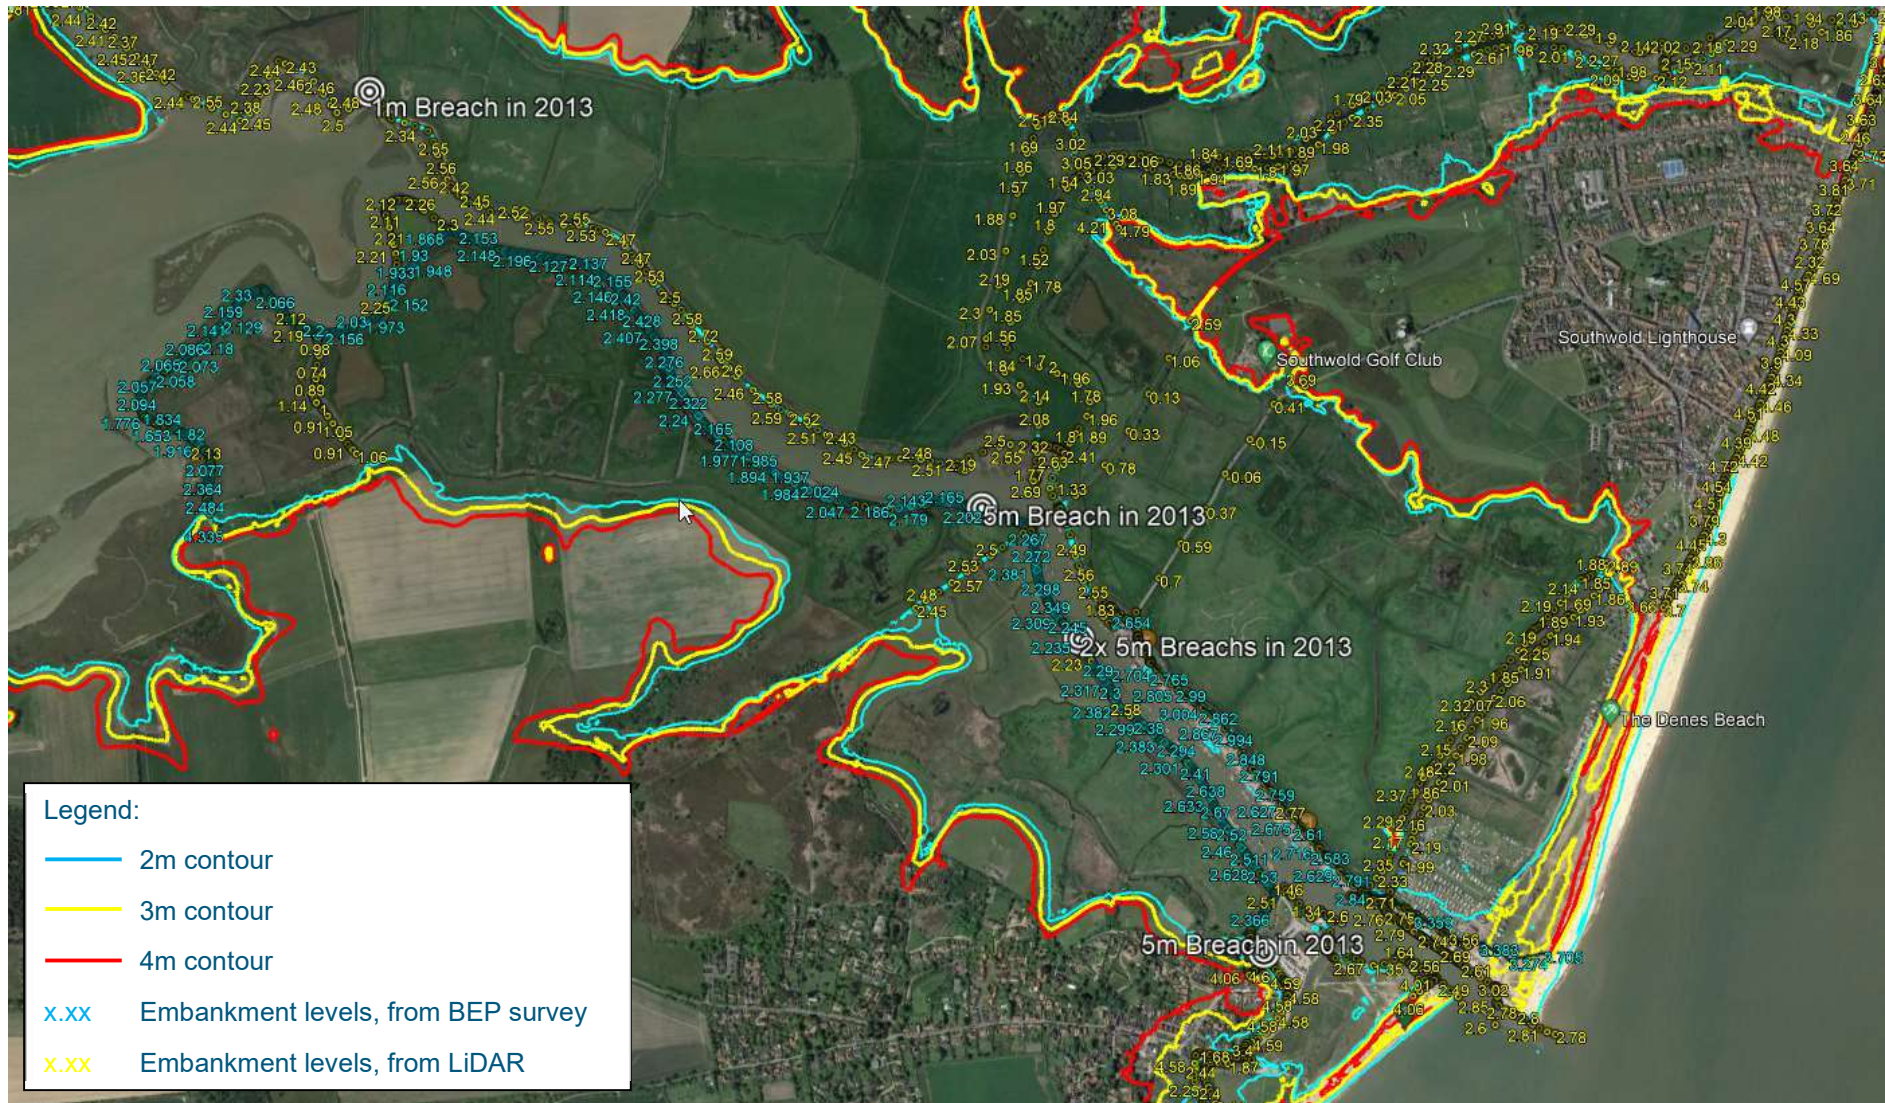
Figure 4-22: Ground levels, embankment levels and 2013 breach locations

The tidal model (**Appendix D**) includes embankment crest levels, based on the LiDAR data for the area. Survey data has also been provided by the Blyth Estuary Partnership. Extracts from this data are included in **Figure 4-22**, which also shows the locations of the embankment breaches that occurred during the 2013 surge event.
