Southwold Harbour Study

Site Inspection Report

Client: Coastal Partnership East for East Suffolk Council

Reference: PB9485-RHD-ZZ-XX-RP-Z-0001

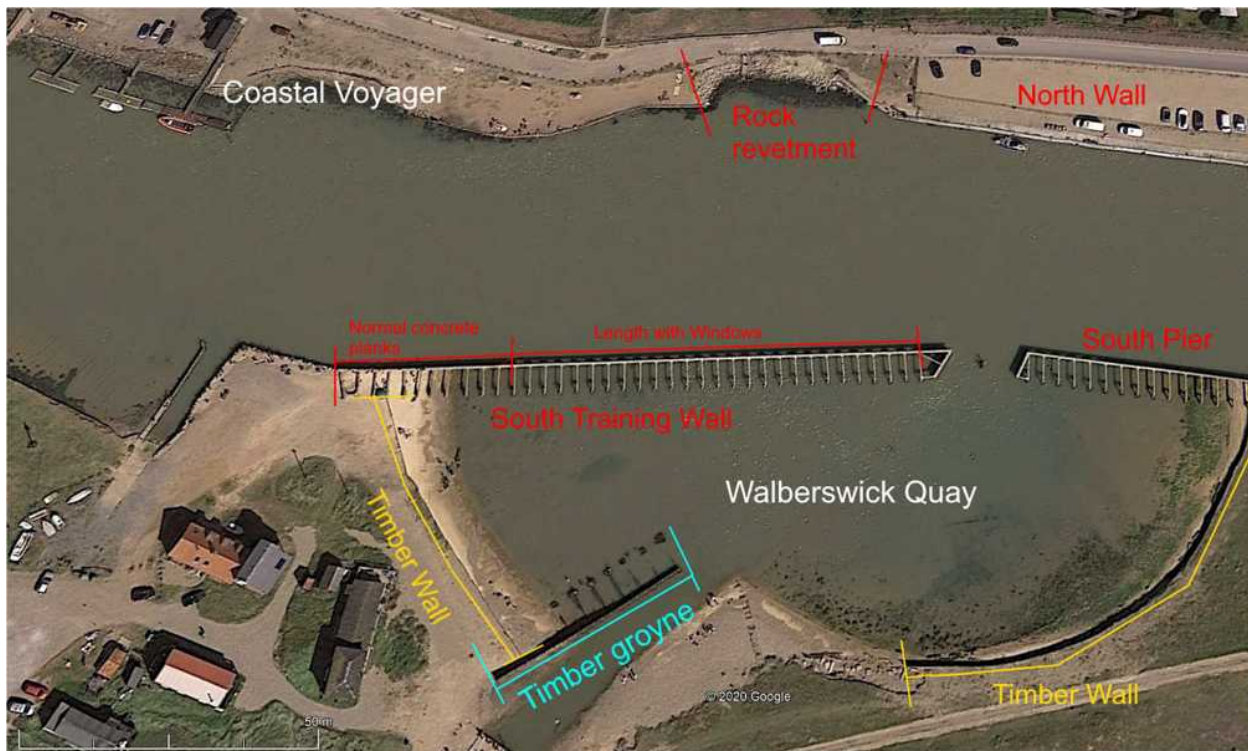
Figure 12 - Map of South Training Wall, Walberswick Quay with marked lengths where windows have been cut in concrete planks

The wall has had windows cut in the North face that would otherwise enclose Walberwick Quay (Figure 13). The toes of the planks remain in situ serving to retain built up sediment in the quay (Figure 14).

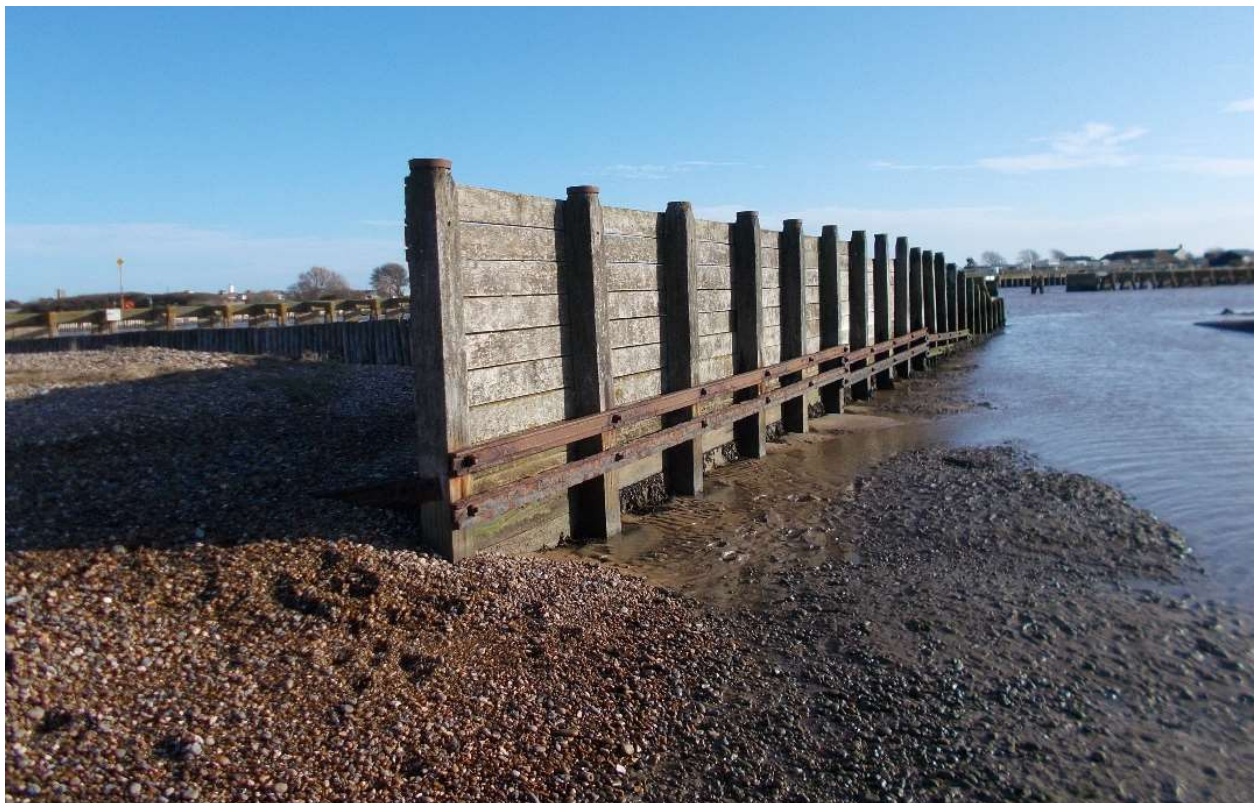
Figure 17 – Timber groyne at Dunwich Creek

A timber groyne runs along the mouth of Dunwich Creek where it enters the quay serving to maintain the West beach here (Figure 17).

The relatively good condition of the timber groyne means that it is expected to have at least another 20 years of life.

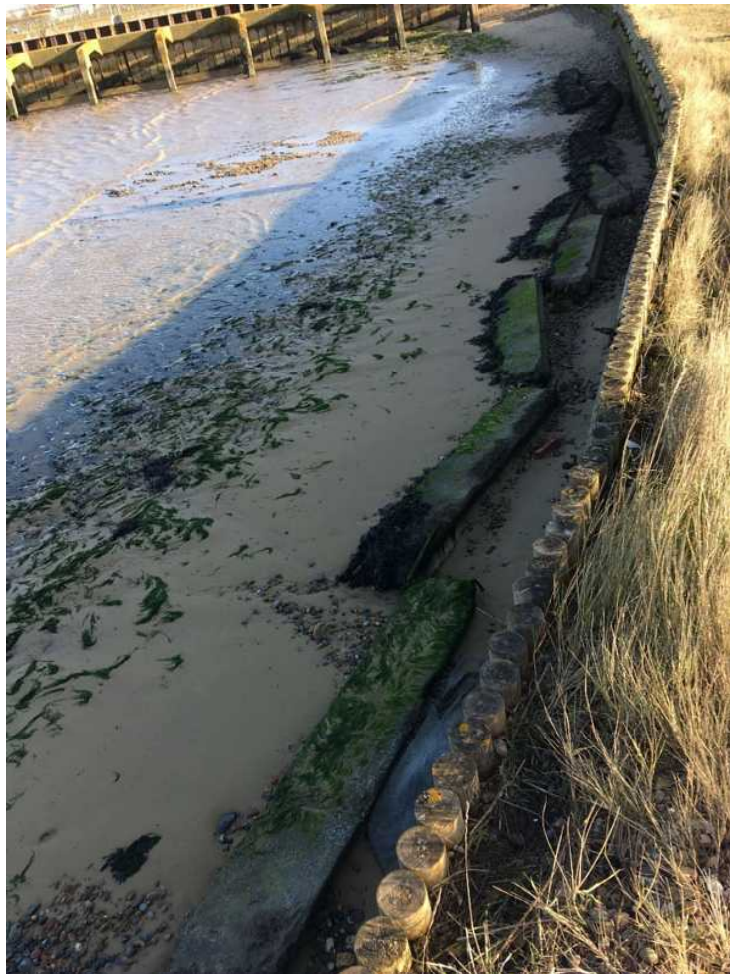
Figure 19 - Timber wall around Walberswick Quay

A timber wall runs around the top of the beach serving as a perimeter to Walberswick Quay and as a retaining wall for the upper level of the shore here (Figure 19).

It is recommended that the wave modelling considers potential changes to the timber wall and beach to assess whether wave reflection could be reduced.

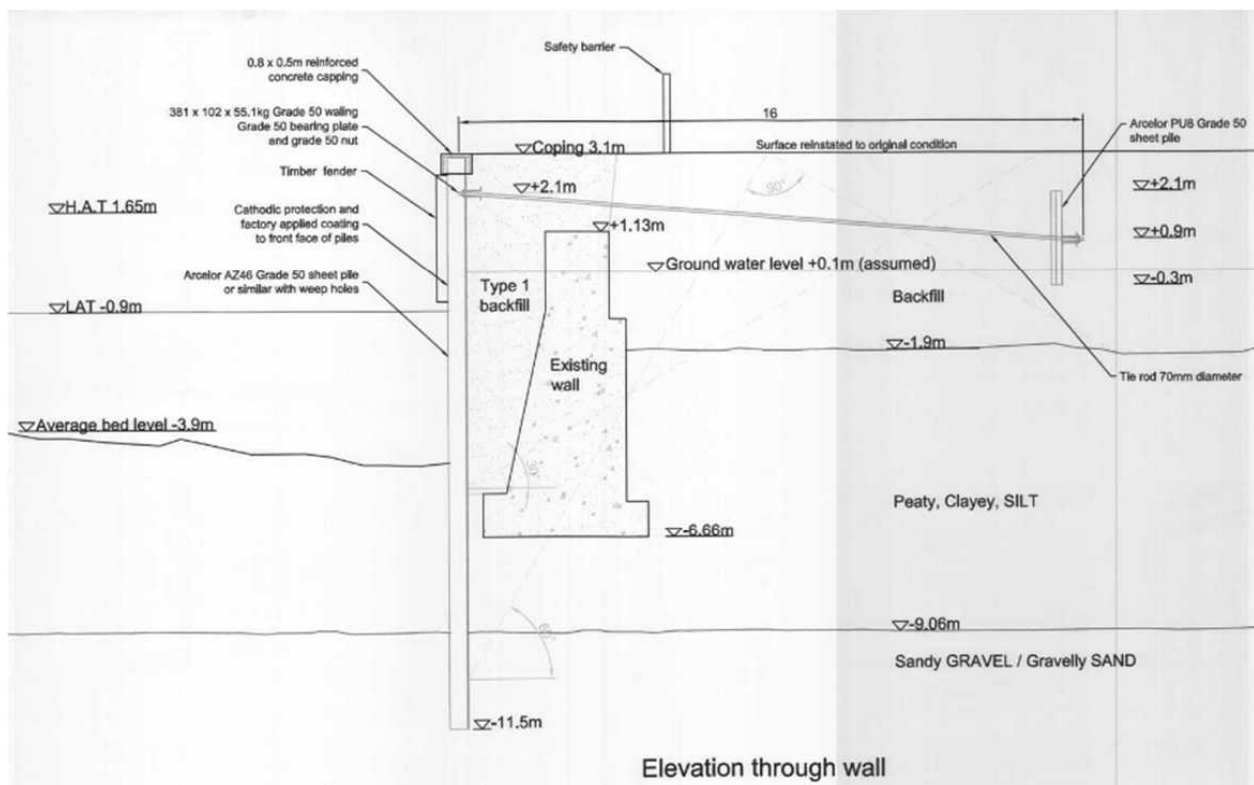
Figure 20 - North wall work drawings - 2012-13

This structure was built less than 10 years ago and is still in a good condition. It is noted that the pile capping beam / coping is shown to be +3.1m AOD in Figure 20, but this has recently been measured as +2.8m AOD.

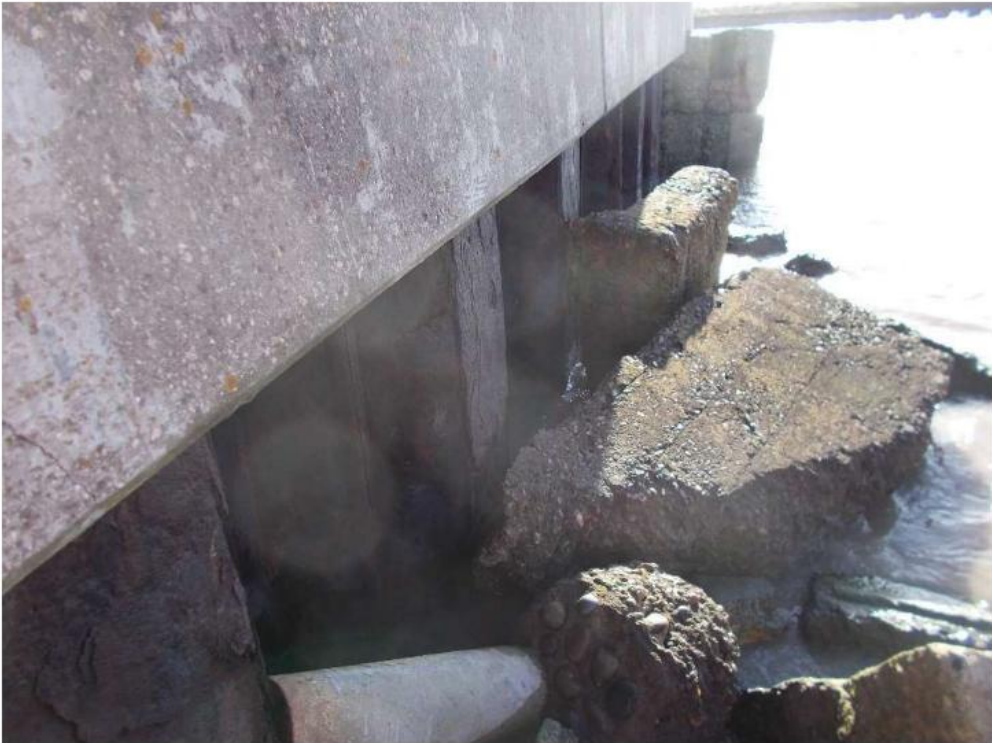
At the west end of the new piled wall there is a short length of old sheet piled wall (Figure 20). To the west of this, extending up to the Blackshore area, lies a stretch of rock revetment approximately 20m in length. This has been topped with loose concrete and masonry rubble.

Figure 23 - Old Steel Sheet Piles at western end of North Wall

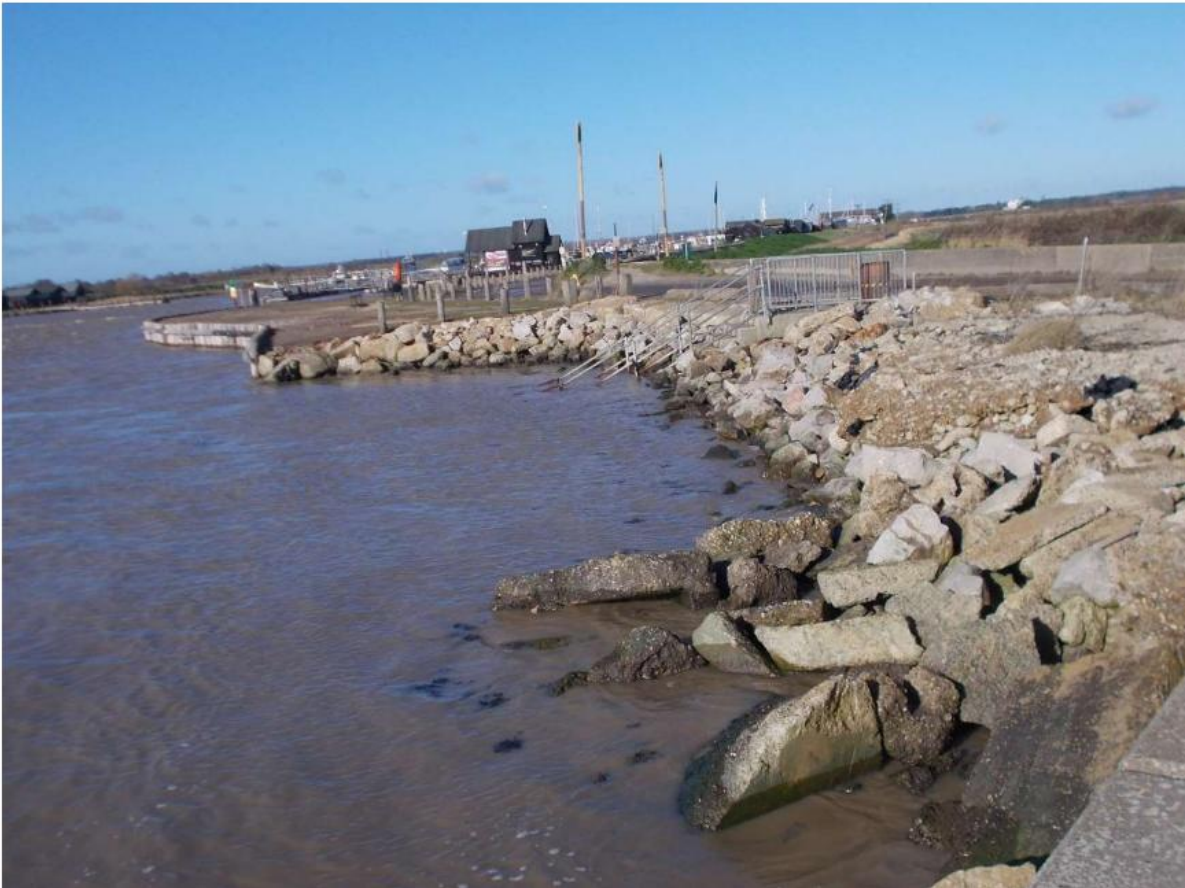
Figure 24 - Rock revetment West of North Wall

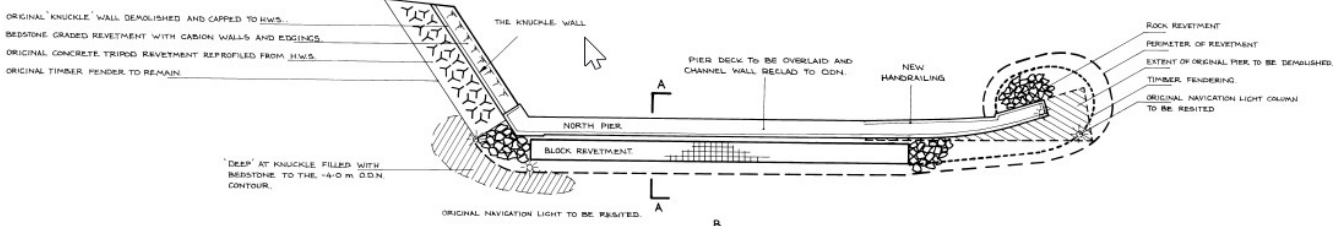
Figure 29 - 1992 North Pier works plan

At the seaward end of the North Pier a stretch of timber fendering (Figure 29) has been installed to protect boats from colliding with the rock armour. This was last repaired in 2007. This fendering is damaged and sections are missing in some places. The timber fendering and rock armour transitions into a SHED concrete block revetment that spans most of the length of the North Pier.

Works were undertaken to the North Pier in 1992 (Figure 29) with the aim of increasing flow through the entrance channel to prevent sedimentation restricting navigation, and to reduce wave energy in the harbour to improve mooring conditions.

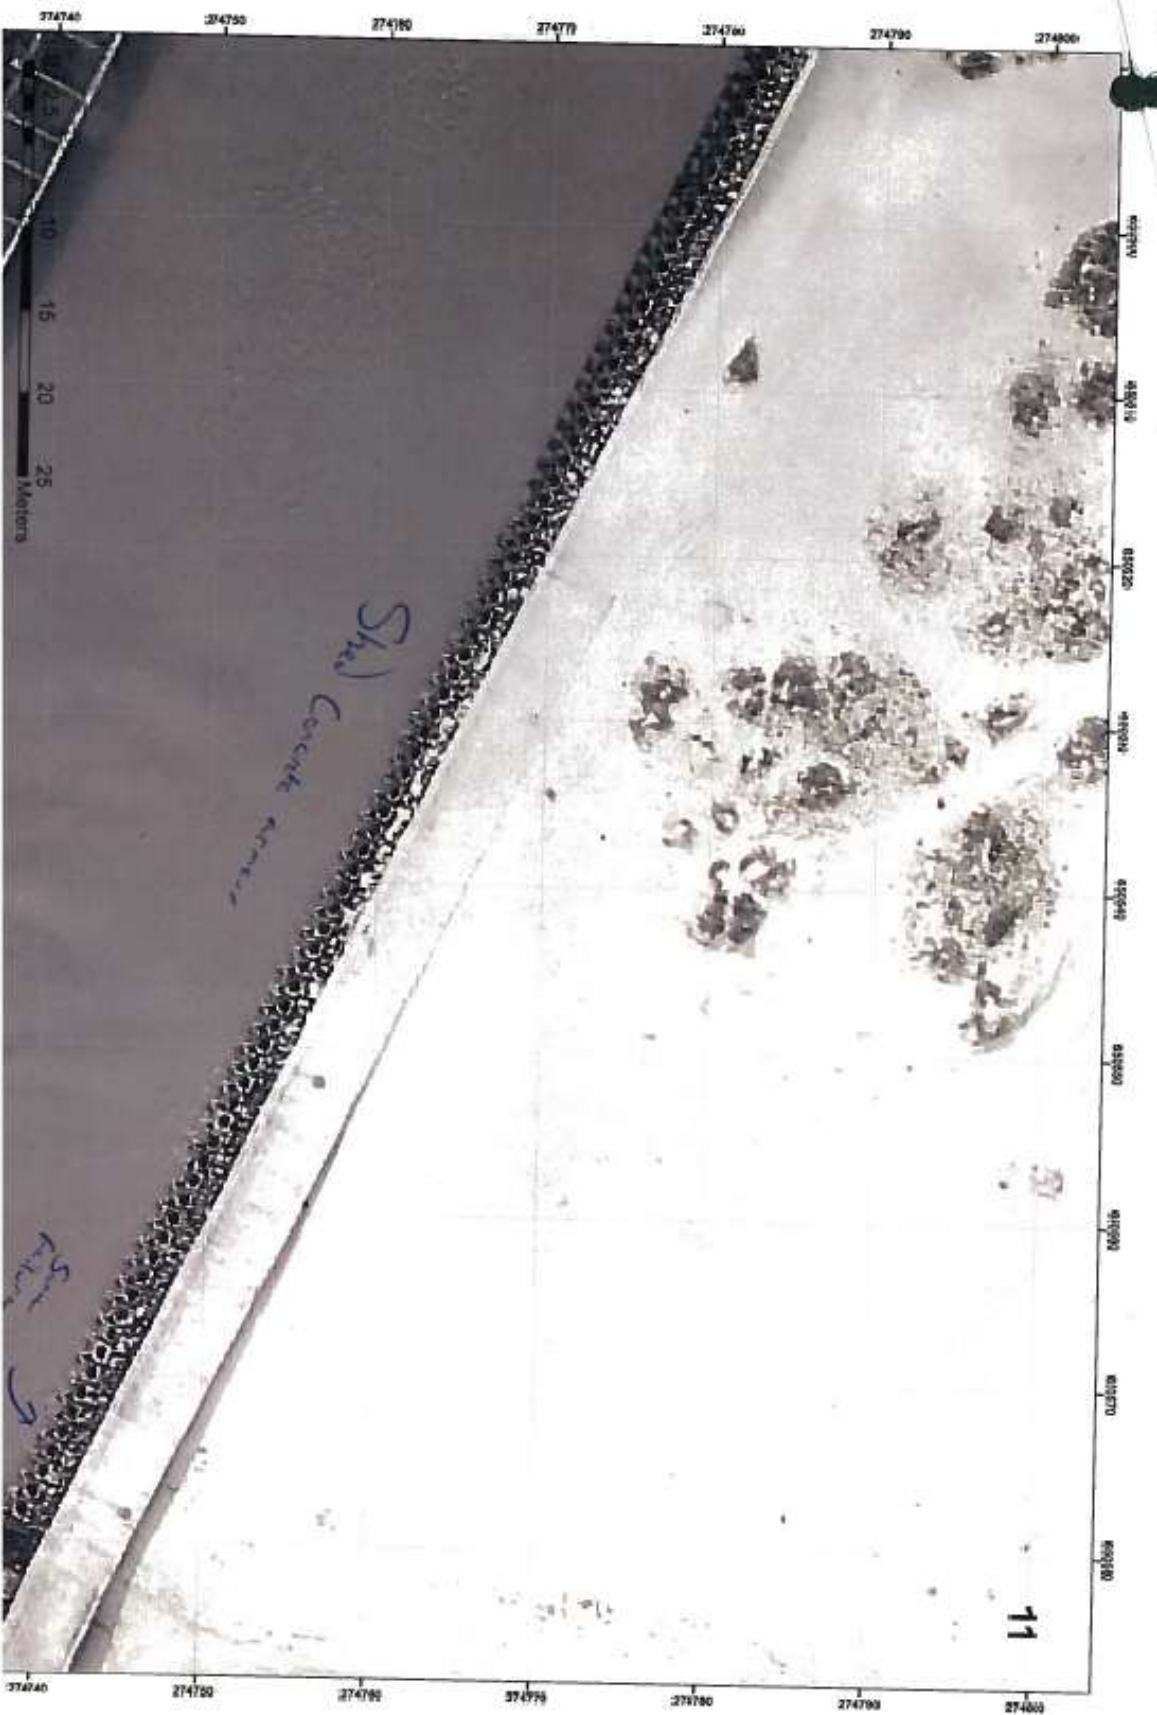
Figure A10 North Pier Shed concrete block revetment
