Item: 9

DC/21/5574/LBC

Repair & Refurbishment of Existing Pedestrian
Bridge

Jubilee Bridge, The Ravine, Lowestoft, Suffolk

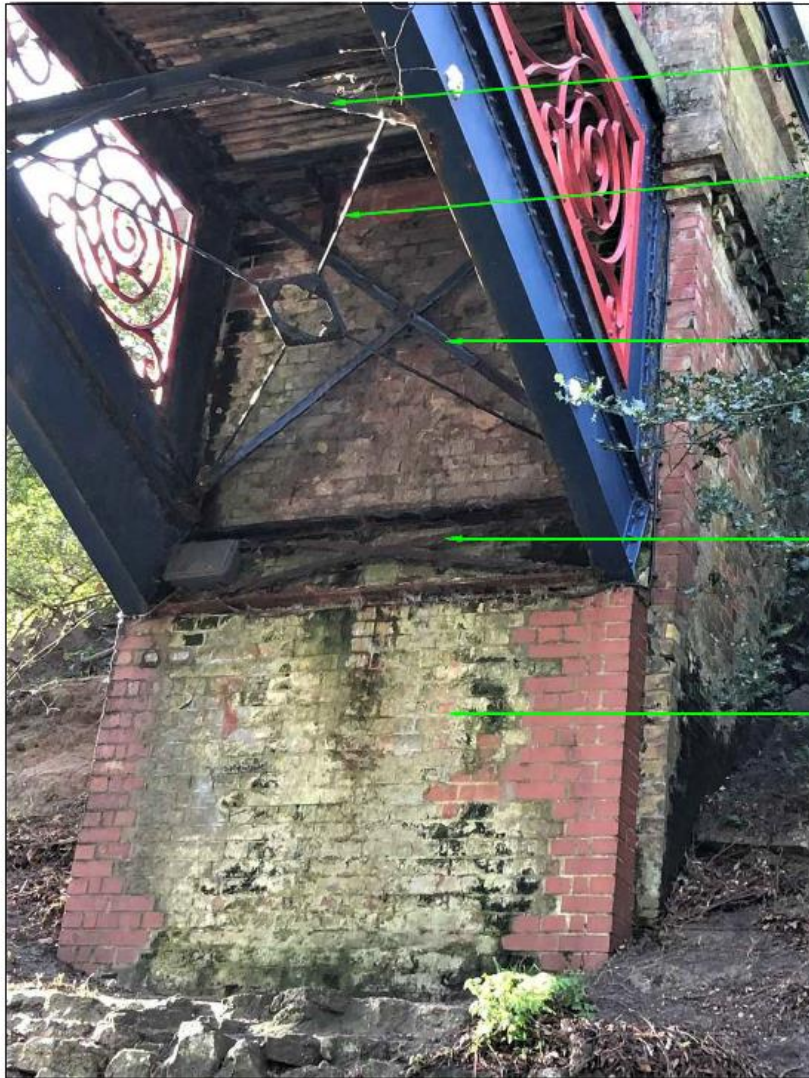
WROUGHT IRON ANGLE SECTION
BRIDGE BEAM BOTTOM FLANGE
LATERAL RESTRAINT MEMBERS.

BRIDGE PLAN BRACING
MEMBERS COMPRISING MILD
STEEL RODS WITH THREADED
ENDS FOR TENSIONING.

WROUGHT IRON FLAT BAR
CROSSED DIAGONAL BRACING
(VERTICAL ORIENTATION) TO
ENDS OF BRIDGE.

WROUGHT IRON FLAT BAR
CROSSED DIAGONAL BRACING
BETWEEN BRIDGE BEAM
BEARING POINTS.

BRICKWORK BRIDGE ABUTMENT

GENERAL VIEW OF SOUTHERN BRIDGE ABUTMENT
SHOWING ARRANGEMENT OF WROUGHT IRON
VERTICAL AND PLAN BRACING MEMBERS

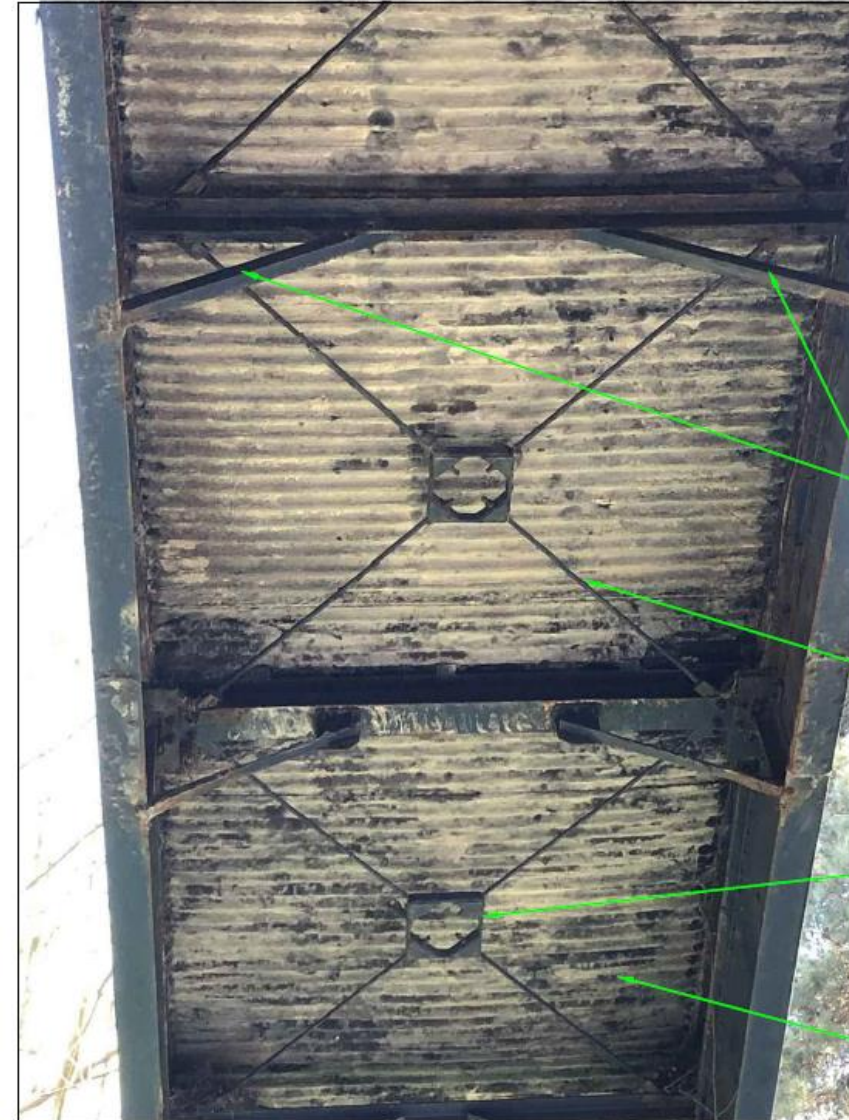
WROUGHT IRON ANGLE SECTION
PRINCIPAL BRIDGE BEAM
BOTTOM FLANGE LATERAL
RESTRAINT MEMBERS.

BRIDGE PLAN BRACING
MEMBERS COMPRISING MILD
STEEL RODS WITH THREADED
ENDS FOR TENSIONING.

FABRICATED MILD STEEL PLAN
BRACING CONNECTORS ALLOW
TENSIONING OF THE BRACING
ROD MEMBERS.

CORRUGATED UNDERSIDE TO
EXISTING CONCRETE BRIDGE
DECK

GENERAL VIEW OF UNDERSIDE OF BRIDGE DECK
SHOWING PLAN BRACING MEMBER ARRANGEMENT

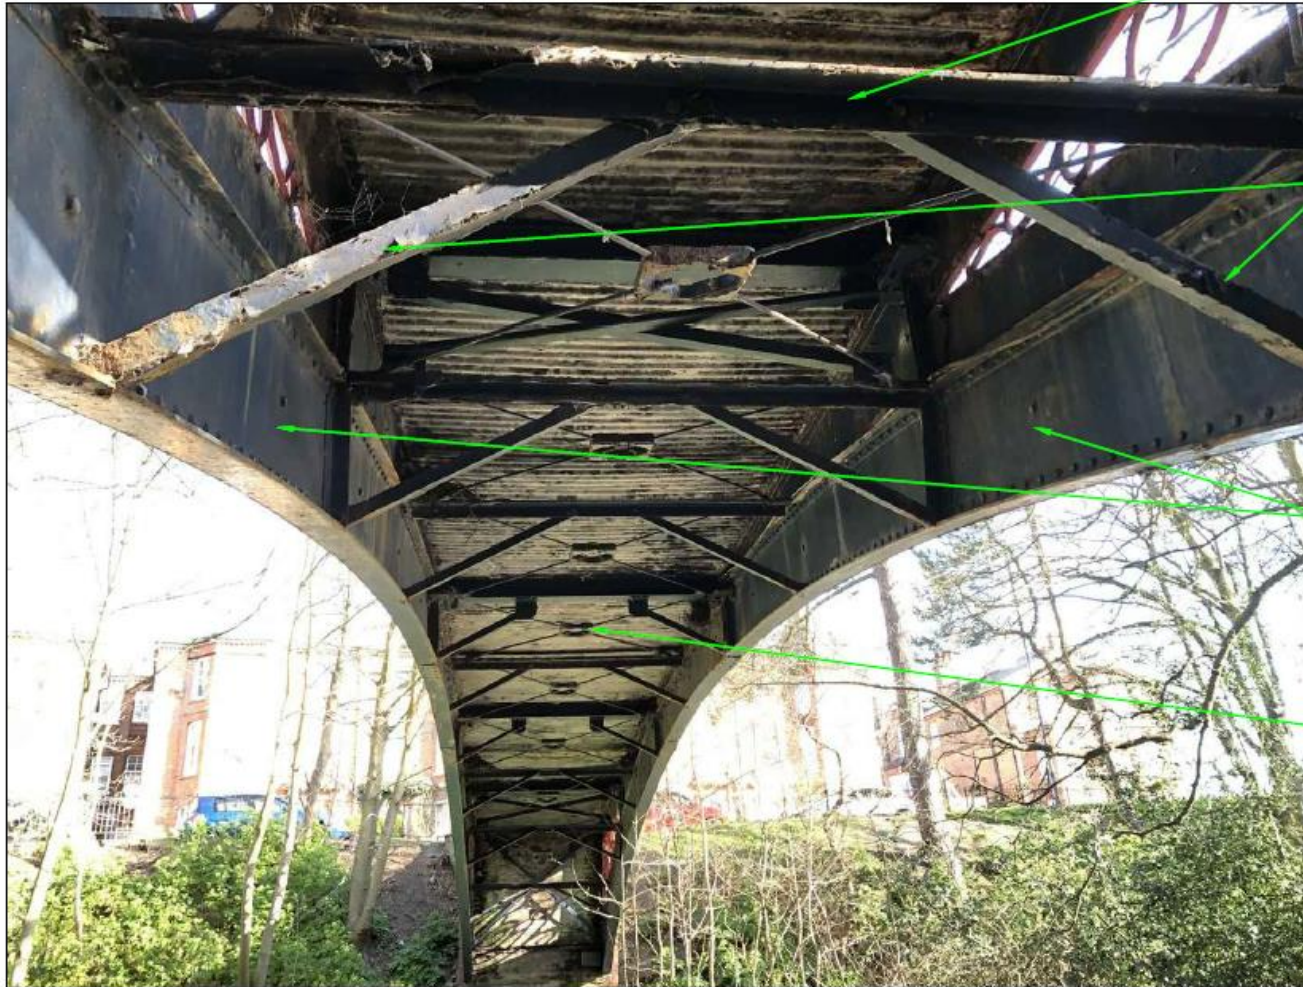
STRUCTURAL TEE-SECTION CROSS-BEAMS PROVIDING HORIZONTAL TIE BETWEEN WROUGHT IRON BUILT-UP PRINCIPAL BRIDGE BEAMS.

WROUGHT IRON ANGLE SECTION PRINCIPAL BRIDGE BEAM BOTTOM FLANGE LATERAL RESTRAINT MEMBERS.

WROUGHT IRON BUILT-UP AND RIVETED PRINCIPAL BRIDGE BEAMS.

BRIDGE PLAN BRACING MEMBERS COMPRISING MILD STEEL RODS WITH THREADED ENDS FOR TENSIONING.

GENERAL VIEW OF UNDERSIDE OF BRIDGE DECK SHOWING PLAN BRACING MEMBER ARRANGEMENT AND BOTTOM FLANGE RESTRAINTS TO PRINCIPAL BRIDGE BEAMS
