Southwold Harbour Investment Plan

Assessment of Dredging Option

Client: East Suffolk Council

Reference: PB9485-RHD-XX-XX-RP-X-0005

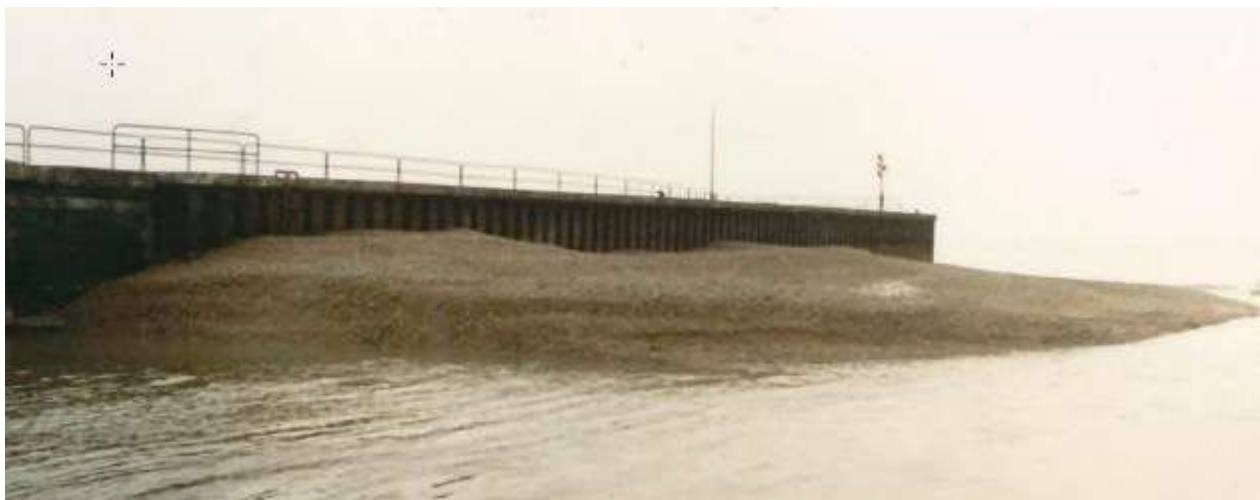
Figure 3-1: Sediment accumulation, north side of harbour, 1987

The sediment accumulation that developed on both the north and south sides of the harbour entrance in 1987 is shown in **Figure 3-1** and **Figure 3-2**. No similar issues have occurred in the last 20 years, which suggests that tidal flow speeds are usually sufficient to keep the entrance channel clear.

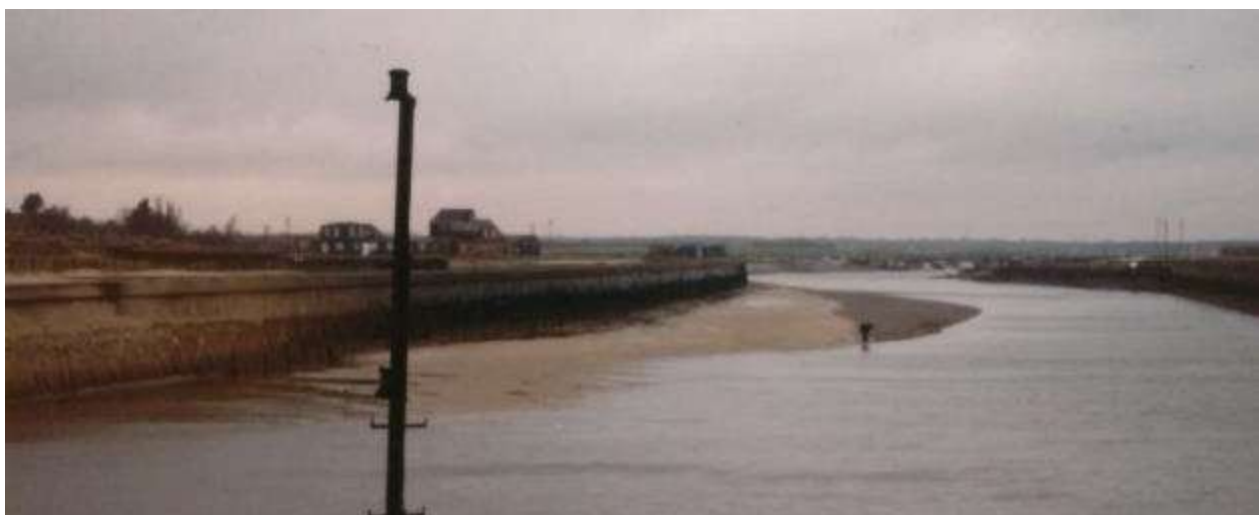
Figure 3-2: Sediment accumulation, south side of harbour, 1987

The sediment bank shown in **Figure 3-2** is the area of interest for this assessment. It is located opposite the North Wall, immediately upstream of the Knuckle, extending along the southern side of the channel towards the Dunwich Creek entrance. Often referred to as the ‘shoal bank’, whilst it is not currently as large as in this photo, it is still present. The shoal bank is reported by harbour users to affect the local hydrodynamic behaviour, with swell waves building over this shallow area. The high sediment bank can also cause incoming waves to break in this area.

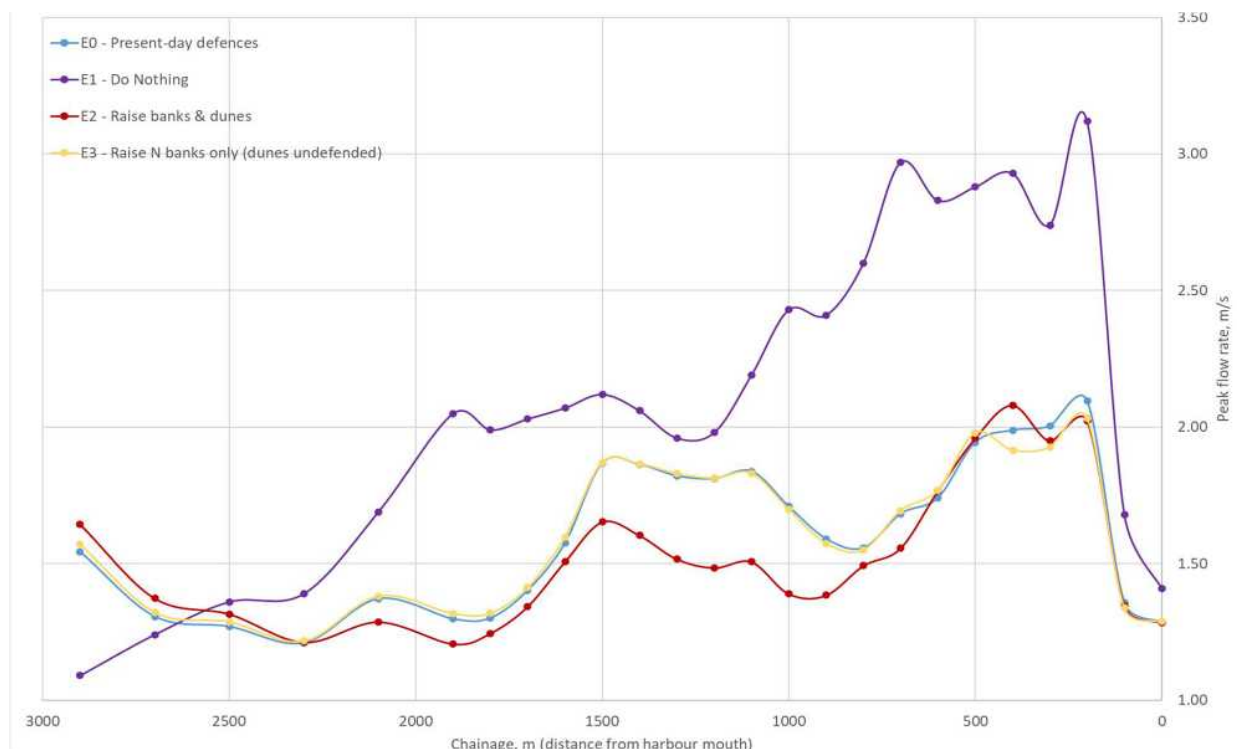
Figure 3-9: Change in peak flow rate along river channel, December 2013 conditions

The predicted increase in peak flow velocity for the Do Nothing scenario (**Figure 3-9**) would be expected to increase the rate of erosion of the shoal bank. The changes in channel bathymetry discussed in **Section 3.2** show erosion of the shoal bank between 2013 and 2020, which could reflect an increasing tidal prism or increased storminess during that period. If the estuary defences were to be raised, peak flow rates would reduce during extreme conditions (**Figure 3-9**), which could result in growth of the shoal bank.

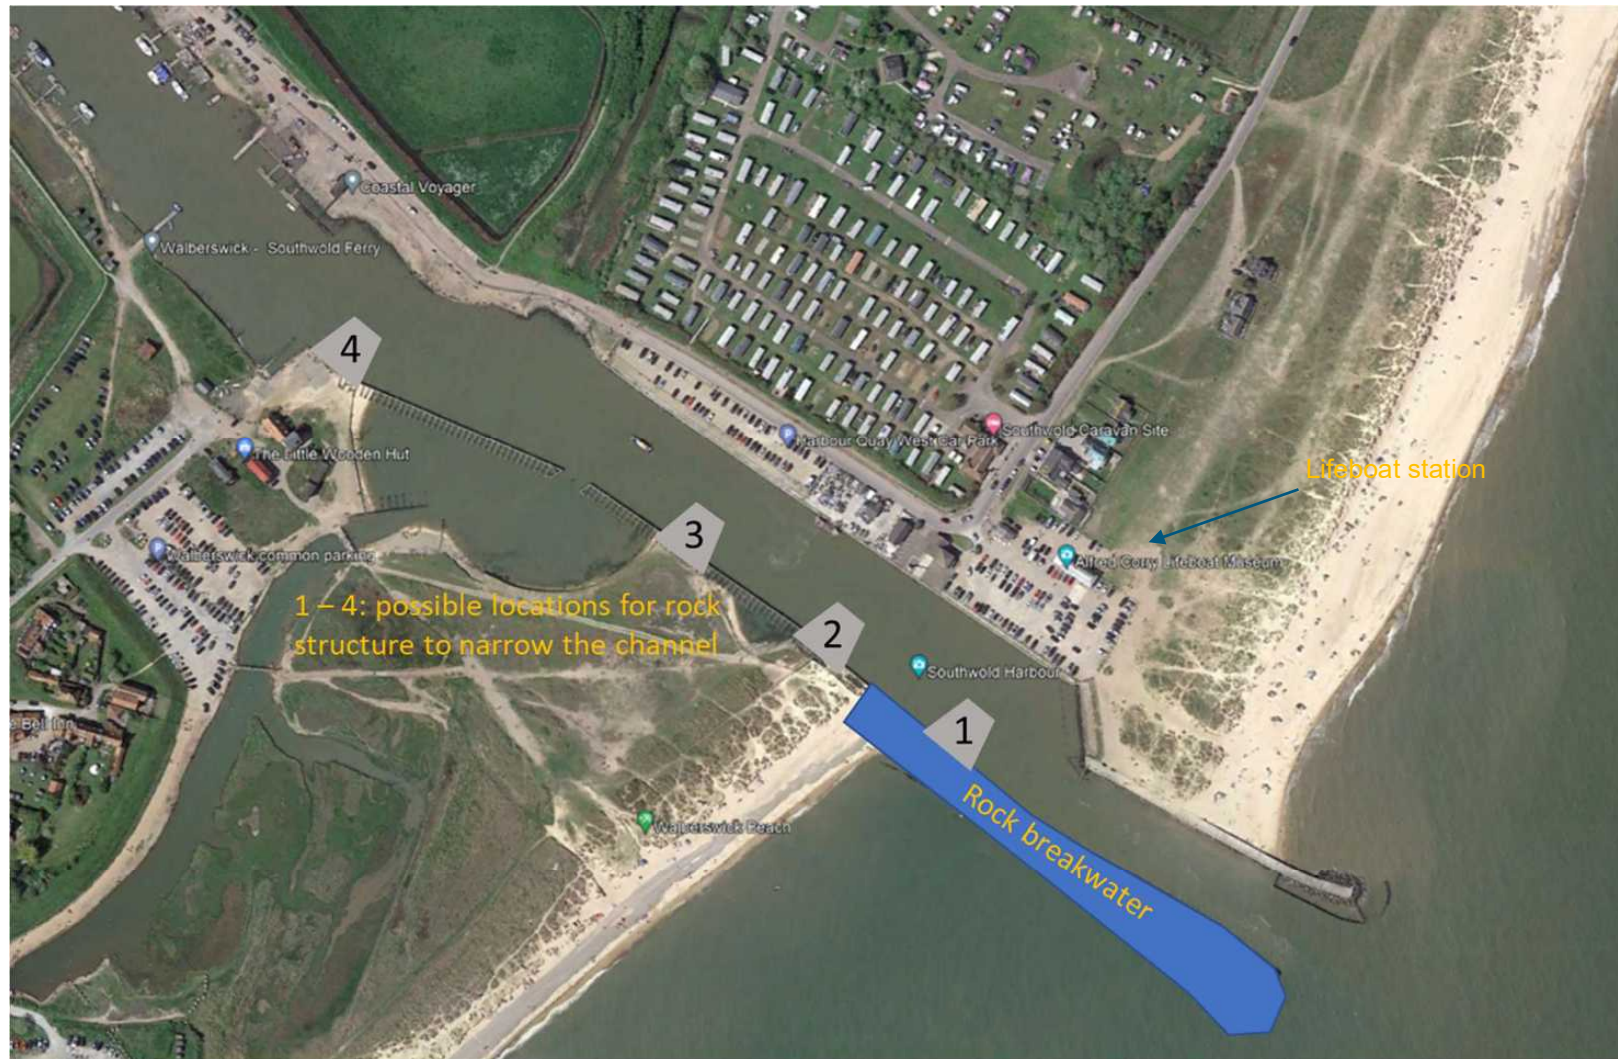
Figure 4-1: Potential locations for rock structure to extend the narrow entrance channel

Figure 5-2 compares the peak water levels for two alternative locations of a narrowed channel (Locations 2 and Location 4, **Figure 4-1**), which shows that Location 4 performs slightly better than Location 2 in terms of peak water levels further upstream, although the difference is less than 5cm.

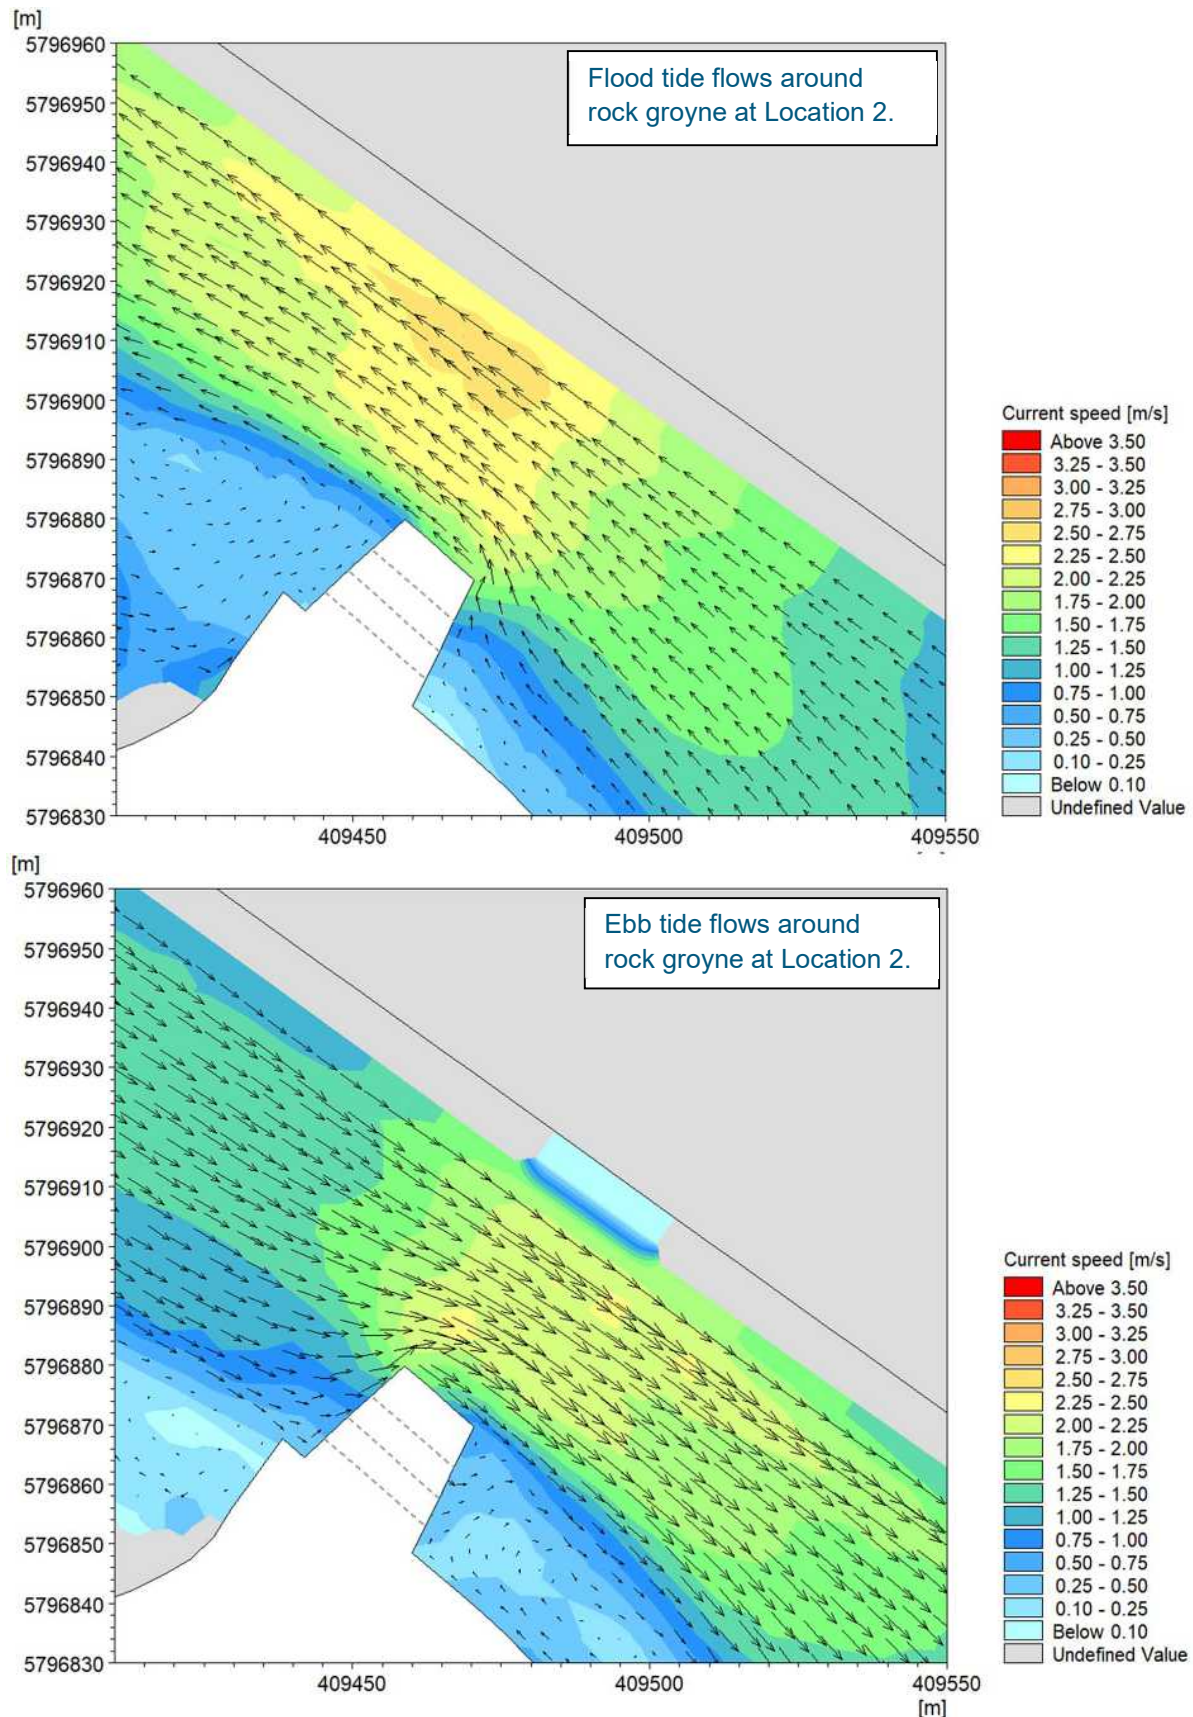
Figure 4-5: Peak flow velocity and direction around the rock groyne structure (narrow channel option), December 2013 conditions

In terms of peak flow velocities with the December 2013 conditions (**Figure 4-4** and **Figure 4-6**), if the embankments were raised and the channel narrowed opposite the North Wall, peak flow rates in the entrance channel would be reduced by about 0.1m/s compared to embankment raising alone. Peak flow rates further upstream are also reduced. The model results showed that peak flow velocities would increase in the vicinity of the rock structure with a narrowed channel (**Figure 4-5**).

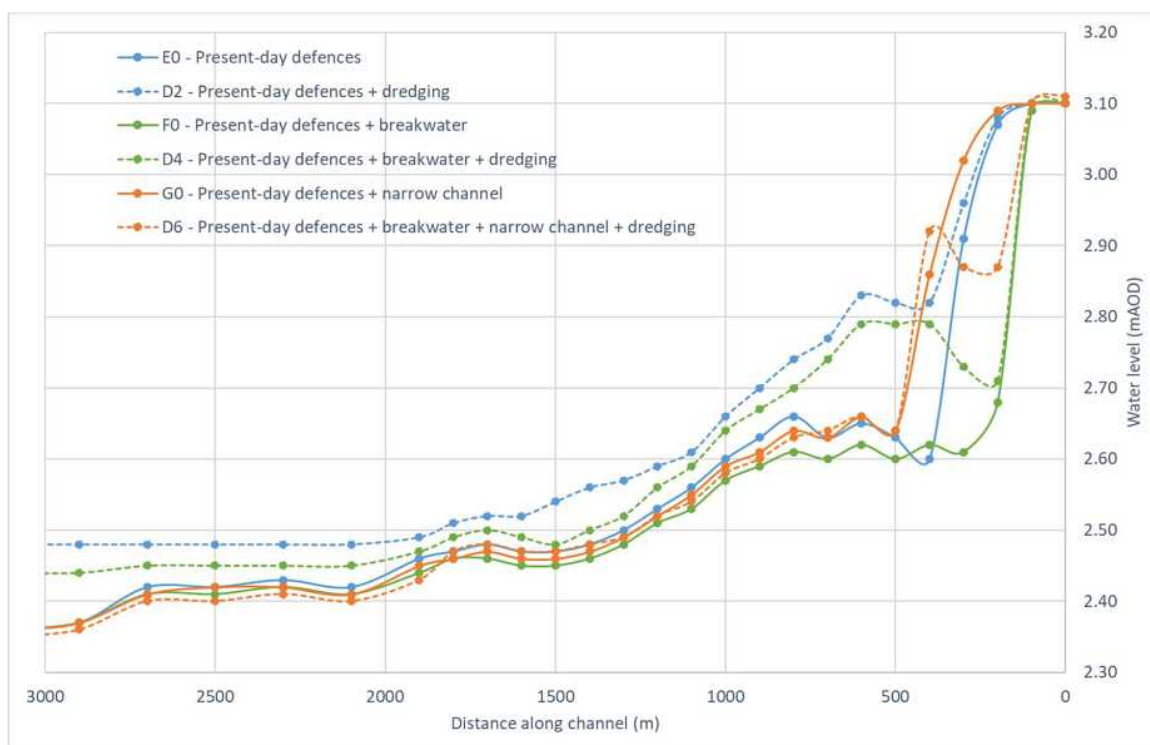
Figure 5-1: Peak water level with dredging, December 2013 conditions

Figure 5-1 compares the peak water levels along the channel for the various options for the harbour entrance structures, with and without dredging. **Table 5-2** gives the peak water levels at key locations in the harbour and further upstream, and **Table 5-3** compares these peak water levels with the present-day conditions for the December 2013 surge event.

For the existing South Pier and estuary defences, dredging the shoal bank would increase peak water levels by about 20cm in the outer harbour and by up to 10cm through the Blackshore for the December 2013 event conditions. The shoal bank currently acts to extend the narrowed channel upstream of the harbour entrance, so removal of this sediment would allow more water to flow into the estuary, raising peak water levels.

If the South Pier was replaced with a rock breakwater, peak water levels through the entrance channel are reduced by up to 40cm, because the rock breakwater constrains the entrance channel more than the existing South Pier (the additional flow through the windows in the pier would be removed). There is a slight reduction in peak water levels at the Blackshore and further upstream with a breakwater. Dredging of the shoal bank with a breakwater in place would increase peak water levels by about 20cm in the outer harbour, but only by a few centimetres further upstream compared to present-day peak water levels for the December 2013 event conditions. Including a narrowed channel as well as the breakwater and removal

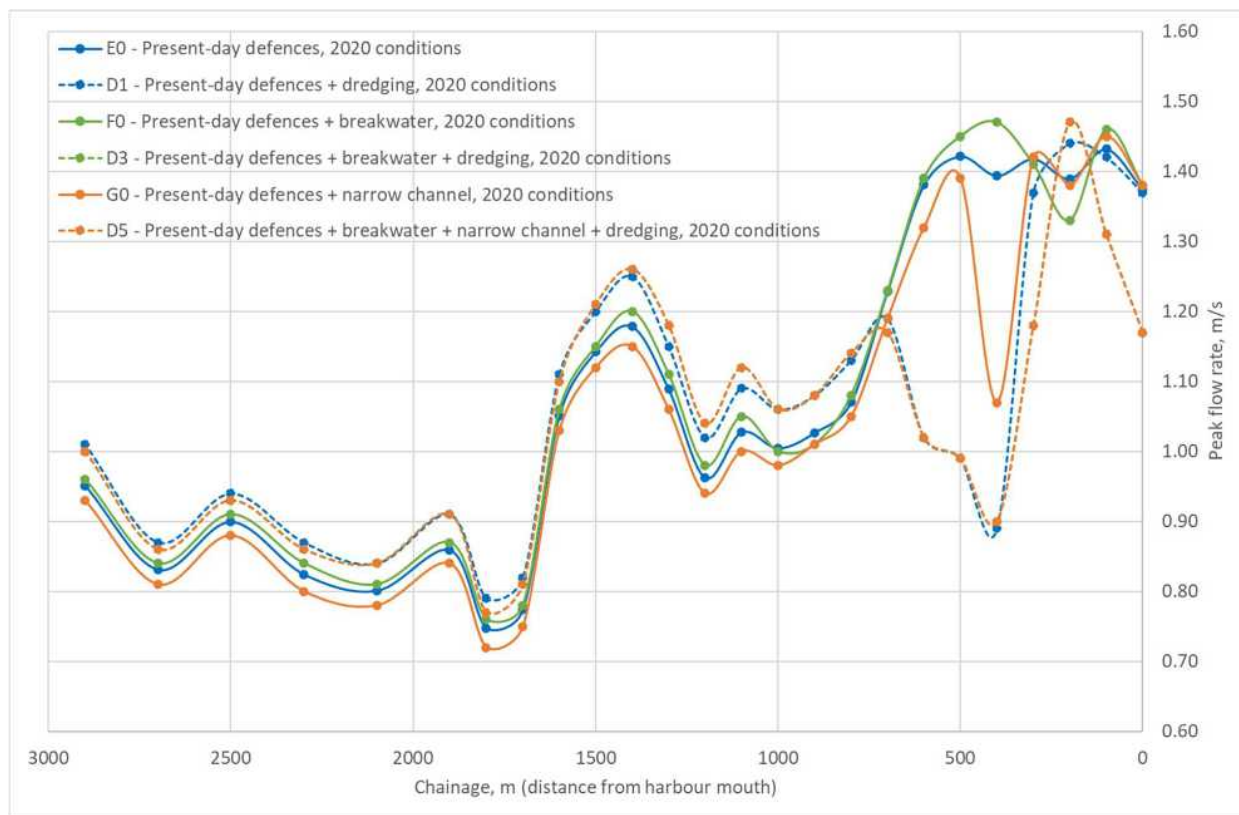
Figure 5-3: Peak flow velocities with dredging, February 2020 conditions

Figure 5-3 and **Figure 5-4** show that with the existing South Pier and estuary defences, dredging the shoal bank would decrease peak flow velocities through the outer harbour by up to 0.5m/s for the February 2020 conditions and by 0.4m/s for the December 2013 surge event conditions. This is due to the increased channel cross section with the removal of the shoal bank. Further upstream, peak flow velocities would increase due to the increase in the tidal prism, although the increase would be less than 0.1m/s for both water level conditions.

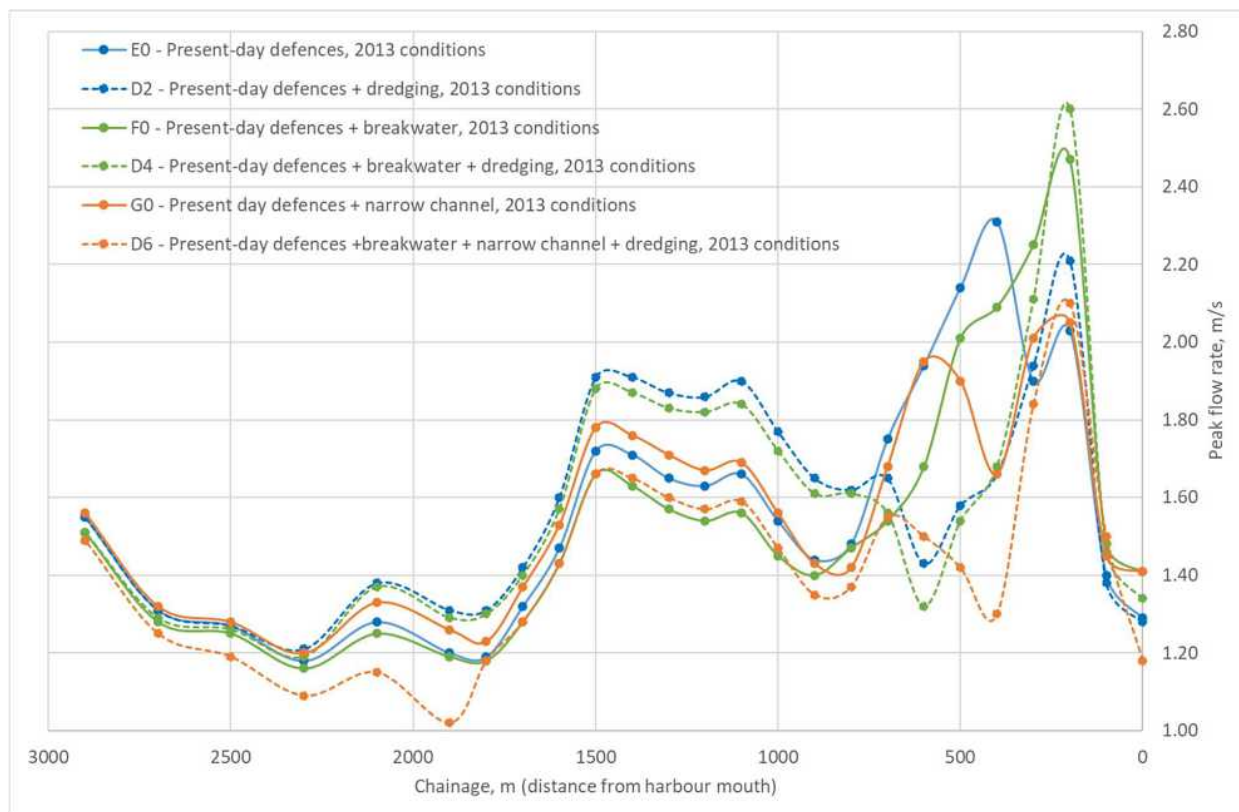
Figure 5-4: Peak flow velocities with dredging, December 2013 conditions
