Appendix E

Option Development

E1 Structural solutions for the harbour entrance

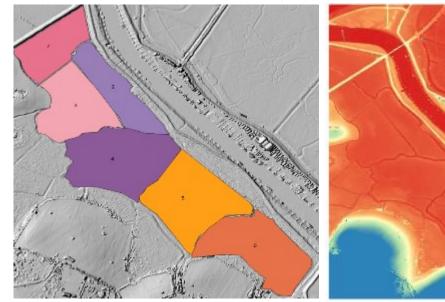
Figure E1 – Sub-compartments and ground levels used in TidalB model

An initial assessment was undertaken for a range of spillway dimensions using the simple 2D hydraulic model TidalB, which was developed in-house by Royal HaskoningDHV. This demonstrated that that a spillway should be viable in terms of the resulting water depth in the marshes and the associated risk of flooding to Walberswick properties. The results of the Tidal B analysis are included in **Table E1**.
