Southwold Harbour Management Committee

Pages
4 Draft Southwold Harbour Study ES/1463	8 - 81
To consider the Draft Southwold Harbour Study.	
5 Update from the Committee's Working Groups	
To receive an update from the Committee's working groups.	
6 Update from the Stakeholder Advisory Group	
To receive an update from the Stakeholder Advisory Group.	
7 Work Programme	82 - 82
To consider the Committee's forward work programme.	
8 Date of Next Meeting	
To note the date of the next meeting as 9 March 2023.

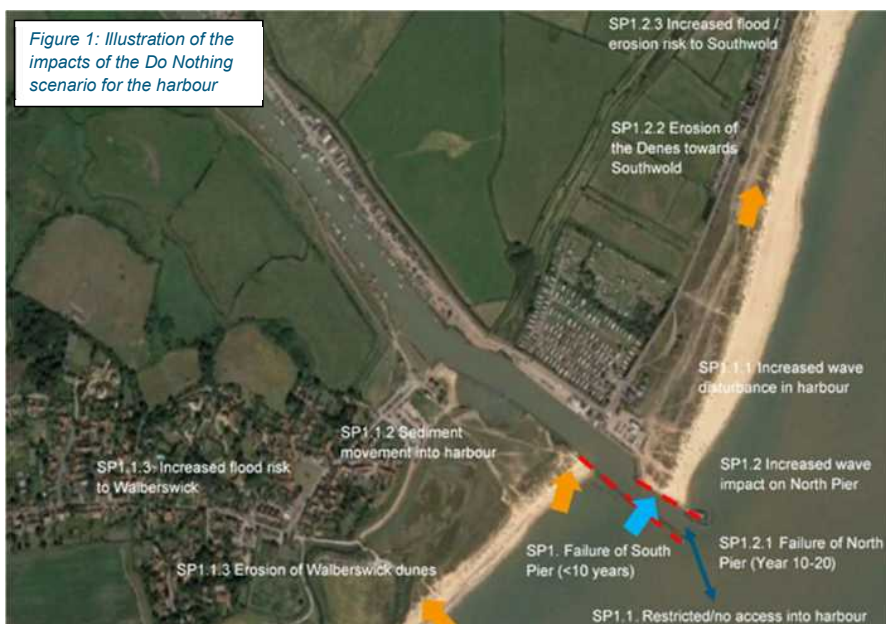
Figure 1: Illustration of the impacts of the Do Nothing scenario for the harbour

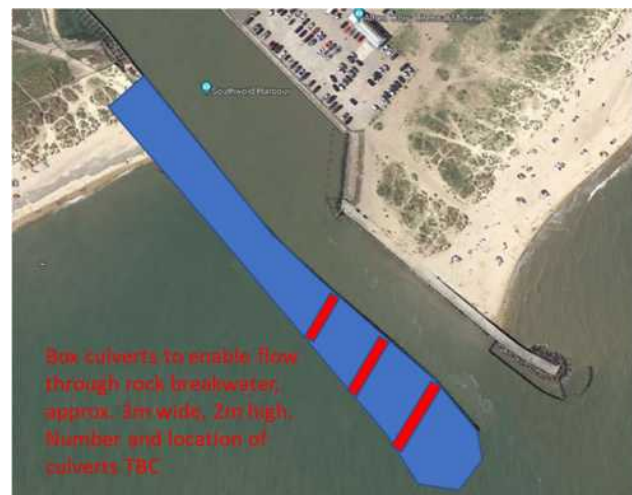
Figure 1-1 – Proposed rock breakwater with box culverts

A key objective for the Investment Plan is to sustain navigation conditions in the harbour entrance. To achieve this, the current recommendation is for large box culverts to be incorporated into the proposed rock breakwater, which would enable flow through the structure in a similar way to the existing windows (see Figure 1-1).

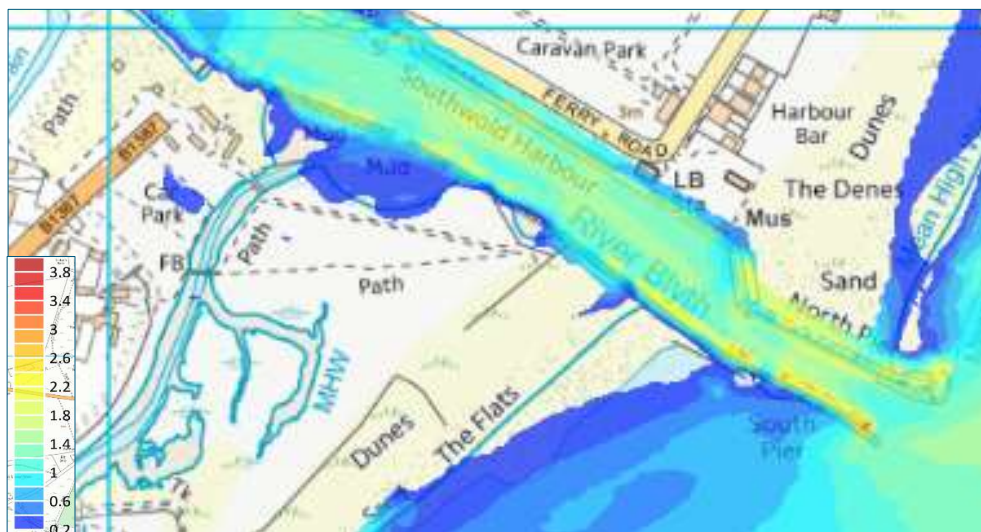
Figure 4-2: Maximum flow velocity in harbour entrance for vertical-walled South Pier (no windows), Feb 2020 conditions

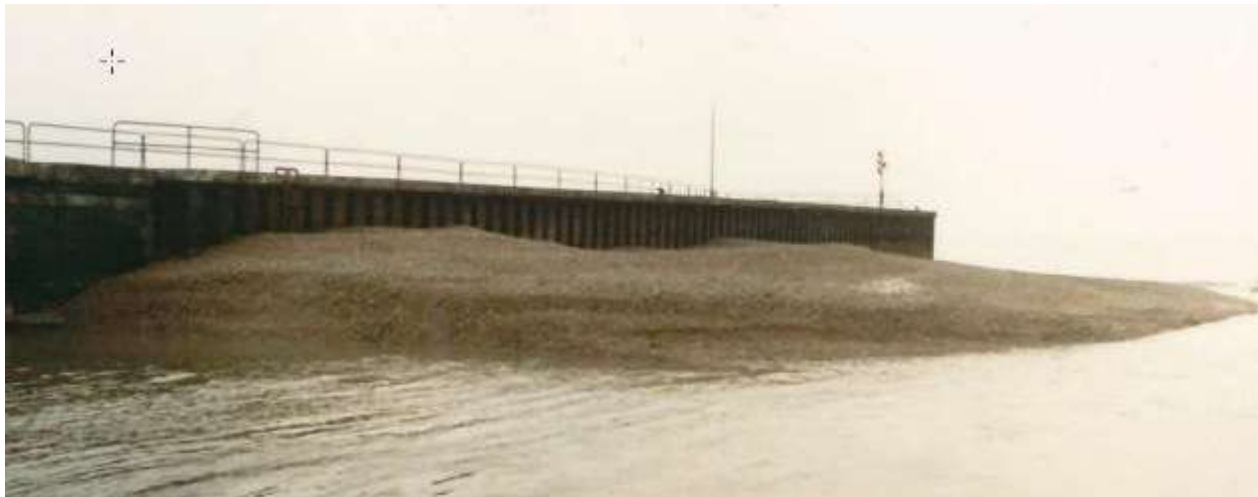
Figure 3-1: Sediment accumulation, north side of harbour, 1987

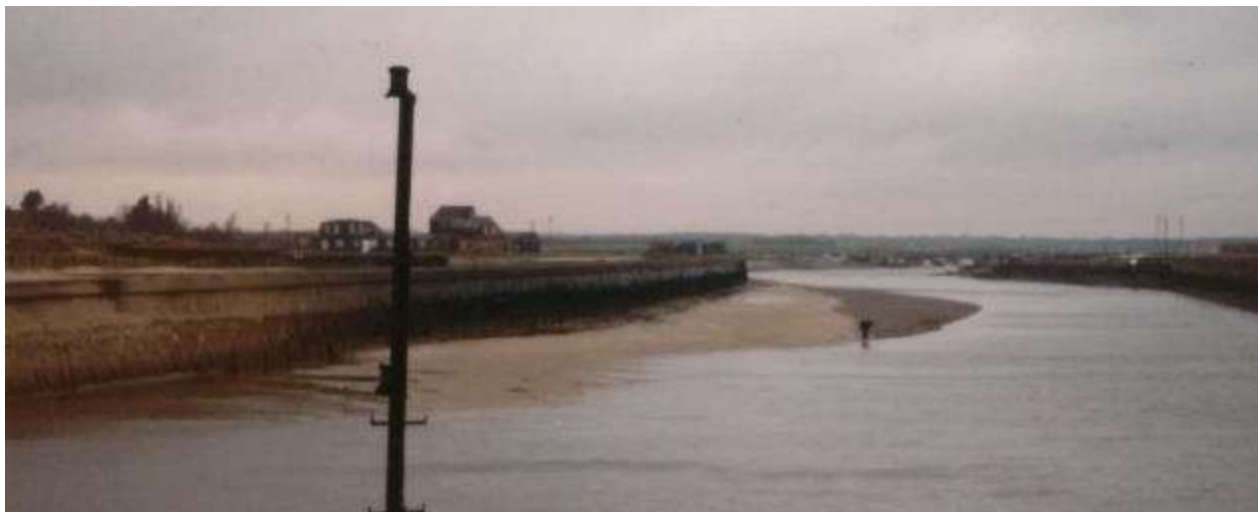
Figure 3-2: Sediment accumulation, south side of harbour, 1987

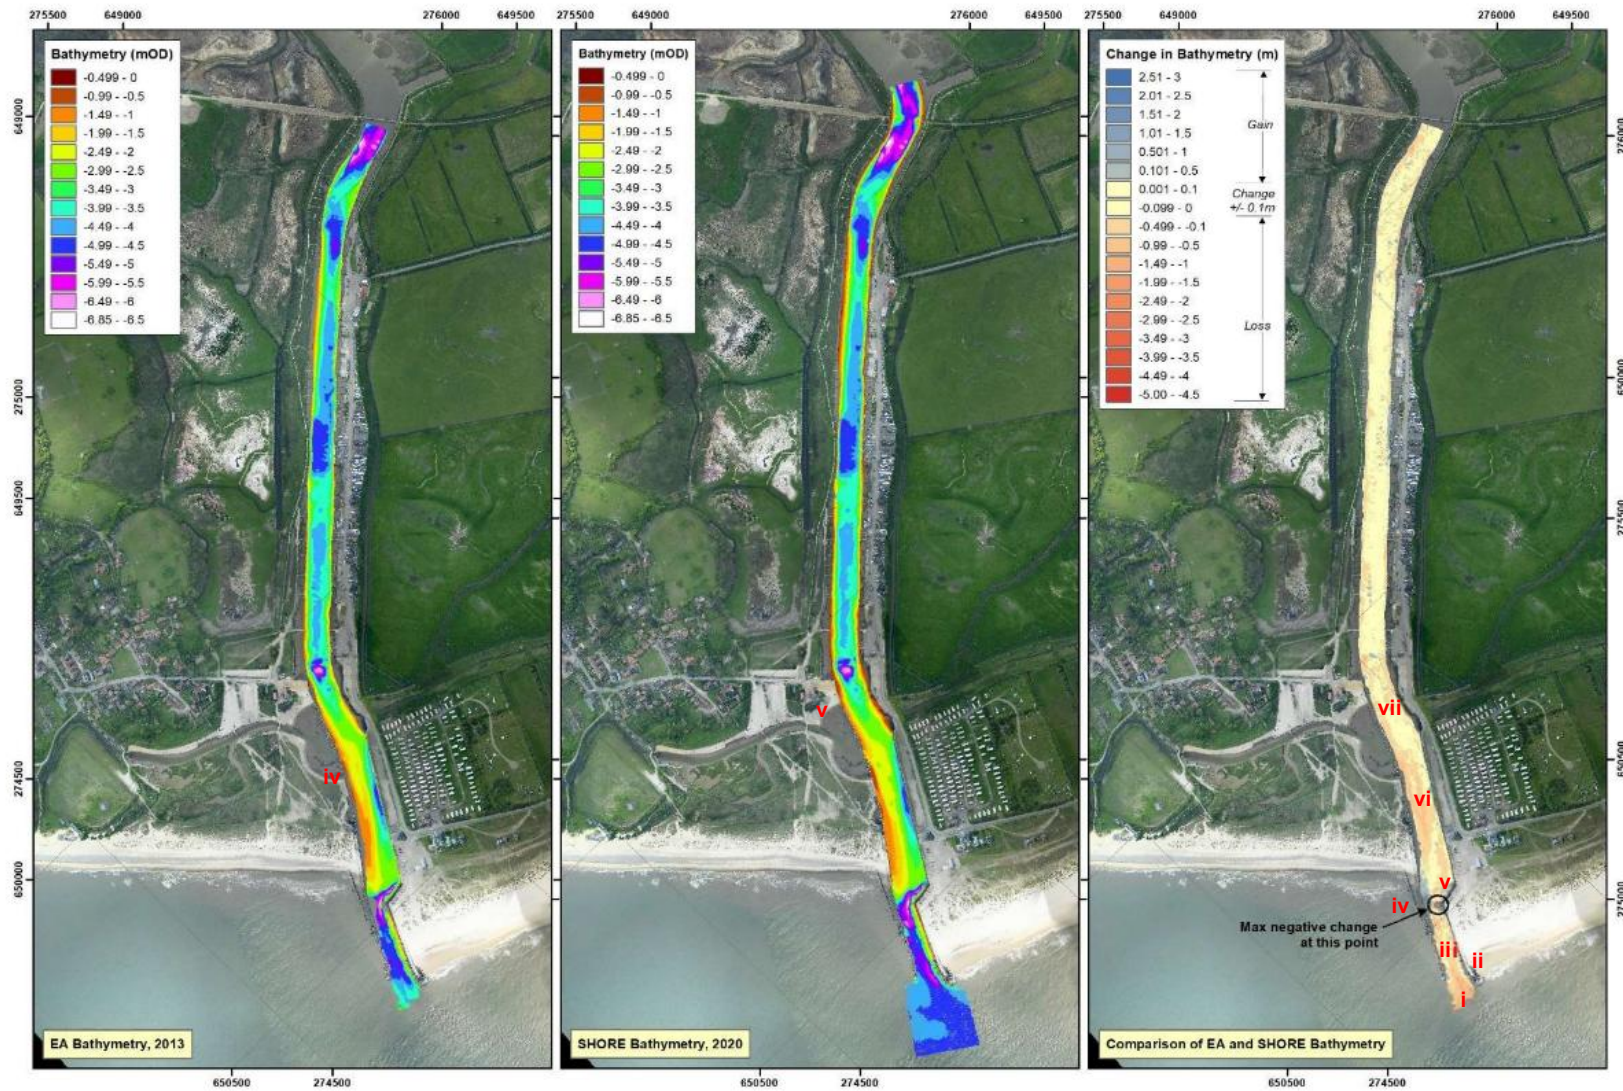
Figure 3-4: Comparison between the 2013 and 2020 bathymetric survey

In terms of the shoal bank opposite the North Wall, comparison of the bathymetric surveys in **Figure 3-4** indicates that this could be gradually extending or migrating to the south, towards the entrance channel, although with a reduction in the crest level of the bank of about 0.5m since 2013.

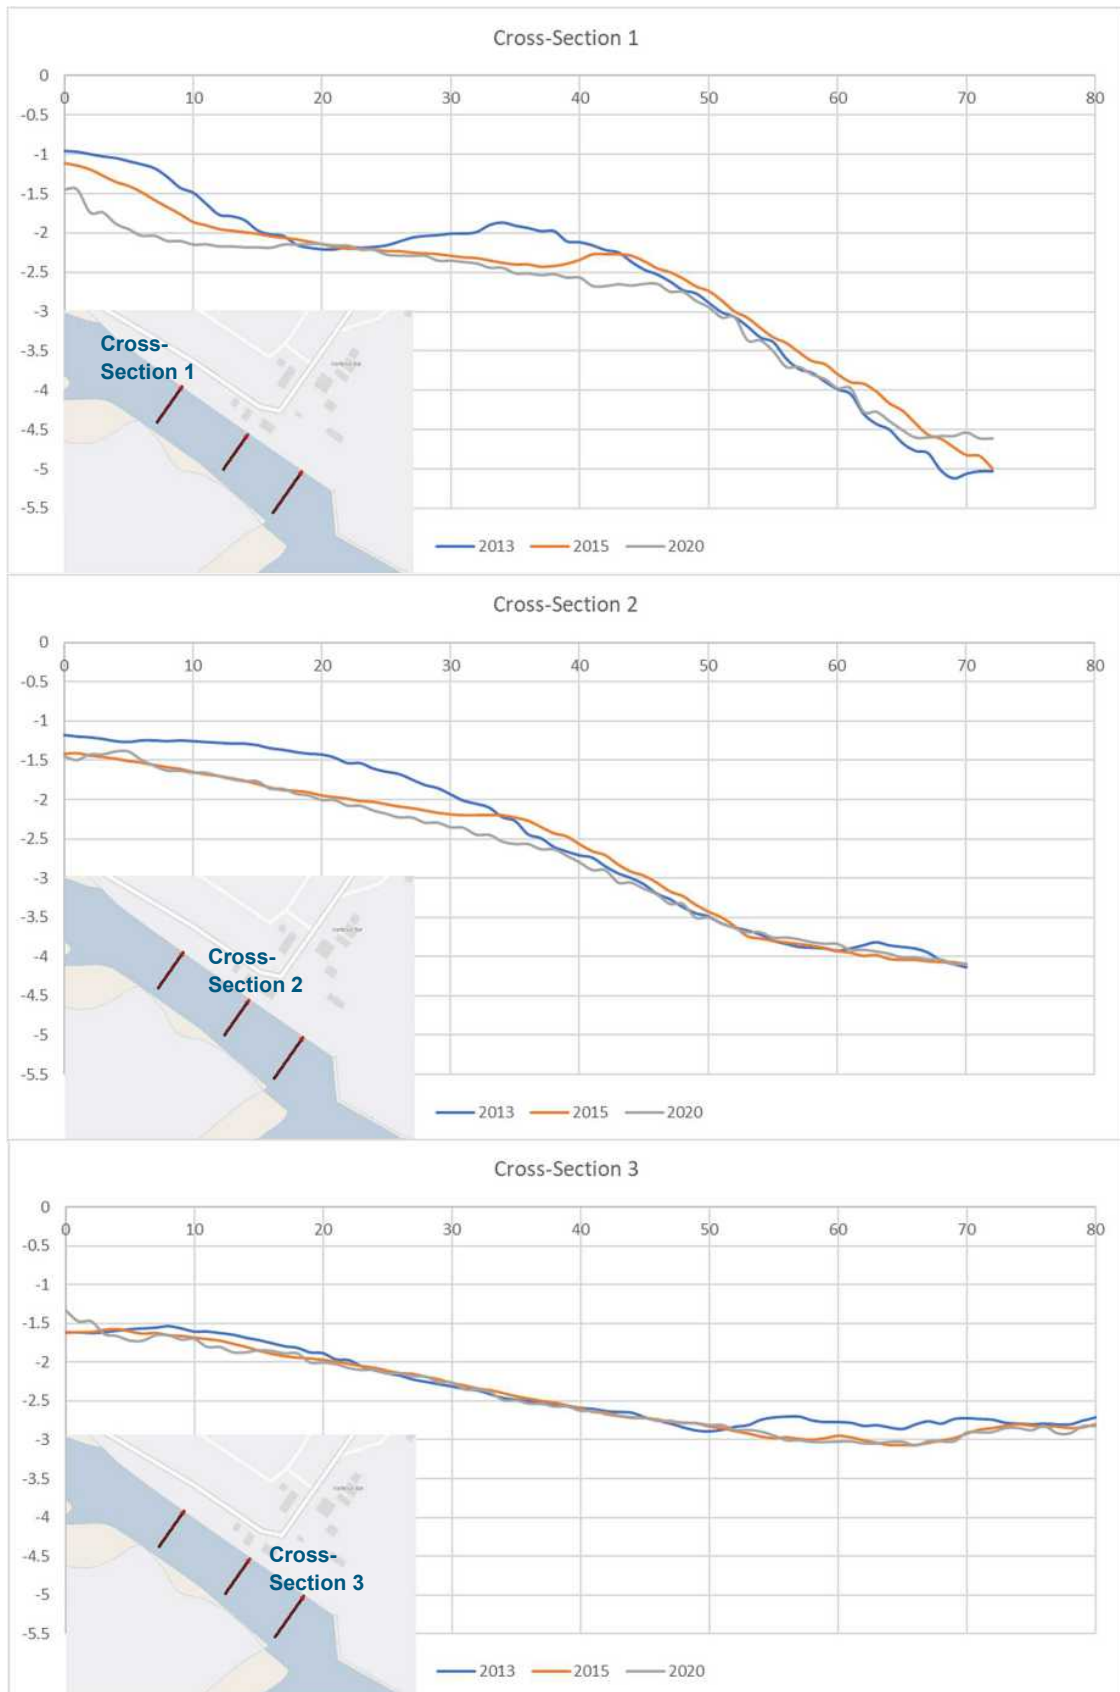
Figure 3-5: Comparison between 2013, 2015 and 2020, for 3 cross sections (see inset location plans)

This potential change in the shoal bank has been considered further by reviewing the change in the bed level for three cross sections in this area, based on survey data from 2013, 2015 and 2020. This comparison is provided as **Figure 3-5**, and confirms the 0.5m reduction in bed level since 2013. The cross sections in **Figure 3-5** show that the width of the bank can vary (e.g. 1-2m increase in width between 2013 and 2015), although in 2020 the bank width was comparable to that recorded in 2013. This data does not indicate any noticeable southerly movement of the shoal bank.
