#### Appendix 4: Structures that make a positive contribution to the Conservation Area

The character and appearance of the Conservation Area are shaped by the structures and spaces within it. This appendix contains a list of the built structures which have been identified as making a positive contribution to the Conservation Area (as per section 4. *Positive Contributors* of the CAAMP). The list contains designated as well as undesignated structures. The list is illustrated on maps in the CAAMP.

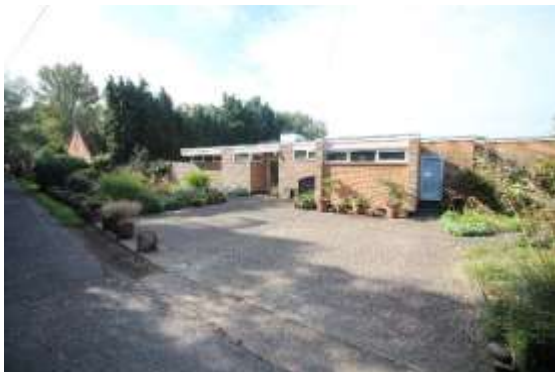
*Willow Fen, Castle Lane* A single storey flat roofed detached dwelling of c1960 within a contemporary landscaped garden. Faced in Suffolk white brick. Its entrance façade has a row of narrow casement windows beneath the eaves and a painted wooden fascia. Glazed door in recessed porch. An inventively designed and well preserved 1960s dwelling. Sympathetically designed single-storey side addition of c2005.

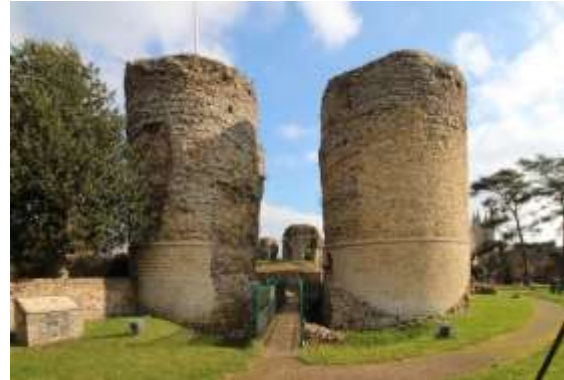
*The Castle* (grade I and scheduled monument). Prior to the Norman Conquest, the land of which Bungay Castle stands formed part of estates held by Stigand, Anglo-Saxon archbishop of Canterbury. Post-Conquest, it was first held by William of Noyers, then, in 1103, the site was bestowed by Henry I on Roger Bigod, beginning a tumultuous phase of ownership by the Bigod family. The first development of the castle site is thought to have been initiated by William de Noyers, with the construction of a motte and bailey with a timber hall and defensive palisade set within surrounding ditches, and it was not until 1140 that more permanent structures in the form of stone fortifications appear on the site, begun by Hugh Bigod, the youngest son of Roger Bigod's heir, William.

The castle, curtain walls and inner bailey walls now mainly consist of flint rubble core material, bound in lime mortar, with almost all former dressed stone or flint facing material now lost, apart from the retained ashlar work to the base of the gatehouse towers. There have been extensive repairs to the inner bailey

The core element of the castle site is the square base of the keep. Attached to the south wall are the remains of the forebuilding. Surrounding the keep are the curtain walls, which are roughly octagonal on plan, and which incorporate the twin semi-circular towers of a gatehouse to the west of the keep. The inner bailey extended from the castle's curtain wall and enclosed a roughly rectangular area to the west of the castle. Beyond the perimeter of this inner bailey area, and loosely conforming to its shape, was a wide ditch which is believed to have completely encircled the castle site. The inner bailey wall extended from the castle curtain wall approximately adjacent to the north-west angle of the castle keep, continuing westwards then abruptly turning southwards, then eastwards, then finally turning north-eastwards to reconnect with the curtain wall a short distance from the southern tower of the castle gatehouse. The final short length of inner bailey wall once incorporated a gateway to the south south-west of the keep and curtain wall, thought to be the second of a series of four entrances to the castle site, this one at the crossing of the inner ditch leading into the inner bailey

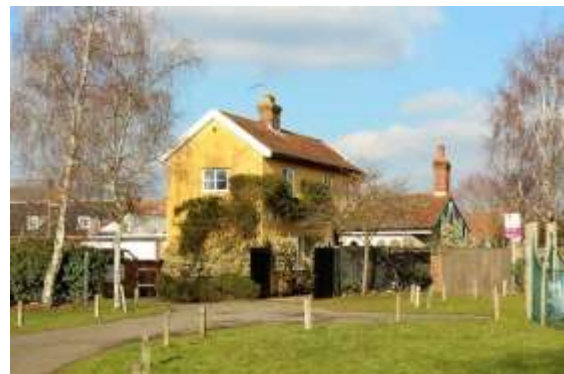
*Castle, Cottage, Castle Yard, Castle Orchard*

*Castle Cottage, Castle Orchard.* A nineteenth century cottage with a red pan tiled roof and rendered walls which is located within the boundaries of the scheduled ancient monument. Two storeys and three bays with twentieth century casement windows. Gabled return elevations with simple bargeboards. Single storey wing. Red brick ridge stack. *Subsidiary structures* Tarred brick and flint boundary wall of probably early nineteenth century date.

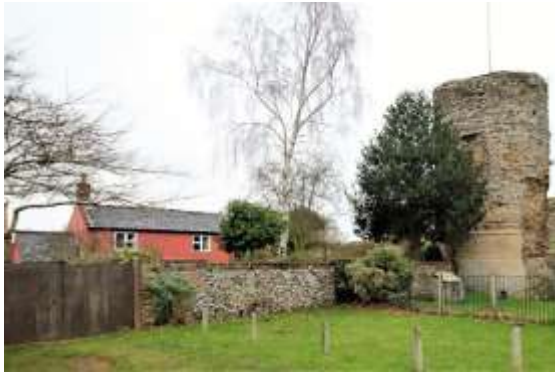
*Keeper's Cottage, Castle Orchard*

*Keeper's Cottage and boundary wall, Castle Orchard* (standing on scheduled land). A nineteenth century cottage with extensive later twentieth century alterations and additions, built within the remains of the Castle complex and within the scheduled ancient monument. Its rear retaining wall is part of the Castle wall. Original cottage has rendered walls and a black pan tiled roof. Red brick ridge stack. Two storeys with a single storey wing. Twentieth century flat roofed porch. Return gable with twentieth century timber oriel window to first floor. Lower red pan tile roofed range to rear. Twentieth century casement windows. *Subsidiary features.* Good nineteenth century flint wall.

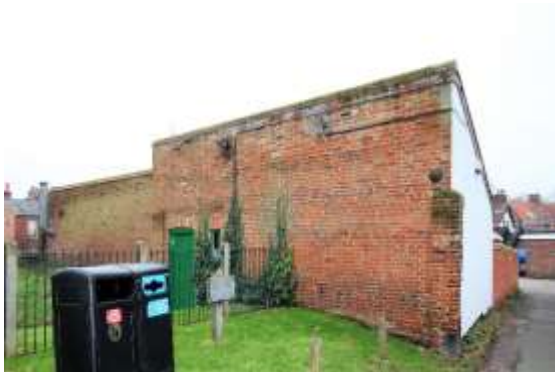
*Jester's Shop, The Keep, Castle Orchard*

*Jester's Shop, The Keep, No.10 Castle Orchard.* A nineteenth century small barn or wagon shed, now altered. Single storey red brick with rendered front and side elevations. Boarded door. Red pan tiled roof. Prominently located on the scheduled ancient monument. Until the 1960s it formed one side of a courtyard to the rear of a substantial house which fronted onto Castle Orchard. Included here primarily for its rear elevation which forms a key part of the

setting of the Castle ruins and directly abuts the scheduled monument.

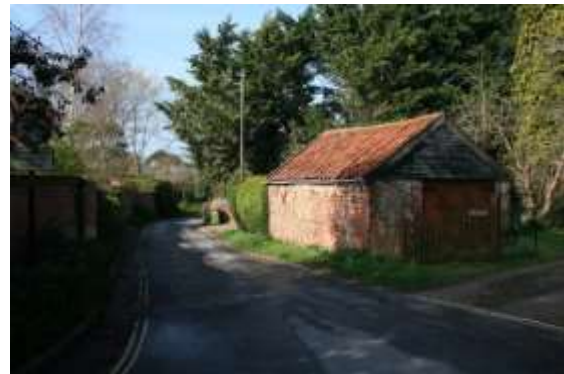
*Outbuilding, The Keep, Castle Orchard*

*Outbuilding, The Keep, Castle Orchard.* A small red brick and rubble outbuilding with a weatherboarded gable and a black and red pan tiled roof. Probably of mid nineteenth century date. Prominently located within the setting of the scheduled ancient monument.

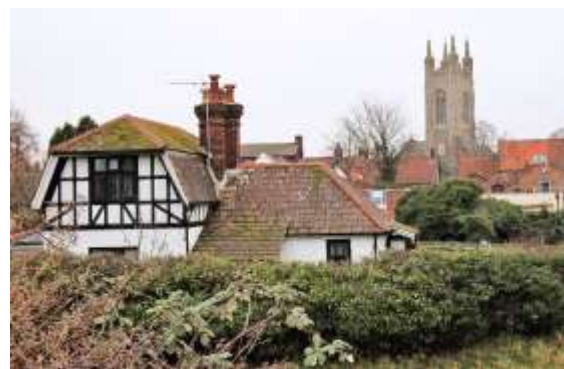
*Castle Cottage, Castle Orchard*

*Castle Cottage, No.11 Castle Orchard.* A detached dwelling of c1918 designed by John Doe and in the vernacular revival style. (See also Nos.14 & 16 Scales Street). Rendered elevations with applied decorative half-timbering. Casement windows with mullions and transoms. Tiled gambrel roof and red brick chimneystacks. Late twentieth century rendered porch. Prominently located adjacent to the scheduled Castle earthworks.

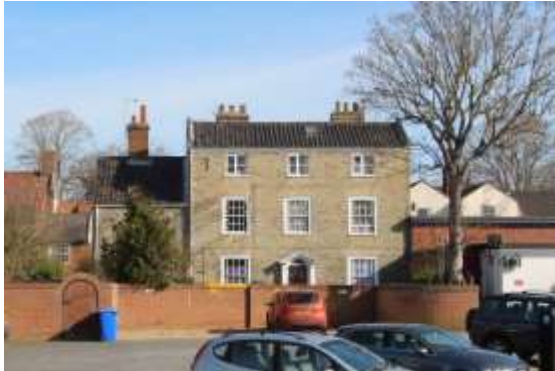
*Nos.24-28 Priory Lane*

*Nos.24-28 (even) Priory Lane* (grade II). A large, early-nineteenth century, detached house, which has been converted into three dwellings. In a sensitive location close to a scheduled ancient monument. Of three storeys, with a symmetrical Suffolk white brick façade of three bays. Return elevations red brick, black pan tiled roof. Sash windows with narrow margin lights and flush frames to first floor. Flat-arched lintels. Twentieth century casements to second floor. Two storey one bay wing with side entrances with twentieth century gabled porch to left. Six-panelled door with arched radial-bar fanlight within a wooden doorcase with pilasters and an open pediment. *Subsidiary structures* Late twentieth century red brick boundary wall and gate piers to Priory Lane not included.

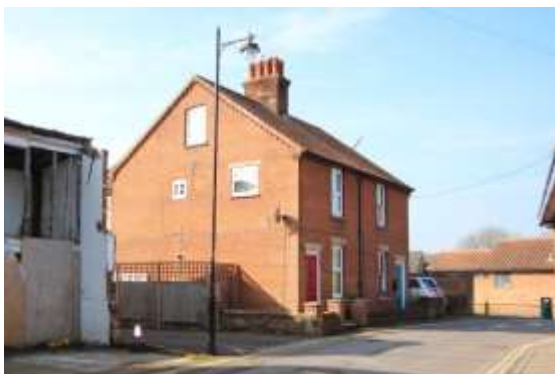
*Nos.5-7 (odd) Priory Lane*

*Nos.5-7 (odd) Priory Lane*. A red brick late nineteenth century semi-detached pair of

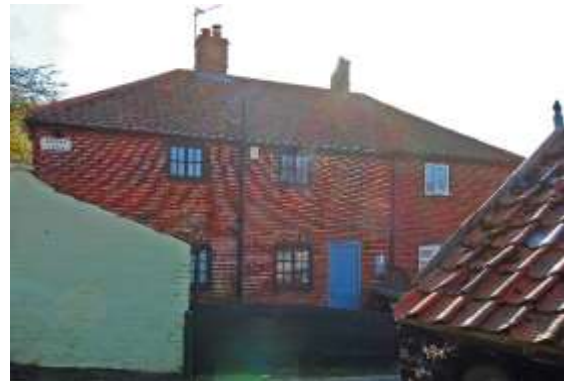
*Nos.11 & 15 Quaves Lane*

*Nos.11 & 15 Quaves Lane with outbuilding and boundary wall to No.11*. A pair of semi-detached houses which were built in the early to mid-nineteenth century as three cottages, Nos.11& 13 are now combined. Red brick with a hipped red pan tiled roof. Two storeys with a single storey nineteenth century lean-to to the north-east (No.11). The east wall to Castle Lane is tarred. Late twentieth century timber doors and casement windows in original openings. *Subsidiary Structures* Low painted boundary wall to Quaves Lane elevation of No.11 which appears to be of nineteenth century date. Twentieth century wall to No.15.

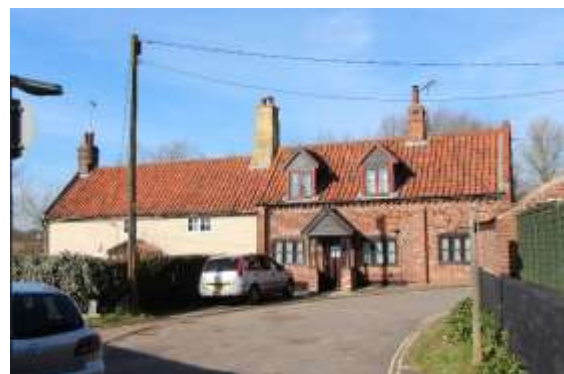
*Nos.27 & 28 Quaves Lane*

*Nos.27 & 28 Quaves Lane and outbuilding.* Pair of cottages probably of early nineteenth century date. No.27 now altered. No.28 built of painted brick with a red pan tiled roof with a parapet gable to the west. Tall ridge stack to east. Two storeys with two windows. Ground floor central entrance door within late twentieth century gabled timber porch. Windows are two-light casements with glazing bars. No.27 built of red brick with a red pan tiled roof with parapet gable to East. Of a single storey with attics lit by two twentieth century gabled dormers. Three, three-light late twentieth century timber casements with segmental brick arches. Entrance door is off-centre to east, with a late twentieth century gabled timber & brick porch with a red pan tiled roof. *Subsidiary structures.* Nineteenth century outbuilding to No.27 with gable end to Quaves Lane and rear elevation to Castle Lane. Tarred rubble and red brick walls, single storey with a weather boarded gable. Twentieth century casement window.

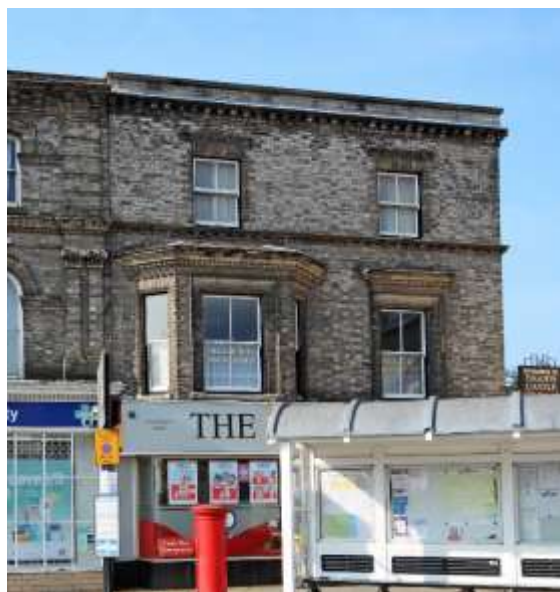
*No.2 St Mary's Street*

*No.2 St Mary's Street.* A red brick house and shop of c1800, re-fronted and partially rebuilt in Suffolk white brick c1870 probably to the designs of William Oldham Chambers of Lowestoft who designed the adjacent façade to the south. Three storey white brick façade of two bays, with canted bay to first-floor left. Horned plate-glass sashes. Parapet with dentilled cornice. Late twentieth century shop fascia. Early nineteenth century red brick range to rear with hornless sashes. Some windows with glazing bars removed. Taller two bay mid-nineteenth century red brick addition with plate-glass sashes. Flat-arched lintels and stone sills. Hipped roof with overhanging eaves. Return elevation rendered.

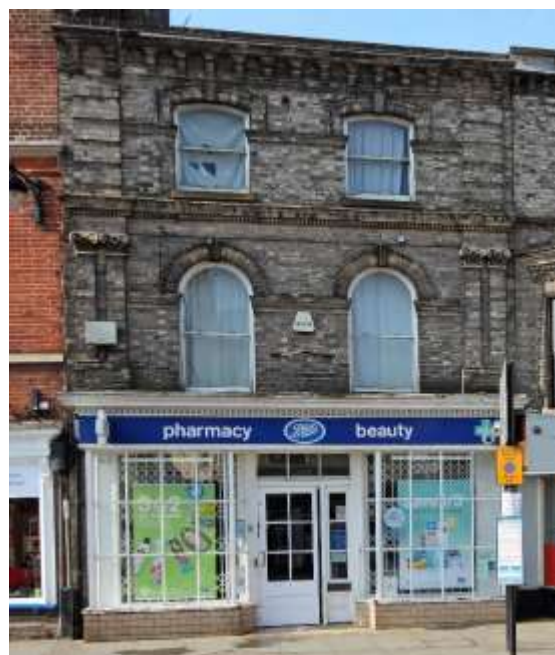
*No.4 St Mary's Street*

*No.4 St Mary's Street.* A house and shop, probably of later eighteenth-century date. Re-fronted and remodelled to the designs of William Oldham Chambers of Lowestoft 1871, for the draper JB Thurtle. Faced in Suffolk white brick. Paired pilasters flanking first floor arched plate-glass sashes. Single pilaster to outer edges of second floor and moulded sill band. Heavy moulded white brick hoods with keystones to windows. A good example of a late nineteenth century commercial building by a regional architect of note. Retaining its original window joinery to the upper floors. Later twentieth century shop fascia possibly retaining original dentilled cornice and upper panel. Heavy corbelled cornice with parapet above. Balustrade and urns removed from parapet in the mid twentieth century. Rear elevation of red brick and probably of later eighteenth-century date. Brown, Hayward, and Kindred, *Dictionary of Architects of Suffolk Buildings 1800-1914* (Kindred, Ipswich, 1991) p66.

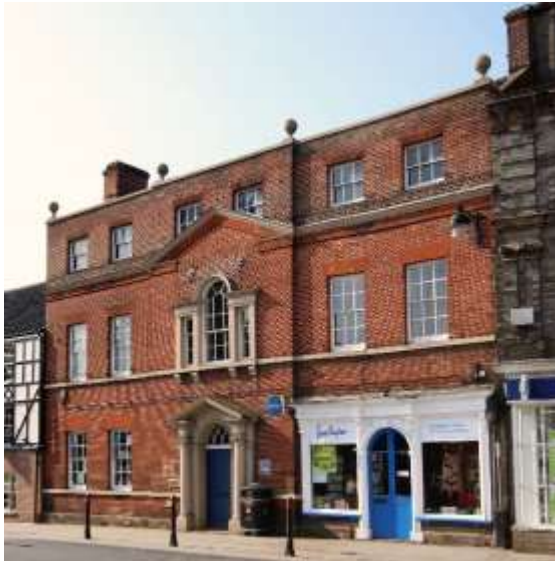
No.6 St Mary's Street and garden walls to rear (grade II). A substantial late eighteenth century townhouse. Of three storeys. Five-bay symmetrical principal façade of red brick with stone dressings. Central breakfront of a single bay, plinth, ground and first floor sill bands. The central breakfront has an open pediment at second floor level above a Venetian window with sashes. Open-pedimented doorcase with Doric  $\frac{3}{4}$  radius columns, triglyphs, and an arched fanlight. Six-panelled door. Twelve-light hornless sashes to ground and first floors, six-light to second floor. Flat-arched lintels. Stone mouldings to cornice at second floor level. Stone cope with four stone ball finials. Fine mid-nineteenth century wooden office window to ground floor right of classical design, with consoles and an entablature. Central glazed entrance with arched door. Rendered rear range with twelve-light sashes. *Subsidiary Structures.* Good late eighteenth century red brick walls surrounding former rear garden. Nos.2 to 22 (even) form a group. Bettley, J, and Pevsner, N, *The Buildings of England, Suffolk: East* (London, 2015) p.157.

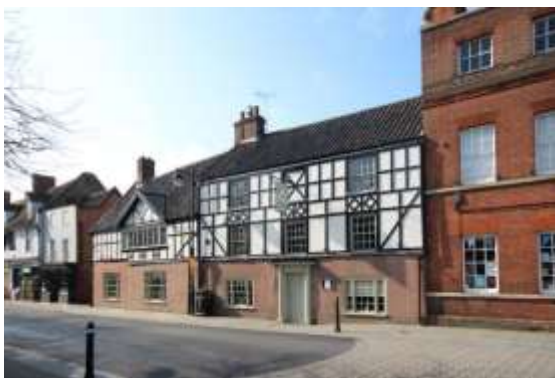
The Fleece Hotel, St Mary's Street

*The Fleece Hotel, Nos.8-10 (even) St Mary's Street and Inn yard walls* (grade II). Early seventeenth century with a later eighteenth century red brick façade, which was rendered and had applied decorative timber-framing added c1920. Ground floor cement rendering in imitation of red brick. Main block has a three storey, three bay principal façade with hornless sixteen-light sashes within flush frames to the first and second floors. Tripartite sashes to ground floor. Painted wooden doorcase with Doric  $\frac{1}{2}$  columns and an unusual bed mould to the cornice. Six-panelled door. Black pan tiles to front face of roof, red to rear face. Left-hand wing formerly with shop front now tripartite sashes. At first floor level a long casement window with leaded lights. Small gable of c1920. Rear elevation also with applied timber-framing. Red brick rear range with red tile roof. Interior: evidence of timber-frame construction, oak corner cupboard and original doors. Nos.6 to 22 (even) form a group. *Subsidiary structures.* The inn yard at the rear (entered from Castle Orchard) is surrounded by red brick walls of primarily nineteenth century date. Some earlier sections which appear to have originally been part of structures. Twentieth century weatherboarded outbuilding. (See also Clover Corner, Castle Orchard) Honeywood F, Reeve C, & Reeve T, *The Town Recorder, Five Centuries of Bungay at Play* (Bungay, 2008) p148-149.

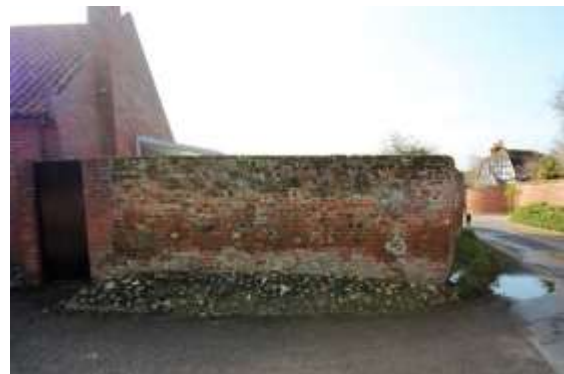
Boundary Wall, Clover Corner, Castle Orchard

*Boundary Walls formerly to the Fleece Inn, now serving Clover Corner, Castle Orchard* (grade II) Red brick boundary walls of largely later eighteenth century date, but containing reused earlier material including stone rubble, tile, and thin brick of possibly seventeenth century date. Clover Corner itself is a late twentieth century dwelling and not of significance. The walls originally belonged to the Fleece Inn St Mary's Street and therefore are probably listed as curtilage structures to that grade II listed building. An important part of the former inn yard and of the setting of the grade II inn.

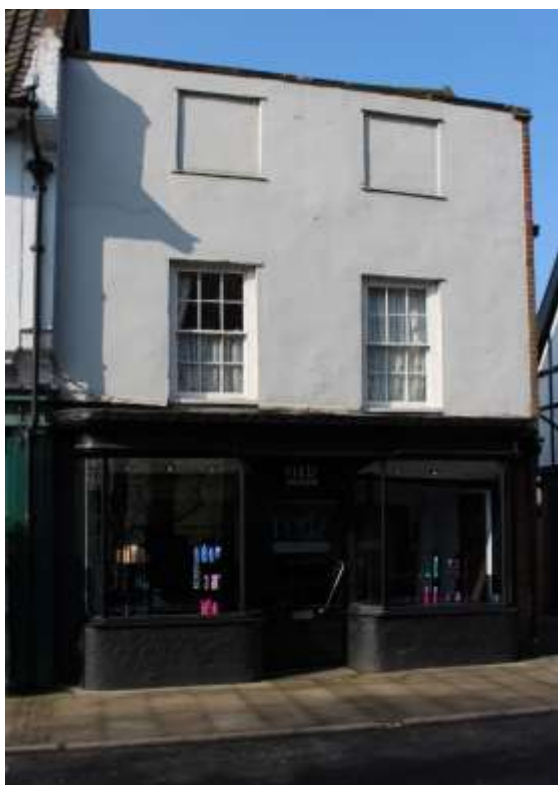
*No.12 St Mary's Street* (grade II) Later eighteenth century, three storey, red brick, with a stuccoed façade and a stone cope. Pan tiles. Good wooden shop fascia with a central door and rounded corners to the flanking bays, later twentieth century glazing. Two twelve-light hornless sashes at first floor level. Two blank panels to second floor. Flush frame sash window in gable on northern return elevation. Nos.2-22 (even) form a group.

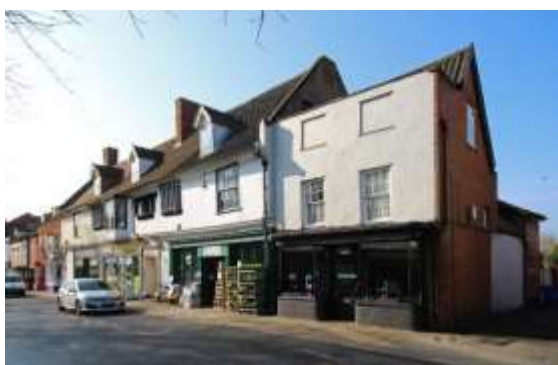
*Nos.14-18 St Mary's Street*

*Nos.14-18 St Mary's Street and boundary walls to rear.* (grade II) A sixteenth century timber framed structure, originally one building. It was considered to have been a private residence by Suckling, though often supposed to have been an inn connected with the Nunnery which stood opposite. Evidence survives at the rear of an external first-floor gallery suggesting that it was once indeed an

inn. The structure is thought to have been occupied by John Duke, who lived in Bungay in 1550. An old mantelpiece removed from the house bore the arms of Bedingfield and D'Oyley and the date 1572, and there was also the figure of a crusader over the entrance; both were bought by Sir Rider Haggard in 1922 and incorporated in "The Three Bells" Ditchingham, when it was converted into a private house. Three original mullioned casement windows remain at first floor-level with projecting carved sills, depicting the slaughter of the Philistines by Samson, and Samson and Delilah, also a child wrestling with two dragons, said to be Hercules. Another has a bust of the Virgin Mary. Another, since removed showed the fate of Actaeon devoured by dogs. An original spiral brick staircase remains at No.18, and a four-centred arch to the cellars beneath. Eighteenth or early nineteenth century alterations, to which twentieth century shop fronts have been added and internal rearrangements made. Of two storeys with an attic lit by three dormers. Timber framed with a jettied first floor, rendered façades, and coved eaves. Tiled roof. Two hornless sixteen-light sashes, and a mid-nineteenth century canted bay with plate-glass sashes. Central eighteenth century eight panelled door with panelled reveals. Doorcase with fluted Doric pilasters, triglyphs and an enriched dentilled pediment. Twentieth century flat-roofed additions to rear not of interest. *Subsidiary Structures* Enclosed yard to rear. It is highly likely that the wall is largely of early nineteenth century date, if not earlier, although the random construction and the incorporation of salvaged brick and stone (possibly demolition rubble from the castle) makes accurate dating problematic. See also the walled enclosure to Clove Corner, Castle Orchard. Nos.2 to 22 (even) form a group. Bettley, J, and Pevsner, N, *The Buildings of England, Suffolk: East* (London, 2015) p.157.

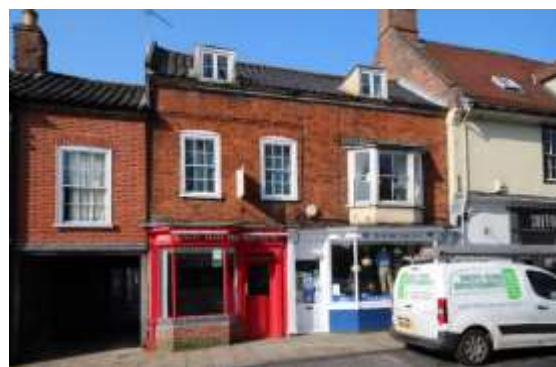
*Nos.20-22 St Mary's Street*

*Nos.20-22 St Mary's Street and outbuilding to rear* (grade II). Eighteenth century, of two storeys and an attic which is lit by two flat-roofed casement

dormers. Red brick with a black pan tiled roof. No.20 has a shallow later nineteenth century canted splay bay at first floor level with centre glazing bars, and a cornice. Mid-twentieth century splayed shop front. No.22, two flush framed twelve-light sash windows at first floor level with glazing bars and cambered brick lintels. Early nineteenth century wooden shop front with pilasters. Rendered return gable with parapet. To the left a single-bay two storey wing with wide vehicle way under. Heavily repointed red brick. At first floor level a hornless twelve-light sash within a flush frame. Red brick single-storey outbuilding of possibly early nineteenth century date at rear of site close to Castle Orchard. Nos.2 to 22 (even) form a group.

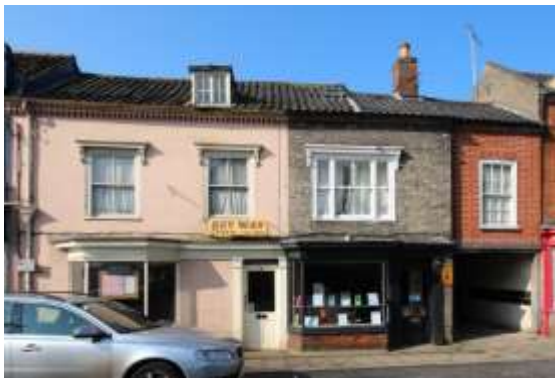
*Nos.30-32 St Mary's Street*

*Nos.30-32 St Mary's Street.* A mid nineteenth century re-fronting of an earlier structure. Its Suffolk white brick façade is now partially painted. Stone dressings. Black pan tiled roof. Canted nineteenth century wooden shop fronts. Four light plate-glass sashes to the first floor with corbelled hoods.

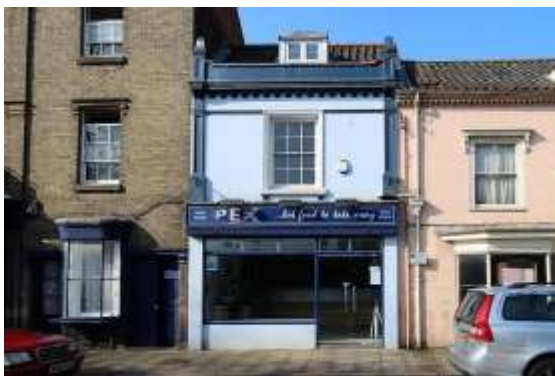
*No.34 St Mary's Street*

*No.34 St Mary's Street.* A mid- nineteenth century re-fronting of an earlier building. Two storeys, painted brick with pilasters and a parapet. Twelve-light hornless sash in heavy moulded frame. Later

twentieth century shop front. Red pan tiled roof with casement dormer.

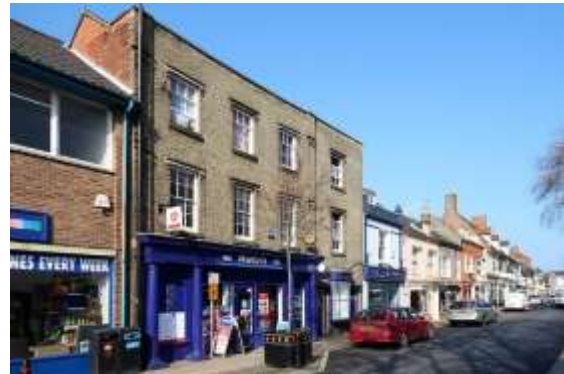
*Nos.36-38 (even) St Mary's Street*

*Nos.36-38 (even) St Mary's Street.* Early nineteenth century building of red brick, with a Suffolk white brick façade. Of three storeys and four-bays No.36 of one bay, No.38 of three with pilasters. Twelve-light hornless sash windows and a high parapet. Good possibly nineteenth century shop fascia with pilasters to No.38. Nineteenth century shop window to No.36.

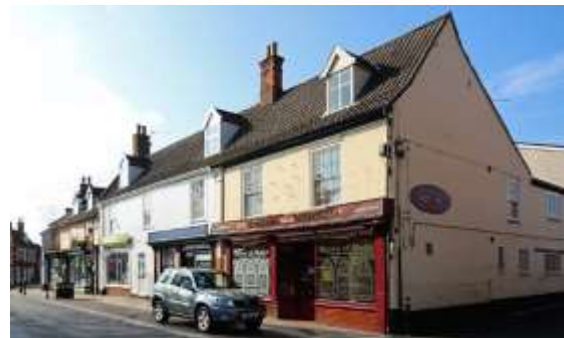
*Nos.42-46 (even) St Mary's Street*

*Nos.42-46 (even) St Mary's Street (grade II).* An eighteenth century, five bay range of two storeys and an attic. Three gabled dormers, painted brick, machine black pan tiled roof. Formerly part with coved cornice two brick pilasters with moulded brick caps. Five hornless twelve-light flush-framed sash windows at first floor level. Mid-nineteenth century wooden shop fronts with cornices and consoles. Red brick lower range to the rear of No.42 with casement windows. Blocked openings to gable end. Nos.42 to 56 (even) form a group.

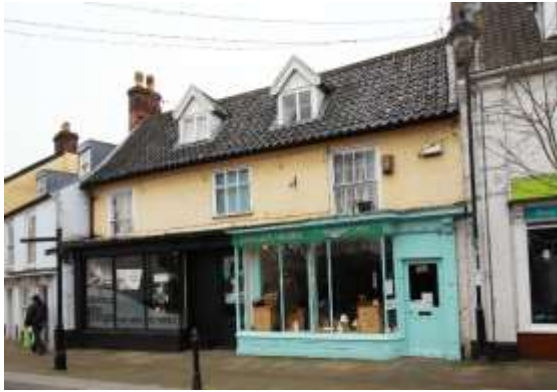
*No.48 St Mary's Street* (grade II). Eighteenth century, of two storeys and an attic. Black pan tiled roof with two gabled dormers. Painted brick. Three-bay rendered façade with sixteen-light flush-framed sashes to the outer bays and a casement window to the centre. Coved cornice. Mid-nineteenth century shop front with cornice and consoles. Nos.42 to 56 (even) form a group.

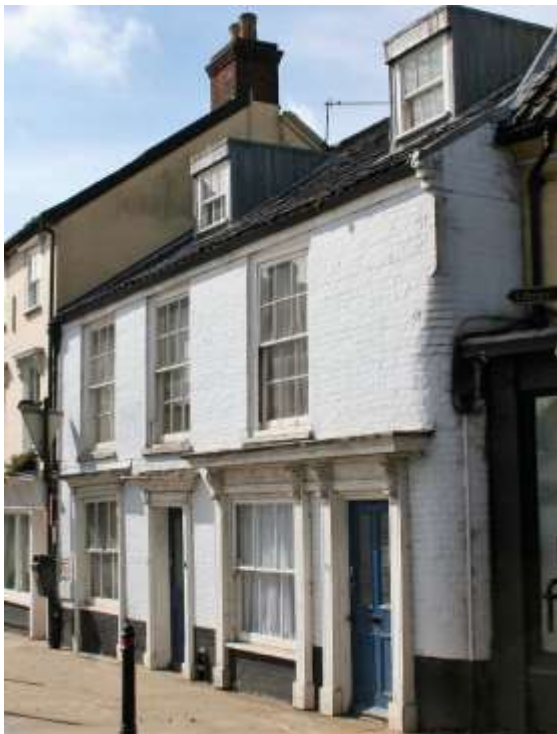
*Nos.50-52 (even) St Mary's Street* (grade II). An early nineteenth century, former public house of two storeys with an attic, two dormers, painted brick, with a black pan tiled roof. Two mid-nineteenth century wooden former pub facias and two doorcases with pilasters. The sash windows within the facias postdate the pubs closure. Four-panelled doors. Nos.42 to 56 (even) form a group. The Prince of Wales public house during the

nineteenth and early twentieth centuries. The earliest reference to its dates from 1823 and the pub is believed to have closed c1912. Honeywood F, Reeve C, & Reeve T, *The Town Recorder, Five Centuries of Bungay at Play* (Bungay, 2008) p151.

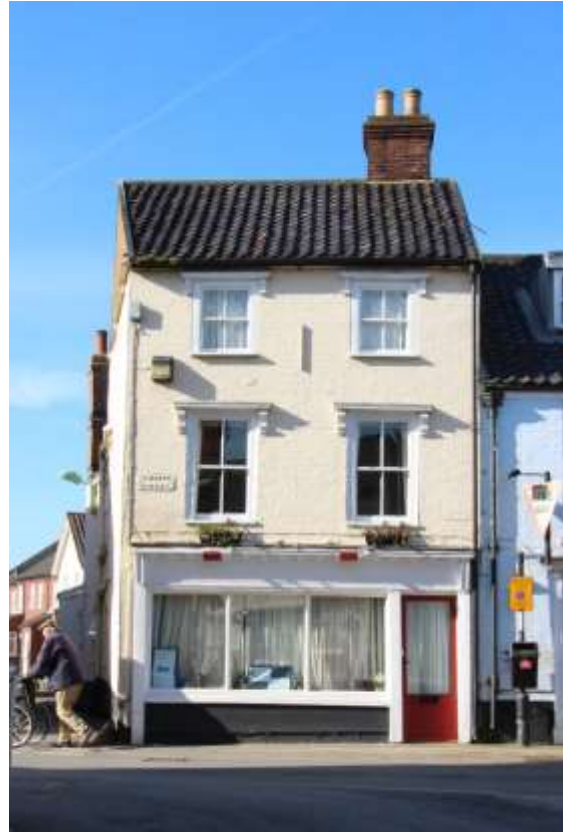
*No.54 St Mary's Street*

*No.54 St Mary's Street*. A three storey painted brick structure with a rendered return elevation to Quaves Lane. Black pan tiled roof. Early nineteenth century altered in mid nineteenth century date. Horned four-light plate-glass sash windows with stone hoods supported on carved corbels. Simple wooden shop facia. Two storey rendered nineteenth century range to rear with late twentieth century casements in nineteenth century openings partially with red pan tiles and partially flat roofed. Further single storey flat-roofed range. A c1860 photo shows the property without the corbelled hoods to the windows. Honeywood F, Morrow P & Reeve C, *The Town Recorder, A History of Bungay in Photographs* (Bungay, 1994) p184-185.

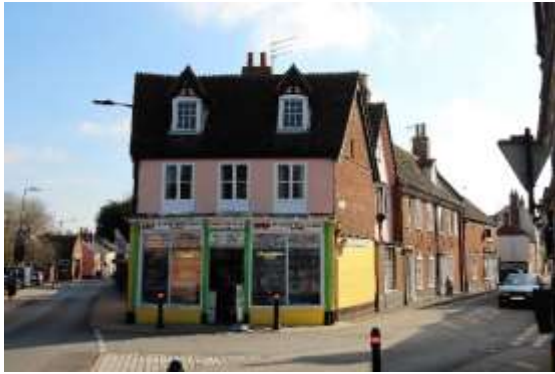
*No.56 St Mary's Street* (grade II). An eighteenth-century structure of two storeys and an attic, standing in a prominent location at the junction of St Mary's Street, Upper Olland Street, and Lower Olland Street. Tiled roof with two gabled sash dormers with glazing bars. St Mary's Street façade of two bays with two, near flush framed casements at first floor level. Red brick, part painted, and part stuccoed. Bowed shop front, with a central entrance, in a wooden case with reeded pilasters and an enriched entablature. No.56 forms a group with No.2 Lower Olland Street and Nos.1, 3, 3A Upper Olland Street. Nos.42 to 56 (even) form a group.

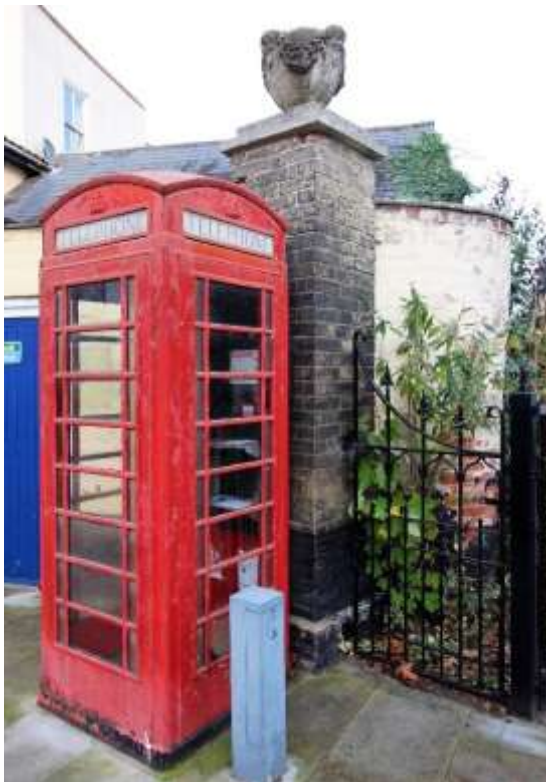
*K6 telephone box and pier, St Mary's Street*

*K6 Telephone Box, St Mary's Street.* The K6 designed by Giles Gilbert Scott was introduced in 1935 to commemorate the silver jubilee of King George V. It was a smaller version of the earlier K2 and went on to be installed prolifically around the country.

*Pier with urn adjacent to K6 telephone box, St Mary's Churchyard.* Probably a curtilage structure to St Mary's Church. Probably of early nineteenth century date. A square section Suffolk white brick pier with a stone cap and an urn. Painted plinth and lower section. A similar pier at the southern end of the churchyard is individually listed at grade II. A similar pier also once existed on Trinity Street but only its base now survives.

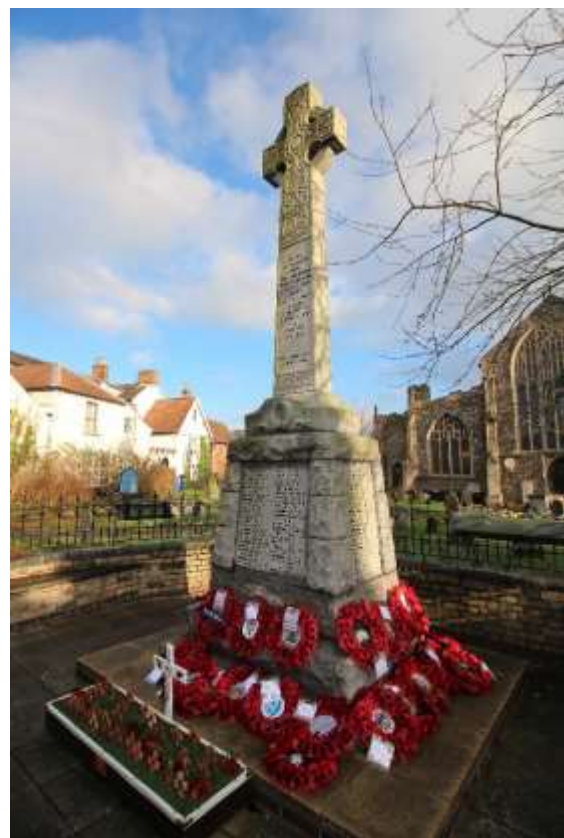
*War Memorial, St Mary's Street* (grade II). Stone Celtic cross on tall rusticated stone plinth with stepped base. Designed in 1921 by Alexander Macdonald and Co. It commemorates 101 men from the First World War and 37 men from the Second World War who lost their lives.

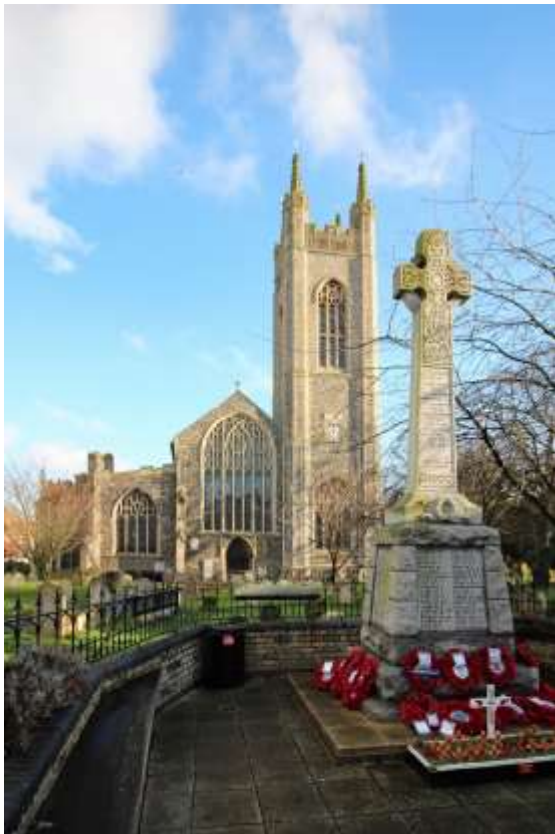
*St Mary' Church, St Mary's Street*

*St Mary' Church and Benedictine Abbey Ruins, St Mary's Street* (grade I). A former parish church, closed 1977, and now redundant. Originally this was the Church of the Holy Cross, attached to a Benedictine nunnery, the ruins of which partially survive to the east side of the church. The nunnery was dissolved and partially dismantled at The Reformation and then badly damaged in the fire of 1688. Nave, aisle and porch primarily fifteenth century. The late fifteenth century tower is arguably the dominant feature in the townscape. Its parapet and battlements are of 1702. Octagonal buttresses carried above the parapet as pinnacles. Fire damaged 1688, internally refitted and south aisle re-roofed, as dated on a rafter, in 1699. Church

reopened in 1701. There is no chancel. Vestry of 1819 with wooden tracery in window. Church altered 1832. Nineteenth century restorations by Thomas Jekyll & RW Drew 1861-5, and Richard M Phipson 1879. Much stained glass destroyed in WWII. Bettley, J, and Pevsner, N, *The Buildings of England, Suffolk: East* (London, 2015) p.148-150. Tricker, R *The Priory Church of St Mary Bungay* (London, 2015).

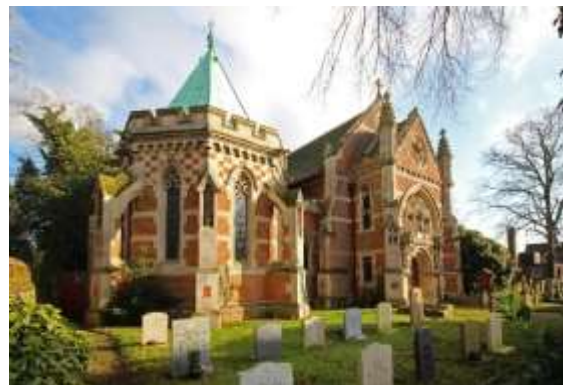
*St Edmund's RC Church, St Mary's Street* (grade II\*) Roman Catholic Church built 1889-1901. Designed by Bernard Smith for the English Benedictine Congregation. Patron Frederic Smith. Red brick with stone dressings and plain tile roof. Decorated and Perpendicular styles. Chancel, with sacristy etc., nave, north aisle, Lady Chapel and octagonal baptistery. Three bay chancel with two-light windows, and four bay nave with three-light windows with buttresses in between. The West entrance projects forward by one bay and has an elaborate carved frontispiece around the door by Ovens of Norwich depicting Saints Gregory and

Augustine and scenes from life of St Edmund. Baptistry has flying buttresses, narrow windows, corbelled battlemented parapet and tall octagonal metal roof. A chapel was built on this site in 1823 near to the parish church and to the remains of the pre-reformation Benedictine nunnery. A presbytery was added in 1829 next to the street. In 1888 Frederic Smith, a local solicitor, offered a new chancel and sacristy in memory of his parents and this was completed in 1889. He then offered the nave which was built round the old chapel and was restricted in its size by the existing presbytery and surrounding graveyard. The old chapel was then demolished, and the new church opened in 1891. The decision was then taken to rebuild the presbytery (qv) to the SE of the church and link it to the church, this was completed in 1894. The baptistry was added to the north west corner of the church 1899-1901. The cost of chancel, nave and presbytery was about £14,000, the whole amount paid by the patron. The church displays both inside and out high quality and rich decoration, and with the presbytery, the Church of St Mary (including the ruins of the Benedictine Convent) (qv), and walls in both churchyards (qv) the presbytery forms a very significant group in the centre of Bungay.

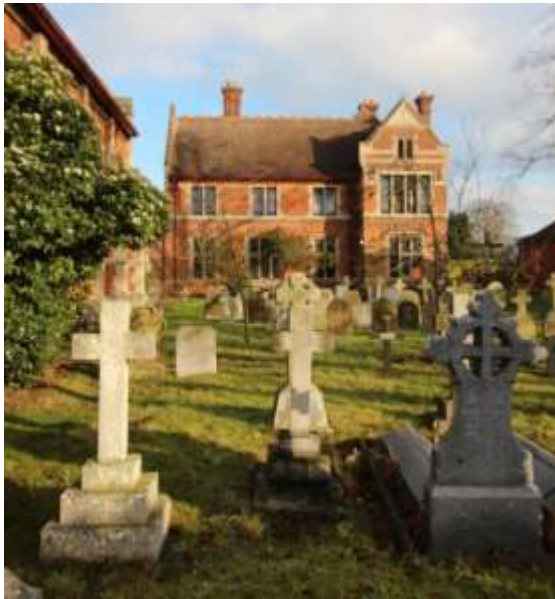
*St Edmund's Presbytery, No.1 St Mary's Street* (grade II). Roman Catholic presbytery built in 1894 to the designs of Bernard Smith for the English Benedictine Congregation. Patron Frederic Smith. Red brick with stone dressings. Plain tile roof with ornamental brick stacks with shafts and cornices. Crow stepped gables. Tudor Revival style, of two storeys and an attic. Gable projecting on right. Four bays with six paired two-light sashes in stone

mullioned surrounds. Two and three-light mullioned and transom windows to ground floor with leaded lights. Entrance under stone arch to right side of projecting gable. Side has similar paired and triple sashes and a projecting gable. Interior contains a corridor leading directly across the whole ground floor from entrance to sacristy of church (qv), to which the presbytery is linked. Together with the church, the Church of St Mary (including the remains of the Benedictine Convent) (qv), and walls in both churchyards (qv) the presbytery forms a very significant group in the centre of Bungay.

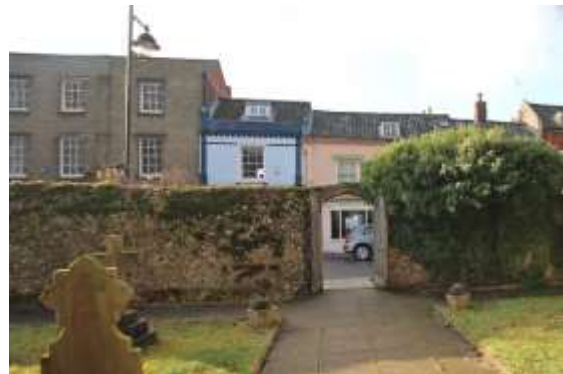
*St Edmund's Churchyard Wall, St Mary's Street* (grade II) Probably mediaeval, about 8ft high and up to 3ft thick, uncut flint.

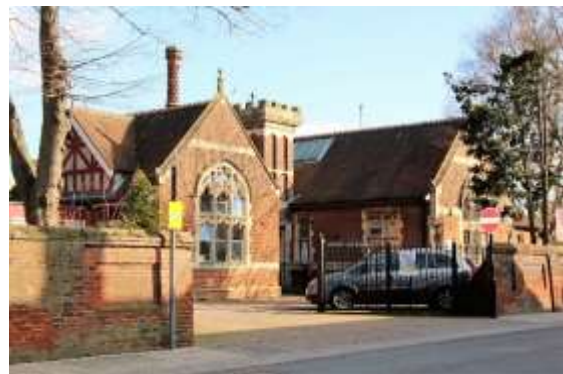
*St Edmund's Roman Catholic Primary School*

*St Edmund's Roman Catholic Primary School, and boundary wall to St Mary's Street.* An impressive and well-detailed gothic school of 1899 designed by FE Banham and built at the expense of Frederic Smith. Largely of a single storey, and of red brick with elaborate stone dressings. Red tile roof. Crenelated entrance tower, and Perpendicular traceried windows, buttresses. Unsympathetic flat-roofed twentieth century additions. A key building within the setting of the GII\* Roman Catholic Church and its GII presbytery. *Subsidiary Structures* Contemporary red brick front wall and gate with blue brick decoration and stone dressings. The wall

panelled with ogee arched doorway. Bettley, J, and Pevsner, N, *The Buildings of England, Suffolk: East* (London, 2015) p.151.

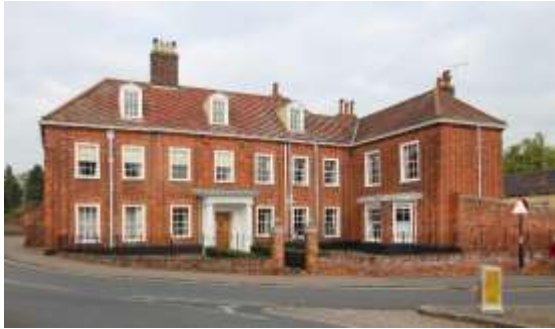
*Trinity Hall, No.1 Staithe Road* (grade II\*). An early eighteenth century house with later additions and alterations. Of two storeys with attics lit by three pedimented dormers. Brown brick with red dressings including a toothed cornice (wood ogee-moulded lead-lined gutter) and a plinth. Plain tiled roof. Later projecting range to right with shallow bay window to ground floor and twelve-light sashes above. The principal range has a seven-bay entrance façade with a three-bay breakfront. The central first floor window is flanked by brick pilasters. Twelve-light hornless sash windows, with flush frames and flat arched lintels. Brick aprons under ground floor windows. Six-panelled door in a wooden case with panelled reveals and a mutular Greek Doric porch of c1830. Trinity Hall with its ancillary building, entrance piers and walls form a group. Bettley, J, and Pevsner, N, *The Buildings of England, Suffolk: East* (London, 2015) p.157.

*Entrance piers of front garden of Trinity Hall Staithe Rd* (grade II). A later eighteenth-century pair of red brick piers, flanking the central entrance of the house. Stone caps and ball finials and pedestrian Gate of wrought iron with scroll ornament.

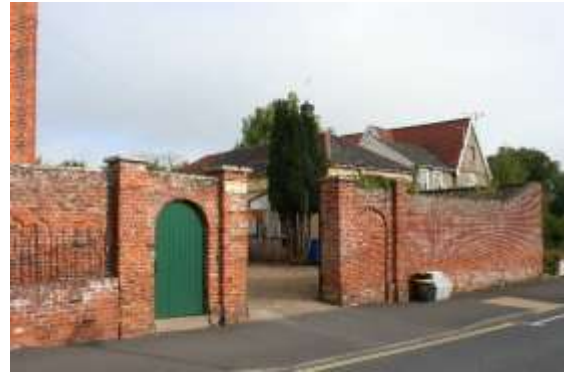
*Front wall of courtyard, Trinity Hall, Staithe Rd*

*Front wall of courtyard, east, of Trinity Hall, Staithe Rd* (grade II). Eighteenth century, of red brick, 10 ft high with two pairs of two square piers with stone caps. Pedestrian arched doorway and arched panel between, respectively; wooden double doors in centre. (For other walls see Trinity Street)

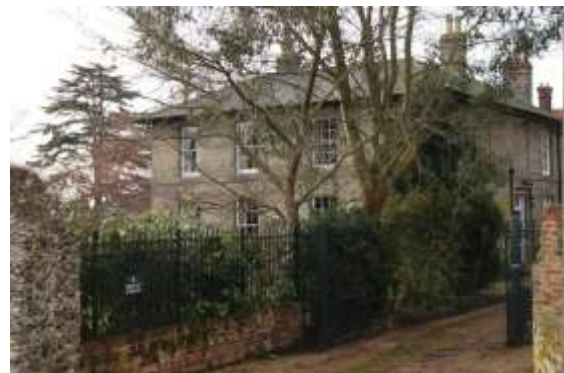
*The Old Vicarage, No.6 Trinity Street* (grade II). A restrained classical early nineteenth century former vicarage. There is a stone inserted in the boundary wall, reputed to refer to this building. Two storeys. Suffolk yellow brick with wide overhanging plastered eaves and a hipped Welsh slate roof. Four bay garden façade, with flat-arched lintels, stone sills, and twelve-light hornless sash windows. The entrance façade faces the churchyard church yard, it has a six-panelled door, and fanlight with glazing bars. Façade embellished with blind recesses. Two twelve-light sash windows at

western end. Red brick rear range. *Subsidiary Structures* Low brick boundary wall with iron railings.

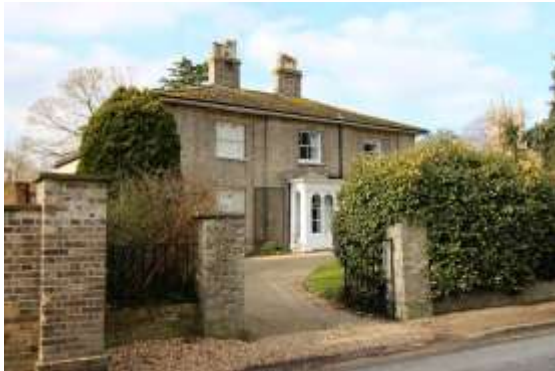
*Trinity House, No.8 Trinity Street*

*Trinity House, No.8 Trinity Street and boundary wall to front.* (grade II). An early to mid-nineteenth century villa of two storeys. Faced in Suffolk white brick. Hipped roof with a wide eave's soffit, now covered in late twentieth century machine tiles. Entrance façade of three bays with wide pilasters close to the outer corners. The central bay projects slightly and the windows of the outer bays set in shallow panels. Three hornless sash windows with narrow margin lights to first floor. Flat arched lintels and painted stone sills. Six-panelled door with arched radial-bar fanlight. Doric porch with exaggerated entasis to columns, and an enriched entablature. Porch enclosed at later date with glazed screen and doors. *Subsidiary Structures* include a nineteenth century Low white brick wall to Trinity Street with twentieth century railings. Four square- section gate piers.

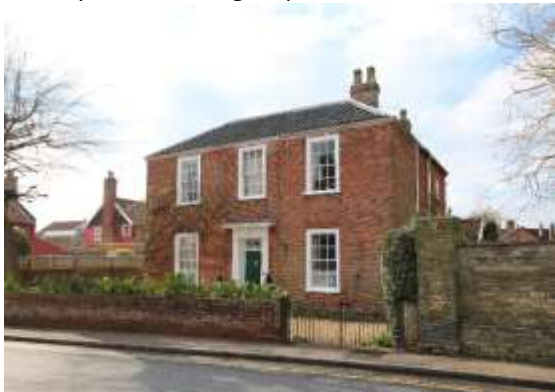
*No.10 Trinity Street*

*Nos.10 Trinity Street* (grade II). Detached house of later eighteenth-century date. Red brick, of two storeys with a black pan tiled roof covering to the Trinity Street façade and red elsewhere. Symmetrical three bay entrance façade with central breakfront. Twelve-light hornless sashes in flush frames beneath flat arched lintels. Central four-

panelled door with geometric glazing to rectangular fanlight. Doric fluted pilasters to wooded doorcase. No.10 and Nos 14 to 18 (even) form a group. *Subsidiary Structures* Low late twentieth century red brick boundary wall.

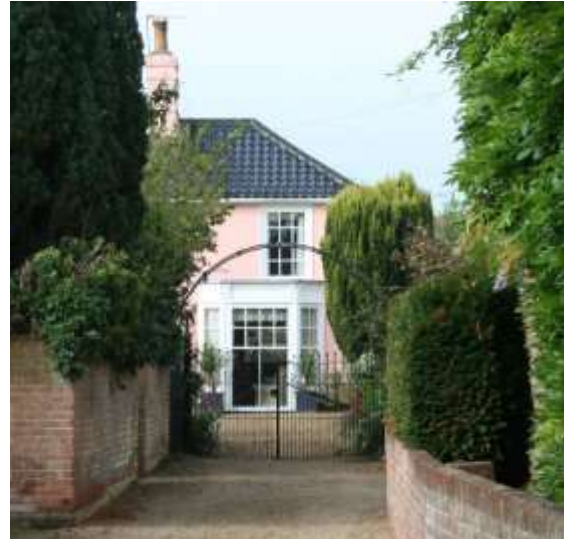
*No.12 Trinity Street*

*No.12 Trinity Street and boundary wall to rear.* Substantial dwelling set back from the road. Probably early nineteenth century. Two storeys rendered facades with a hipped roof with later twentieth century replacement black pan tiles. Principal façade has moulded surrounds to windows and a canted bay window. Central ridge stack. *Subsidiary Structures* Red brick and cobble boundary wall to rear. Boundary walls to Trinity Street appear to be late twentieth century red brick structures.

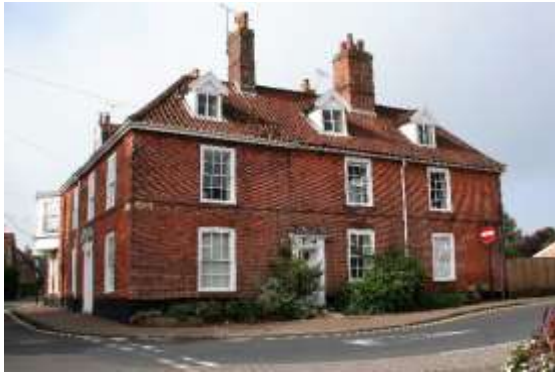
*Nos.16 &18 Trinity Street*

*No.16, 18a, & 18b Trinity Street* (grade II). On the corner of Wharton Street. Two eighteenth century houses of two storeys with attics lit by three gabled dormers. Three-bay façade to Trinity Street. Twelve-light hornless sashes in flush frames, those to the ground floor with flat arched lintels. Red pan tiled roof. Six-panelled doors in wooden cases with dentilled cornices. No.16 has its entrance on the northern (return) elevation. This has three twelve-light hornless sashes in flush frames at first floor level and two similar below. Large nineteenth century casement to ground floor north-east corner. Nos.10 and Nos.14 to 18 (even) form a group. Nos.14 to 18 form a group with Nos.9, 11A & 11 Wharton Street.

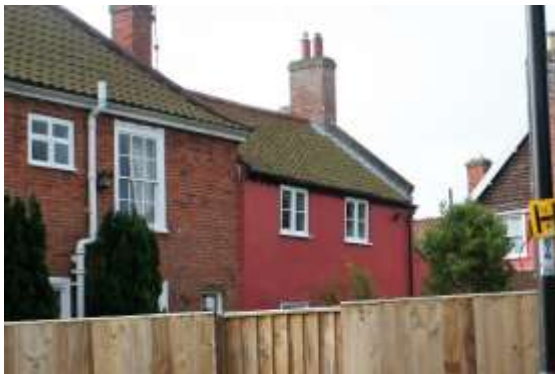
*No.18a Trinity Street*

*No.18a Trinity Street.* Former service range of No.16 early nineteenth century, Wharton Street elevation red brick with a black pan tiled roof and sash windows, Trinity Street elevation rendered with casement windows and a red pan tiled roof. No.16 appears to have been subdivided prior to listing as No.18a is shown as a separate dwelling on the 1970 1:2,500 Ordnance Survey map.

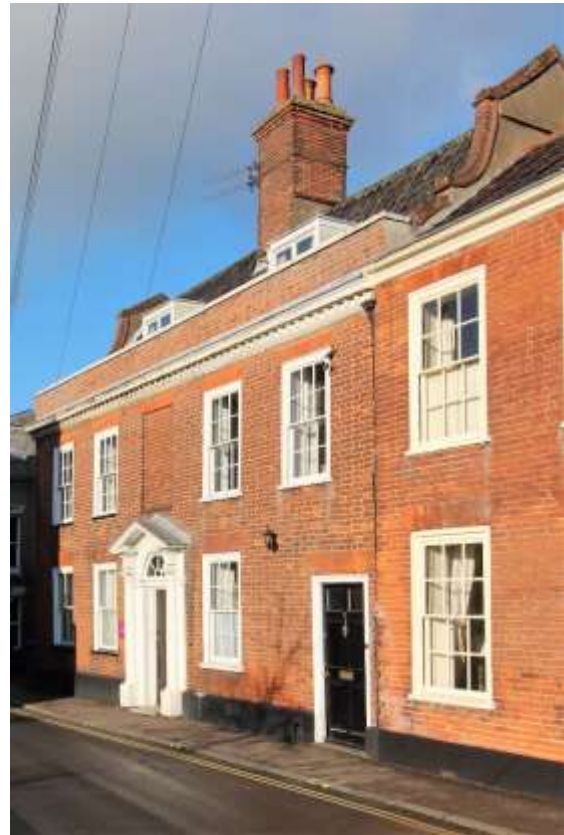
*Nos.11 & 13 Trinity Street* (grade II). Late seventeenth century, of two storeys and an attic lit by two dormers. Clad in red brick; Dutch gables with pediments to the return elevations. Parapet and ogee bracket cornice to principal façade; pan tiled roof. Principal façade of five bays with a central blank panel above the doorcase. Twelve light hornless sashes to first floor with flush frames and flat arched lintels. To the ground floor a six-panelled door with arched radial bar fanlight, doorcase with Doric 3/4 columns, triglyphs and an open pediment. Side entrance right, in lieu of window, with gauged flat arched lintel above a six-panelled door. One twelve light hornless sashes and two four pane plate-glass sashes to ground floor. No.13 with fine full height closed-string staircase within rear wing. Nos.1 to 19 (odd) form a group. Bettley, J, and Pevsner, N, *The Buildings of England, Suffolk: East* (London, 2015) p.157.

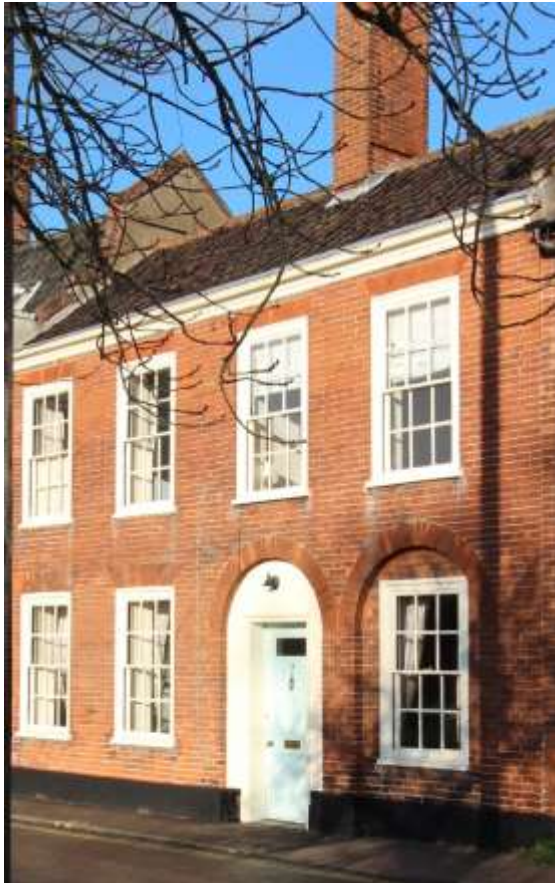
*No.15 Trinity Street* (grade II). Late seventeenth century with eighteenth century red brick façade. Two storeys, red brick, wood cornice, black pan tiled roof. Twelve light hornless sashes in flush frames. Flat arched lintels. Pair of arched recesses under each right-hand window the left-hand one containing a five-panelled door, the right a twelve-light sash. Nos 1 to 19 (odd) form a group.

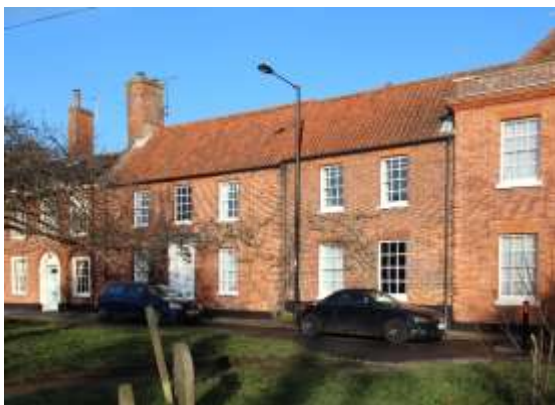
*No.17 Trinity Street* (grade II). An eighteenth century red brick house of two storeys. Red pan tiled roof and a corbelled brick eaves. Range to left of three bays with a central doorcase and painted dummy window above. Twelve-light

hornless sashes to the outer bays. Six-panelled door in wooden case with panelled reveals, eared architrave, frieze, and cornice. Lozenged fanlight. Slightly recessed two storey wing to the right, including painted dummy window at ground floor and brickwork with dark headers. Nos.1 to 19 (odd) form a group.

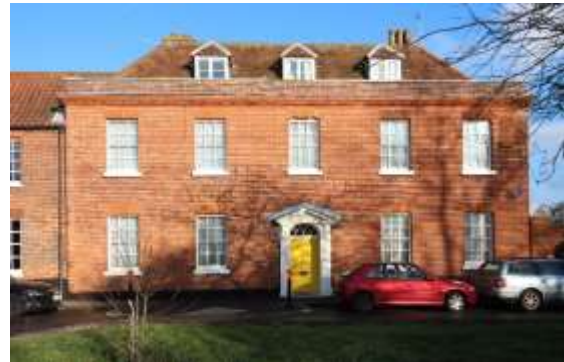
*No.19 Trinity Street* (grade II) A later eighteenth-century façade to a late seventeenth century structure. Two storeys with an attic lit by three hipped casement dormers, red plain tiles at front, pan tiles at back. Parapet with stone cope, and a moulded brick dentilled cornice. Symmetrical five bay façade to Trinity Street. To the first floor five twelve-light hornless sash windows with flat arched lintels. Central first floor window lintel with a shaped soffit. Five-panelled door, with an elliptical fanlight with curved bars, panelled pilasters, consoles, and an open pediment. Windows to older portion are either sashes in flush frames, or mullion transomed leaded casements. Coved cornice. Lower two-storey wing, two windows, corbelled brick cornice, pan tiles, cambered arches. Interior: some original mantels and wood arched panelled screen. Nos.1 to 19 (odd) form a group. A number of the subsidiary features at No.19 are separately listed. Bettley, J, and Pevsner, N, *The Buildings of England, Suffolk: East* (London, 2015) p.157.
