#### Appendix 4: Structures that make a positive contribution to the Conservation Area

The character and appearance of the Conservation Area are shaped by the structures and spaces within it. This appendix contains a list of the built structures which have been identified as making a positive contribution to the Conservation Area (as per section 4. *Positive Contributors* of the CAAMP). The list contains designated as well as undesignated structures. The list is illustrated on maps in the CAAMP.

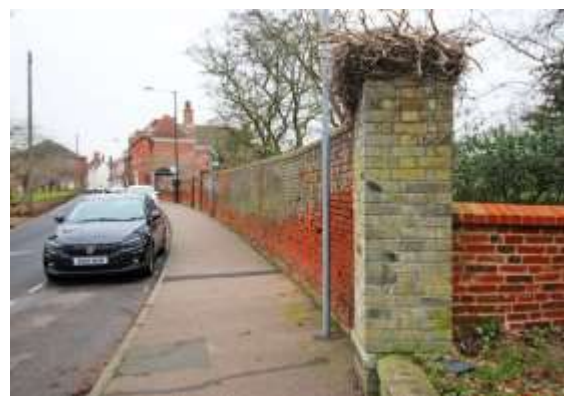
*Wall of Garden to Trinity Hall, Trinity Street with pier of Holy Trinity Churchyard walls*

*Front wall of drive to No.19 Trinity Street* (grade II) Eighteenth century, red brick, with pedestrian arch, stone cope, square piers with stone caps (gates removed). Nos.1 to 19 (odd) form a group.

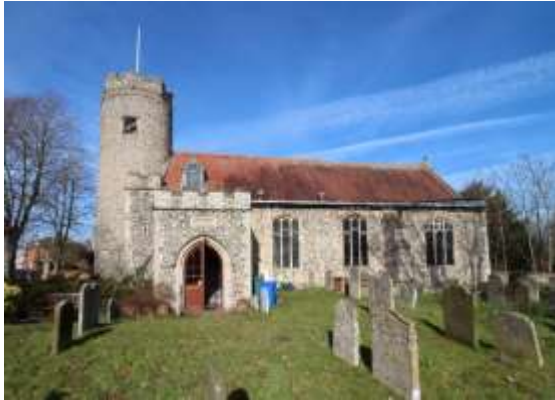
*Holy Trinity Church, Trinity Street* (grade I). The church consists of a nave, wide south aisle and south porch, with a fine round tower. The latter is reputed to be late Saxon in origin with a fifteenth century octagonal embattled top bearing the arms of Bigod, Montacute, Brotherton, Westminster, Bury Abbey, Spencer, Bishop of Norwich, Beauchamp and Edward the Confessor. There remains a gabled arch in the tower giving grounds for the Saxon date. Fire damaged and partially rebuilt 1553. Ruinous chancel demolished c1754, nave partially rebuilt 1757. Restored by JD Botwright c1852 with further work including south porch by Thomas Jeckyll 1859-60. Chancel 1926 by FE Howard. Flint rubble with stone dressings and a red plain tile roof. Bettley, J, and Pevsner, N, *The Buildings of England, Suffolk: East* (London, 2015) p.150.

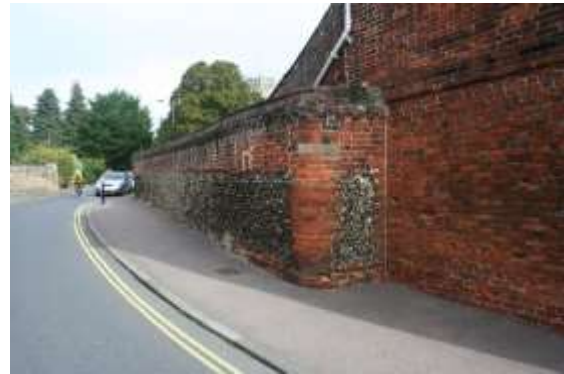
*Wall of Garden to Trinity Hall, Trinity Street* (grade II) Eighteenth century red brick with some stone rubble with roll-moulded nineteenth century terra cotta cope, 7 to 8 ft high, terminated at north by the yellow brick square pier to the churchyard of the Holy Trinity Church, qv. Trinity Hall with its ancillary building, entrance piers and walls form a group.

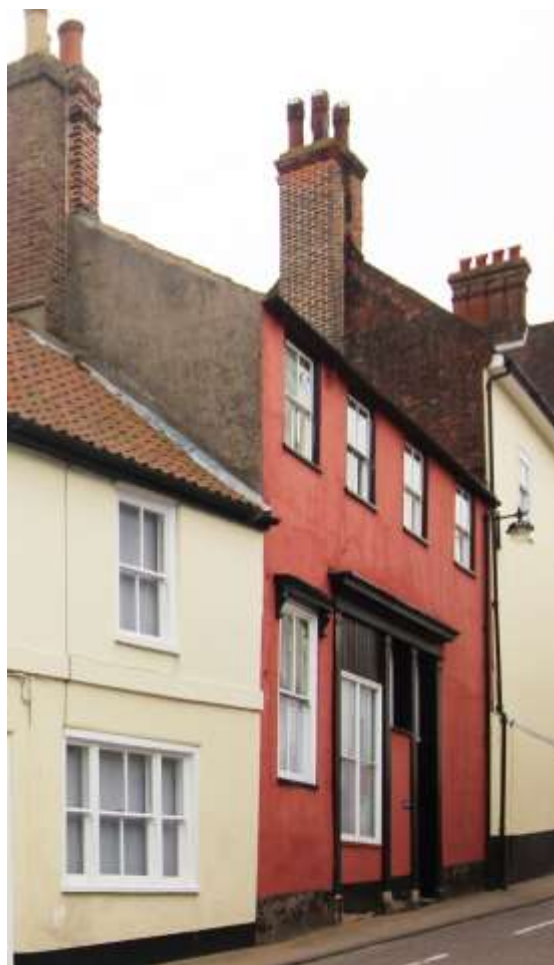
*Nos.2 Bridge Street*

*Nos.2 Bridge Street (grade II). Formerly part of the Queen's Head Public House (see also No.3 Market Place) and probably of eighteenth, or early nineteenth century date. Painted stucco or imitation brick front of two storeys with a pan tiled roof. The first floor is lit by four, flush framed plate-glass sash windows. Later nineteenth century tall wooden former public house fascia with elongated pilasters. Part of the fascia now contains a twentieth century casement window. Nineteenth century flush-framed plate glass sash window to ground floor left, with hood supported on consoles. Twentieth century door. Tall red brick stack to left hand gable. The Queen's Head probably closed c1913. Nos.2, 4, 6a & 6b, 12 to 20 (even), 24 to 34 (even), 40 to 44 (even), 48 and 50 form a group. Honeywood F, Reeve C, & Reeve T, *The Town Recorder, Five Centuries of Bungay at Play* (Bungay, 2008) p 89 & 131.*

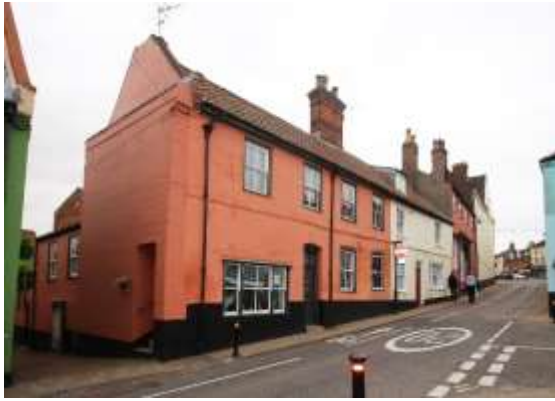
*Nos.4, No. 6a, & 6b Bridge Street*

*Nos.4, No. 6a & 6b Bridge Street and garden walls to rear.* (grade II). Standing on the corner of Borough Well Lane and probably of early eighteenth century date. Of two storeys and an attic, with a low two storey rear range facing Borough Well Lane. Rendered and painted with a platt band below the first-floor windows. Four-light plate glass sashes with horns to the first floor. One gabled dormer to No.4 within a replaced red pan tiled roof. No.4 is shown with a shop fascia to the ground floor right on c1920 photographs, but this has been replaced by a tripartite sash. To the left of the four-panelled front door is a relatively recent four-light horned sash, in a segmental arched opening. A small central window at first floor level is also shown on early photographs. To the rear of No.4 is a red brick range with an elevation facing a yard off Trinity Street. This has a black pan tiled roof to Borough Well Lane and a red pan tiled roof to its other faces. A late nineteenth century wooden oriel window is set within the end wall at first floor level. Below this window there was evidently a further recently demolished single storey projection

missing. Four-light plate glass sashes to rear range fronting Borough Well Lane. Nos.6a & 6b were once the Green Dragon Public House and are shown as a public house on the 1885 Ordnance Survey map. The pub reputedly closed c1909. Nos.2, 4, 6a & 6b, 12 to 20 (even) 24 to 34 (even), 40 to 44 (even) 48 and 50 form a group. Reeve C, *Bungay Through Time* (Stroud, 2009) p57. Honeywood F, Reeve C, & Reeve T, *The Town Recorder, Five Centuries of Bungay at Play* (Bungay, 2008) p97 & 132.

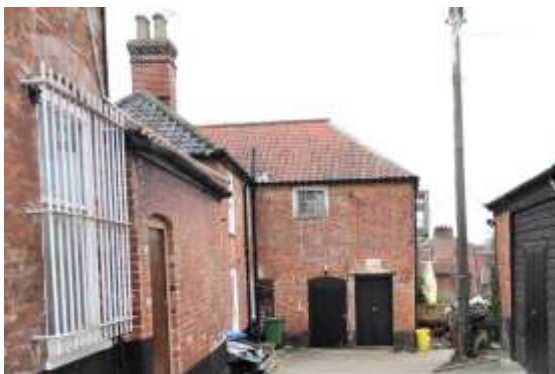
*Rear range of No.4 Bridge Street from Trinity Street*

Nos.6a & 6b also have a platt band. Partially glazed panelled front door to No.6a, No.6bs entrance set back within the return elevation. Large tripartite sash to left of front door. Four light sash and casement to left. Apex of gable to return elevation

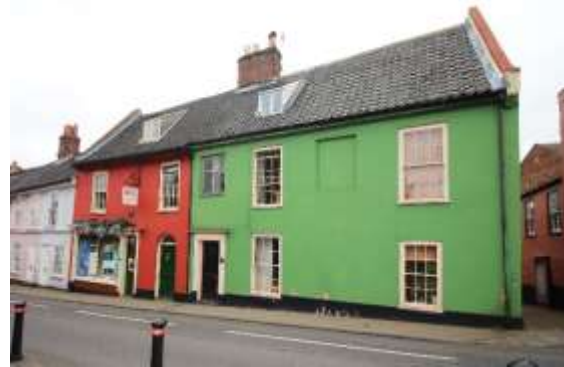
*Nos.12-14 (even) Bridge Street.*

*Nos.10-16 (even) Bridge Street.* (grade II). Early eighteenth century, and of two storeys with an attic lit by two casement dormers. Black pan tiled roof and central red brick ridge stack. Rendered and painted façade to Bridge Street with a plinth. No.12 with horned twelve-light sash windows of late twentieth century date probably replacing those described in the statutory list. Blind central panel at first floor level. Six-panelled door with a simple wooden doorcase with pilasters and a four-light casement window above. No.12 has a return elevation to Borough Well Lane, some rebuilding work to gable. Casement window within gable, small casement at first floor level and door opening beneath. Two storey red brick rear range with later twentieth century small pane casement windows and four-panelled door; ground floor rendered. (For rear range see Borough Well Lane). No.14 has two flush frame twelve-light hornless sash windows to the first floor and has an arched entrance with a four-panelled door and a simple semi-circular fanlight. No.16, has a wooden shop front with pilasters and a panel of early twentieth century glazed tiles beneath. Partially glazed door. No.10 is a small red brick cottage with an entrance on Borough Well Lane which was probably originally part of No.12. partially rendered with casement windows. Nos.2, 4, 6a & 6b, 12 to 20 (even), 24 to 34 (even), 40 to 44 (even), and 48 and 50 form a group.

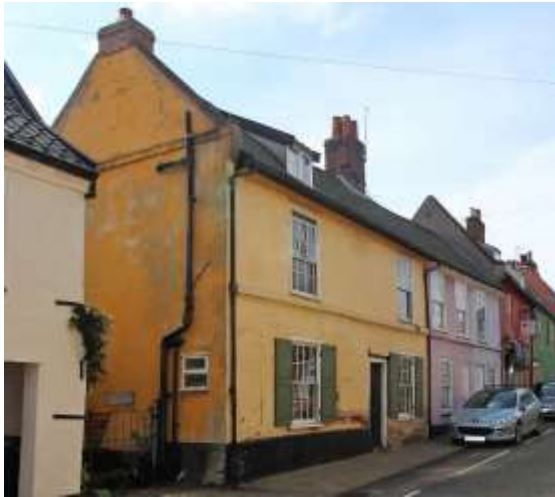
*Nos.18-22 (even) Bridge Street*

*Nos.16-22 (even) Bridge Street (grade II).* Three cottages, two within front range and No.22 at the rear. Early eighteenth century, of two storeys and an attic. Black pan tiled roof with a single flat roofed dormer to No.20. Colour-washed brick, with a moulded brick platt- band. Part with later applied projecting plinth. Nos.16-18, have their original sixteen-light hornless sashes at first floor level. To the ground floor centrally placed four panelled doors flanked by similar flush framed hornless sash windows with flat lintels. No.20 has two sixteen-light hornless sash windows to each floor. Those to the ground floor having panelled shutters. Centrally placed six-panelled door with near-flush frame. Scarring of former window openings with segmental heads visible in front wall to both ground and first floors of No.20. Lower range to the rear. Nos.2, 4, 6a & 6b, 12 to 20 (even), 24 to 34 (even) 40 to 44 (even), 48 and 50 form a group.

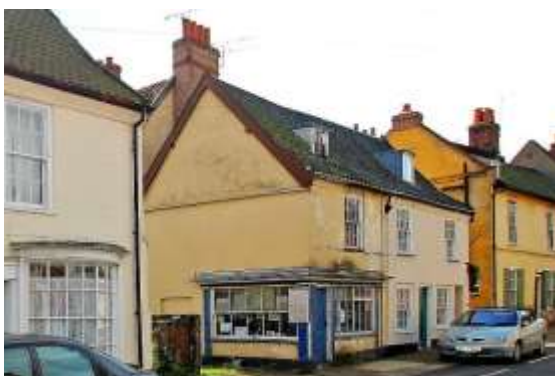
*Nos.24 & 26 (even) Bridge Street*

*Nos.24 & No.26 (even) Bridge Street with outbuildings to rear (grade II).* An eighteenth century pair of cottages of two storeys and an attic. Street frontage range with a black pan tiled roof covering and two flat roofed casement dormers. No.24 faced in colour-washed brick with two early sixteen-light hornless sashes at first floor level. The

shop windows described in the listing description now replaced by small pane sashes. No.26, stuccoed, with a nineteenth century wooden shop fascia with pilasters retaining small glazed panelled windows. Panelled door. A single sixteen-light hornless sash above within a flush frame. Blocked doorway in gabled return elevation.

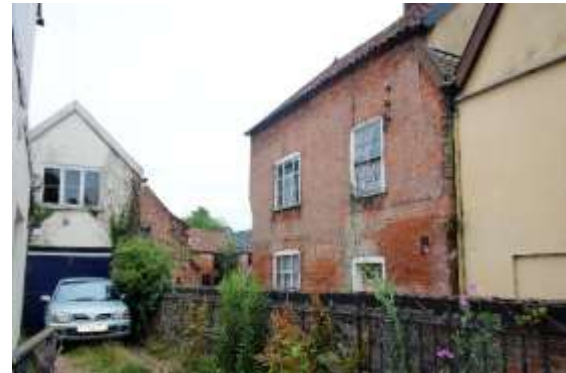
*Rear range and outbuildings at No.26 Bridge Street*

Substantial rear range with red brick façade, which was possibly originally a separate dwelling. Two storeys with a two-bay principal façade facing towards the river. Casement windows beneath cambered brick lintels, one hornless twelve-light sash at first floor level. Blocked door opening to ground floor centre. Good group of probably early nineteenth century red brick outbuildings in yard to the rear of No.26 including gabled cart shed with loft above. Red pan tiled roofs some now missing. Last used as an abattoir. Nos.2, 4, 6A, 12 to 20 (even), 24 to 34 (even) 40 to 44 (even), 48 and 50 form a group.

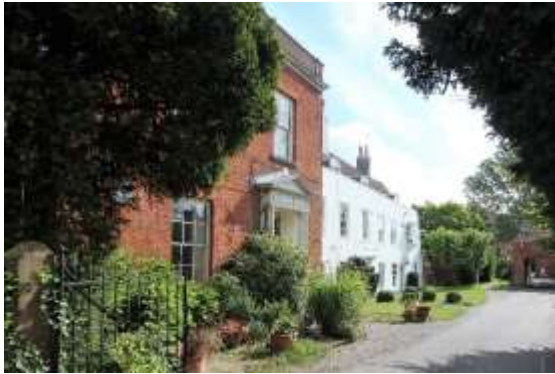
*Bridge House No.34 Bridge Street* (grade II). A substantial multi-phased townhouse of late sixteenth century origins with a large extension fronting Bridge Street of c1776. Further additions to rear. The house stands at a right-angle to the Street with a principal façade facing south. In 1688 it was occupied by Gregory Clarke who was rebuilding it at the time of the great fire, from which it was saved by the watchman. The western portion (fronting Bridge Street) is of red brick and of two high storeys. Its Bridge Street façade is of two bays with a blank-window panel to right on each floor, with flat arches, and stone sills. Horned twelve-light sashes to left-hand bay. Cornice, below a parapet with a stone cope. Hipped roof. Entrance front to south of three bays, with hornless twelve-light sashes. Six-panelled door with arched patterned radial fanlight above, set within a doorcase with panelled reveals, fluted Doric columns, triglyphs, and a dentilled pediment.

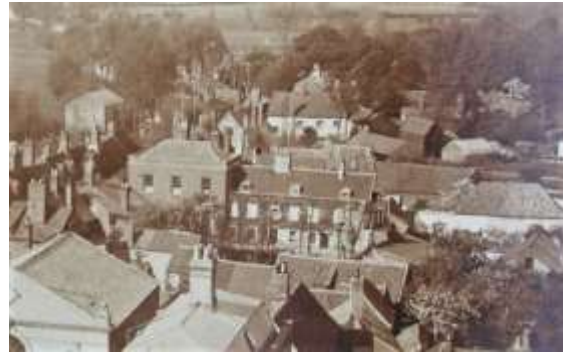
*Bridge House from St Mary's Tower c1920*

Earlier portion at rear, of two storeys and an attic, three dormers with segmental pediments. Brick, rendered. Tiles. Five flush-frame sash windows with glazing bars, and a canted oriel. four-panelled central door in wooden case with consoles. Second door, right, with six flush panels and a pedimented hood. Chateaubriand resided here in 1795 when the house was occupied by the Reverend J Clement Ives. Nos. 2, 4, 6a & 6b, 12 to 20 (even), 24 to 34 (even) 40 to 44 (even), 48 and 50 form a group. Bettley, J, and Pevsner, N, *The Buildings of England, Suffolk: East* (London, 2015) p.156-157.

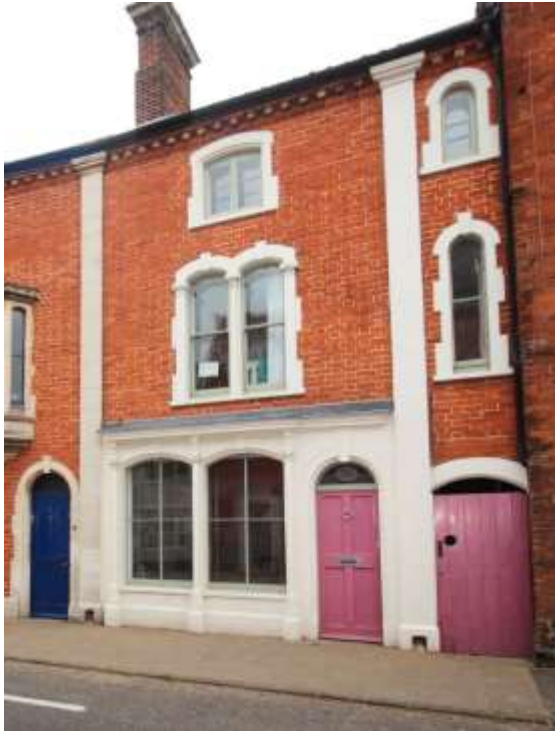
*No.36 Bridge Street* (local list). A substantial later nineteenth century red brick former shop and dwelling with painted stone dressings, dentilled eaves cornice and full height pilasters. Plate glass sash windows. Three storey, two bay principal façade. Arched doorcase with keystone and four panelled door within rendered later nineteenth century former shop fascia. Simple semi-circular fanlight. Twin shallow arched windows to left with keystones beneath a corbelled cornice. Passage way with boarded door within shallow arched opening to right. Substantial red brick chimneystack. Forms part of a semi-detached pair with No.36.

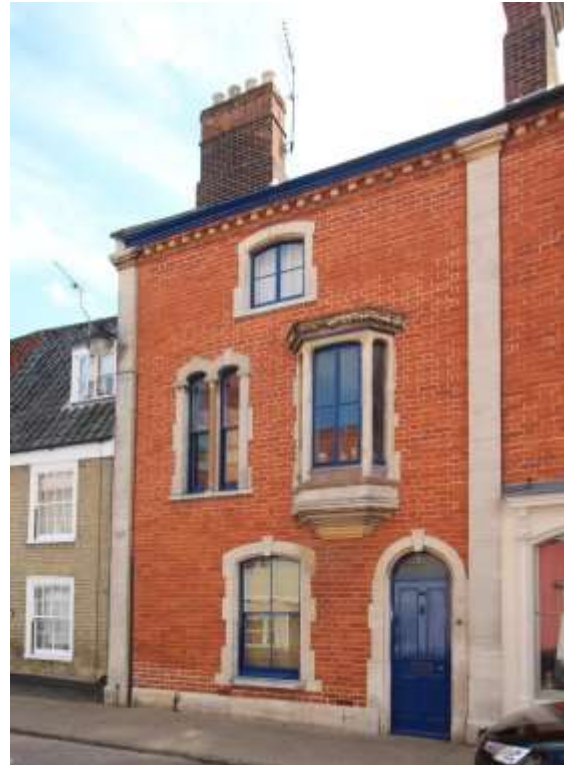
*No.38 Bridge Street* (local list). A substantial later nineteenth century red brick dwelling with stone dressings, dentilled eaves cornice and full height pilasters. Plate glass sashes and some later casements. Three storey, two bay principal façade. Arched doorcase with keystone and four panelled door. Simple semi-circular fanlight. Cantled stone oriel window above. Substantial red brick chimneystack. Forms part of a semi-detached pair with No.36.

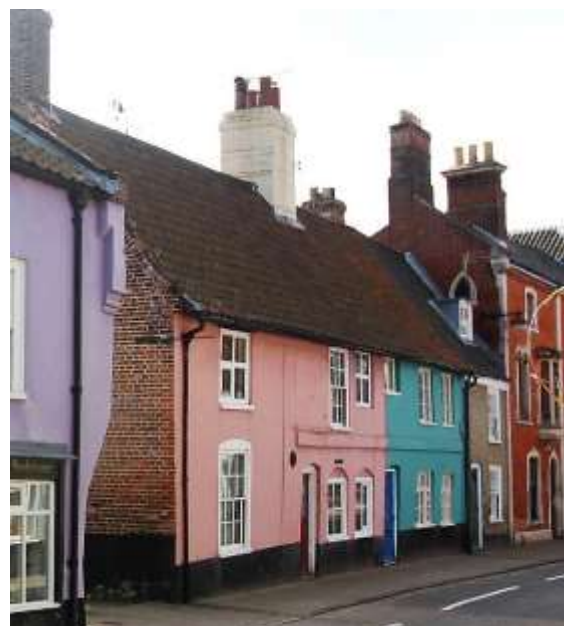
*Nos.40-44 (even) Bridge Street*

*Nos.40-44 (even) Bridge Street (grade II).* A row of three cottages, Nos.42-44 the former Kings Arms Inn and recorded as such in the seventeenth century (closed c1910). Seventeenth century with later alterations, partially re-fronted. Of two storeys and attics. No.40 with black pan tile roof covering, Nos.42-44 red. No.40, is of two storeys and attics and has an early nineteenth century white brick façade with gauged flat arched lintels. A single, late twentieth century flush frame sash window with glazing bars to each floor and late twentieth century front door with original cambered lintel. Flat roofed dormer in roof slope above. Nos.42 and 44 rendered. No.42 with flush frame casement windows. Ground floor openings to No.44 recessed beneath cambered brick arched lintels. One four-light sash and one casement. Twelve-light hornless sash and small casement above. No. 42 has a later twentieth century six-panelled door, No.44 a partially glazed four-panelled door. Nos. 2, 4, 6A, 12 to 20 (even), 24 to 34 (even) 40 to 44 (even), 48 and 50 form a group. Honeywood F, Reeve C, & Reeve T, *The Town Recorder, Five Centuries of Bungay at Play* (Bungay, 2008) p136-137.

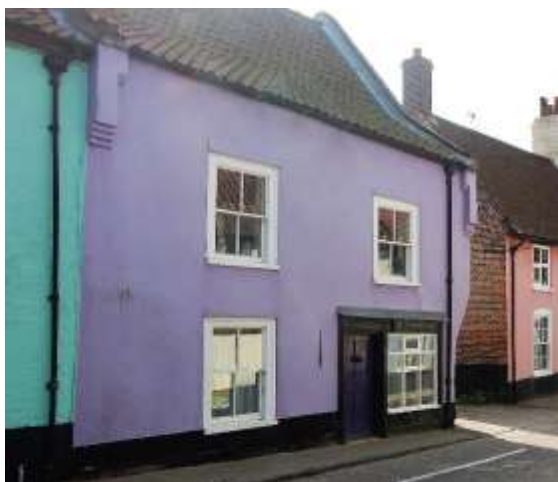
*The Smokehouse, No.48 Bridge Street*

*The Smokehouse, No.48 Bridge Street (grade II).* Of eighteenth century date with an addition of 1804. Of two storeys with a two-bay façade to Bridge Street. Four-light plate-glass sashes to first floor and ground floor left. Stucco lined and painted. Black pan tiled roof. Small former shop window right, and four-panelled door all set within a simple wooden fascia. Blind gabled return elevation to entrance to Wharf Yard. Nos.2, 4, 6a & 6b, 12 to 20 (even), 24 to 34 (even) 40 to 44 (even), 48 and 50 form a group. *Subsidiary Structures* To the rear in Wharf Yard a nineteenth century red brick former smoke house of two storeys with attached structures of uncertain origins. Ground floor with

black pitch finish, small casement windows above. Pan tiled roof patched in various colours. Highly visible from the river side footpath. Reeve C, *Bungay Through Time* (Stroud, 2009) p61.

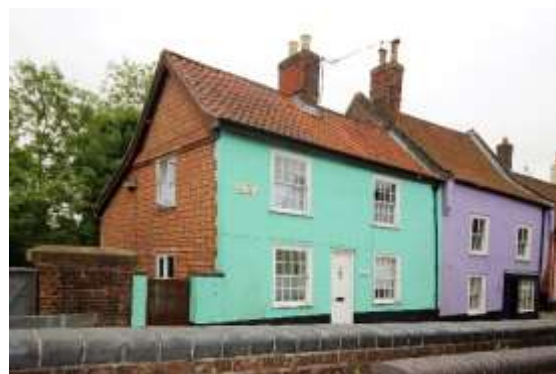
*The Hermitage, No.50 Bridge Street*

*The Hermitage, No.50 Bridge Street (grade II).* An early eighteenth century cottage standing in a prominent location by the bridge. Two storeys with a symmetrical limewashed red brick façade. Red pan tile roof with a central red brick ridge stack. Two, sixteen-light flush framed hornless sash windows to each floor. Four-panelled door with a flush frame. Casement windows to return elevation and catslide roof to rear. Nos.2, 4, 6A, 12 to 20 (even), 24 to 34 (even) 40 to 44 (even), 48 and 50 form a group.

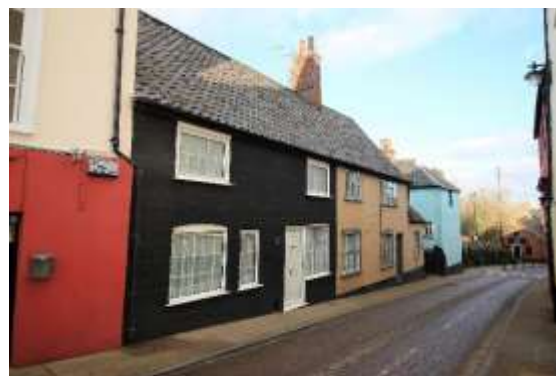
*Nos.1 & 7 (Odd), Bridge Street*

*Nos.1&7 (Odd), Bridge Street (grade II).* Formerly a row of four cottages, now two dwellings. Significantly altered since the present listing description was compiled. Probably of early eighteenth century date. Two storeys, with a steep black pan-tiled roof, colour washed brick façades. The upper windows now either uPVC or late twentieth century wooden casements. Late

twentieth century panelled doors with integral fanlights. No.7 retains two six-pane shop fronts which are possibly of mid nineteenth century date one beneath a segmental arched lintel. Single storey wing with a red pan tiled roof and a small pane casement window beneath a segmental arched lintel. Nos.1 to 7 (odd) form a group. Also Nos.1 to 5 (odd) form a group with Nos. 1 & 3 Nethergate Street.

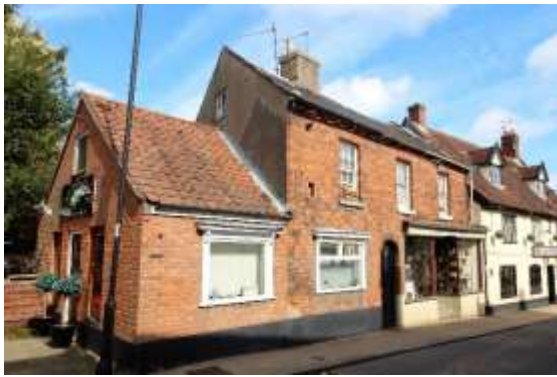
*Nos.17-21 (odd) Bridge Street*

*Nos.17-21 (odd) Bridge Street (grade II).* No.19 early seventeenth century and later, with a nineteenth century public house façade. Now shop and dwelling. Of two storeys, faced in red brick and with a black pan tile roof covering to the main block. Single storey wing to left with red pan tile roof. Rendered ridge stack. Three hornless twelve-light sashes to the first floor with flat arched lintels and stone sills. Arched passage opening with six-panelled door with wood tympanum above matching the door. Mid twentieth century shop fascia to No 21. Two small twentieth century casements to ground floor, left. In the late nineteenth and early twentieth centuries at least part of the structure was the Beaconsfield Arms Public House. Nos.17, 21 & 23 form a group.

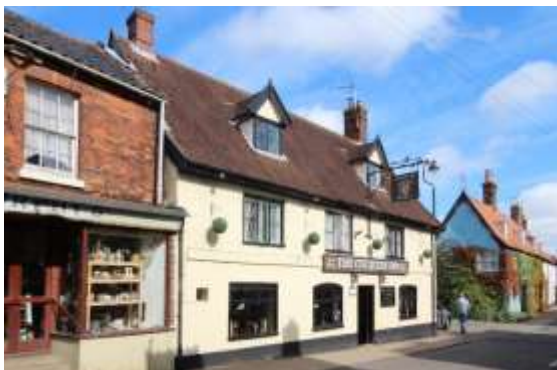
*Chequers Inn, No. 23 Bridge Street*

*Chequers Inn, No. 23 Bridge Street (grade II).* An early century public house, of two storeys, with an attic lit by two gabled dormers. Tiles. Red brick,

floor band, plinth. Three flush framed casement windows at first floor level. Segmental arched lintels to two casements flanking the front door. Six-panelled door with near-flush frame. The right-hand has later twentieth century door and window openings inserted following the demolition of the adjoining cottage in the mid twentieth century. Catslide roof to rear. Nos.17, 21, & 23 form a group. Honeywood F, Morrow P & Reeve C, *The Town Recorder, A History of Bungay in Photographs* (Bungay, 1994) p156. Reeve C, *Bungay Through Time* (Stroud, 2009) p58-59.

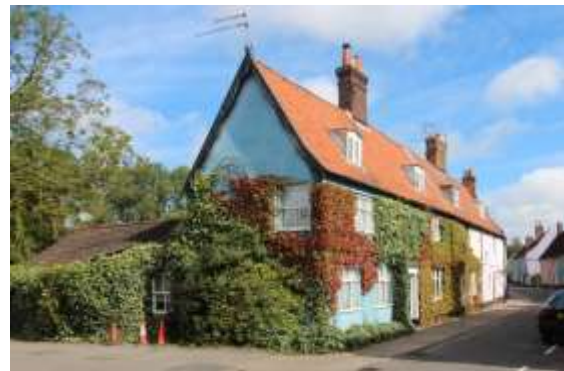
*No. 29 Bridge Street*

*No.29 Bridge Street (grade II).* Seventeenth century, of two storeys and an attic. Steeply pitched red pan tiled roof with two flat roofed dormers. C1900 photographs however show the building with gabled dormers. Cement rendering on brick, with a first floor platt band. First floor lit by two three-light casements which replaced the sash windows shown on early photographs. Early nineteenth century six panelled front door described in statutory list now replaced with a partially glazed one. Good doorcase with pilasters and a dentilled cornice. Ground floor shop fascia replaced by further casements. Single storey range to rear with casement windows and a red pan tiled roofed. Nos.29 to 45 (odd) form a group. Honeywood F, Morrow P & Reeve C, *The Town Recorder, A History of Bungay in Photographs* (Bungay, 1994) p156.

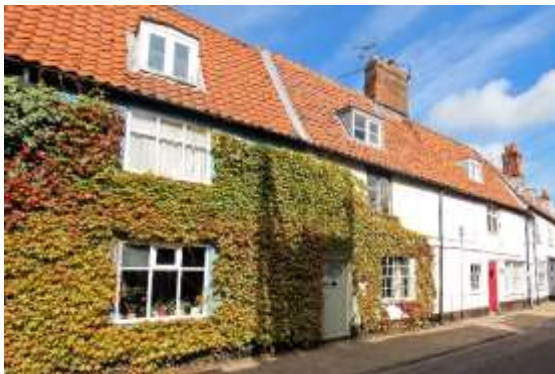
*Nos. 31-33 (odd) Bridge Street*

*Nos.31-33 (odd) Bridge Street (grade II).* Seventeenth century, and of two storeys with an attic. Two flat roofed dormers with centrally opening casements, within a red pan tiled roof. Brick colour-washed, with platt band. First floor has two early mullioned and transomed casements with flush frames which the statutory list describes as being 'original' to the present facade. Twenty-light hornless sash window to ground floor of No.31. Other ground floor windows now casements but all retain segmental arched lintels. Mid twentieth century door with oval light to No.31, twentieth century boarded door to No.33, both set within flush frames. Small nineteenth century former shop window to No.33. Nos.29 to 45 (odd) form a group.

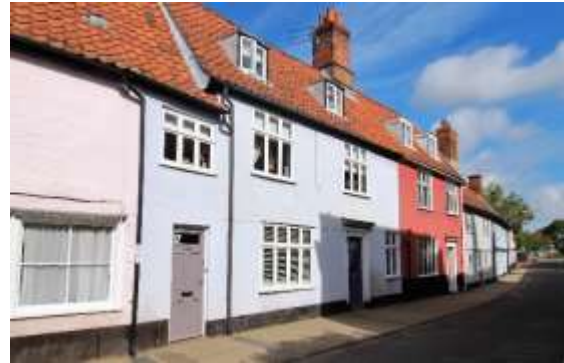
*Nos. 35-37 (odd) Bridge Street*

*Nos.35-37 (odd) Bridge Street (grade II)* Early eighteenth century, of two storeys with an attic lit by four flat roofed dormers. Red pan tiled roof and substantial central red brick ridge stack rising from party wall. Stucco on brick, lined as ashlar. The first floor has early nineteenth century casements, of six lights, in flush frames. Flat heads formerly with keys to two eight-light ground floor windows. Inserted four-light casement to right of doorway within No.35. Part glazed door to No.35 eared architrave, pulvinate frieze and dentil cornice. Modern door to No.37 in wooden case with architrave frieze and cornice. Nos.29 to 45 (odd) form a group.

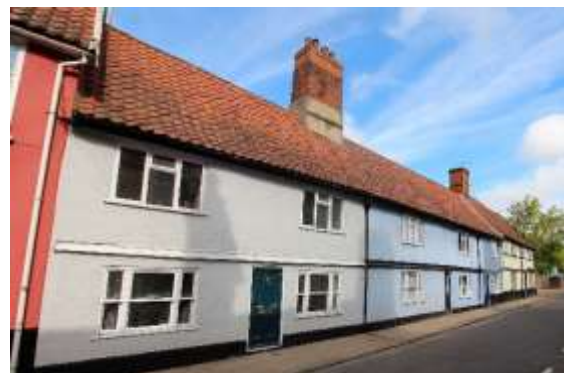
*Nos. 39-43 (odd) Bridge Street*

*Nos.39-43 (odd) Bridge Street (grade II).* A group of three seventeenth century cottages. Two storeys, with an attic which was formerly lit by dormers according to the statutory list. Red pan tiled roof and a centrally placed red brick ridge stack. Rendered brick ground floor, with a timber framed and plastered first floor. Continuous drip mould band at first floor level. Row of five casements in flush frames to the first floor, mostly of later twentieth century origin. Horned sash windows with margin lights to ground floor of Nos.41 & 43, No.39 with twentieth century casement windows in flush frames at ground floor level. Four-panelled front door to No.39. Nos.41 & 43 with panelled doors with glazed upper panels. Heavy flush door frames for Nos.39 and 43. Nos.29 to 45 (odd) form a group.

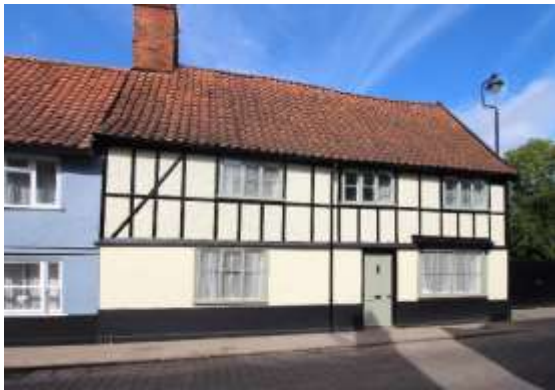
*No. 45 Bridge Street*

*No.45 Bridge Street (grade II).* A seventeenth century, two storey brick building, with a twentieth century cement rendered ground floor. Timber framed, plastered and with twentieth century applied half-timbering to the first floor. Red pan tiled roof. Three, three-light casement windows to the first floor. Small former shop window to ground floor right probably of later nineteenth century date. Four panelled front door of probably twentieth century date with near-flush frame. Gabled return elevation to the bridge with applied timber framing and casement windows. Lower outshot to rear. Nos.29 to 45 (odd) form a group.

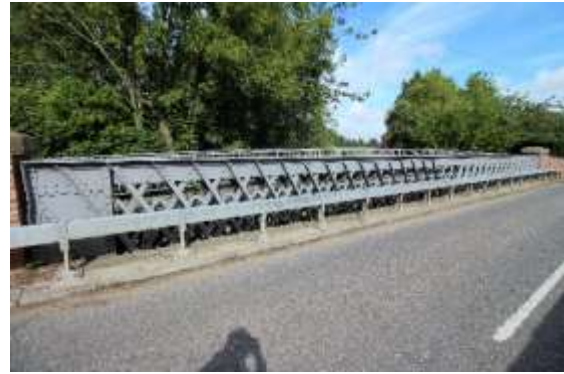
*Falcon Bridge, Bridge Street*

*Falcon Bridge, Bridge Street (local list)* Road bridge over the River Waveney. Partially in Norfolk. Made by Westwood Ballie & Co, engineers and contractors of Poplar, London c1872. Brick piers and walls to each bank with stone caps. A key structure in the approach to the town from Ditchingham.

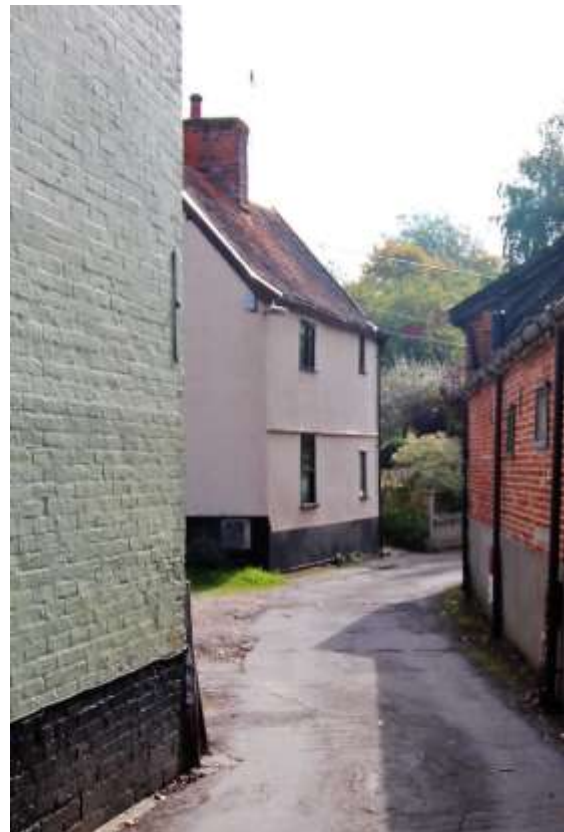
*No.3 Castle Lane*

*No.3 Castle Lane.* Cottage of two storeys and two bays with roughcast rendered walls and a steeply

pitched red pan tiled roof. Possibly of mid eighteenth century origins. Plat band above ground floor windows. Central red brick ridge stack. Dentilled eaves cornice. Entrance in gabled eastern return elevation. Four-panelled door with glazed upper lights. Western return elevation blind. Plain wooden bargeboards. Flat roofed single storey rear addition on site of earlier range shown on historic Ordnance Survey maps. Later twentieth century wooden casement windows. Group value with the grade II listed Nos.69-73 (odd) Earsham Street.

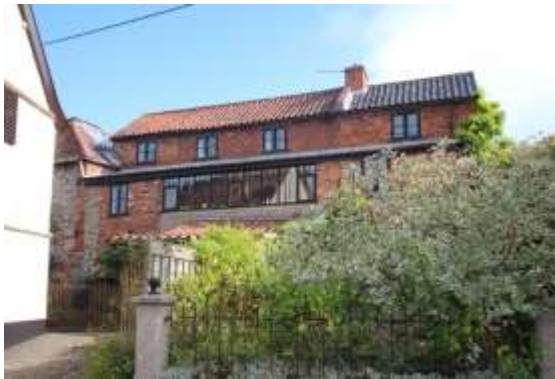
*No.4 Castle Lane*

*No.4 Castle Lane.* Two storey red brick with pan tiled roof of both red and black pan tiles. Probably early to mid-nineteenth century but with late twentieth century casement windows. The central two bays probably represent the earliest surviving phase and have a single bay, two storey addition at either end. Ridge stack on former gable end. Forms part of the setting of a section of the scheduled Castle wall.

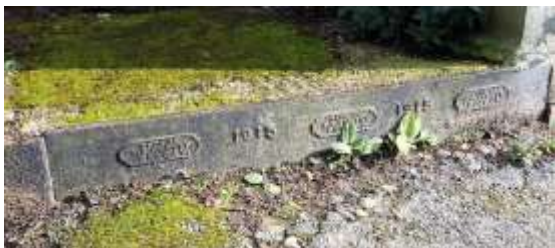
*Stair to Nathan's Yard, Castle Lane*

*Stair and railings to Nathan's Yard, Castle Lane.* An early twentieth century concrete staircase to the former Rumsby's Ironworks site on Earsham Road. The lowest step with an iron plate with Rumsby's mark and the date 1915. The concrete treads of other stairs incorporating reused ironwork. Contemporary concrete wall, square-section piers, and railings with iron finials. The stair is not shown on the 1905 Ordnance Survey map but is shown on that of 1927. Forms part of the setting of a section of the scheduled Castle wall.

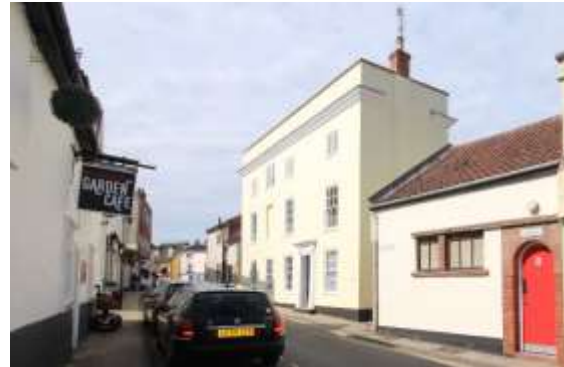
*Nos.1-3 Cross Street* (grade II). Of early nineteenth century date but extensively altered in the late twentieth century. Its present (2018) listing description is now out of date. A three-storey rendered brick structure with a four-bay principal façade, which is only one room deep. Three flush frame hornless sash windows, of twelve lights at first floor level and one blank recess. Three casements to the second floor. Late twentieth century hornless sashes to the ground floor and a late twentieth century classical doorcase. Photographs in the National Monuments Record taken in 1977 show a brick building without the present parapet and with a straight joint to the right of the principal entrance. The first-floor windows had cambered brick lintels. It also has or had a pan tile roof. Neither the doorframe or any of the ground floor windows existing in 2017 are shown in the 1977 photographs. Honeywood F, Morrow P & Reeve C, *The Town Recorder, A History of Bungay in Photographs* (Bungay, 1994) p158.

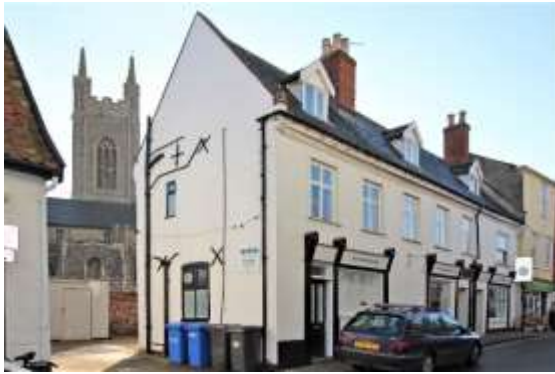
**Nos.2 & 4 Cross Street** (grade II). Of later seventeenth century date with nineteenth century alterations. Of two storeys, with an attic lit by three gabled dormers. Roughcast on brick, with a coved cornice. Black pan tiled roof slope to Cross Street façade and red to the churchyard. Five mullioned and transomed casement windows at first floor level, and a near flush framed hornless sash window with glazing bars. No.2, has a late nineteenth century former pub fascia of wood with pilasters to the right-hand bay (former Crown Inn), its other shop fascia is probably a later twentieth century copy. No. 4, also has a late twentieth century shop front in the style of that of No.2. At the rear of No.2 a two-storey red brick eighteenth century range with a red pan tile roof and a single casement window at first floor level which abuts No.15 Market Place. The rear elevation which is visible from Saint Mary's Churchyard forms an important part of the setting of the grade I listed church. Honeywood F, Morrow P & Reeve C, *The Town Recorder, A History of Bungay in Photographs* (Bungay, 1994) p158. Honeywood F, Reeve C, & Reeve T, *The Town Recorder, Five Centuries of Bungay at Play* (Bungay, 2008) p141.

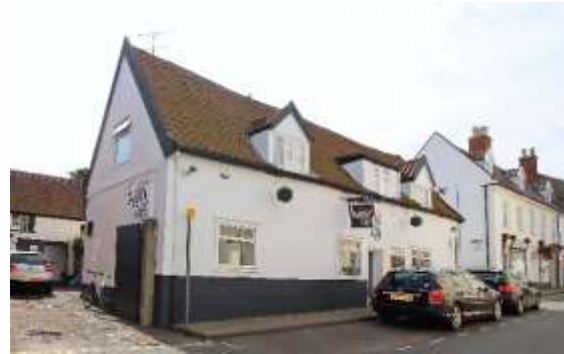
**No.6 Cross Street**

**No.6 Cross Street and outbuilding** (grade II). Former Jolly Butchers Public House; closed early twentieth century. Of early seventeenth century date, and of a single storey with attics. Timber framed and plastered. Replaced red pan tile roof covering with two gabled, and one flat roofed dormer; the latter of later twentieth century date. Later twentieth century door and casement windows. To the rear a detached former stable and cart shed probably of early nineteenth century date. Painted brick with a red pan tile roof. The building reputedly suffered bomb damage in World War Two. Honeywood F, Morrow P & Reeve C, *The Town Recorder, A History of Bungay in Photographs* (Bungay, 1994) p158. Honeywood F, Reeve C, & Reeve T, *The Town Recorder, Five Centuries of Bungay at Play* (Bungay, 2008) p140. Honeywood F, Reeve C, & Reeve T, *The Town Recorder, Five Centuries of Bungay at Play* (Bungay, 2008) p91-92 & 139.

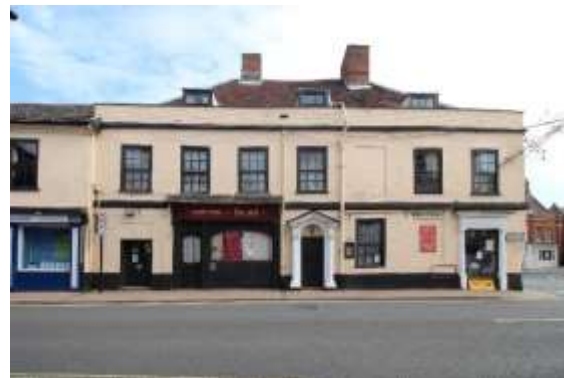
**The Three Tuns, No.2 Earsham Street**

**The Three Tuns Inn, No.2 Earsham Street** (grade II). A seventeenth century structure of two storeys and an attic, occupying an island site with façades to Earsham Street, Broad Street and Market Place. The large wing to the left was in retail use by early

twentieth century and is not included within the listing. Hipped plain tile roof with two massive red brick ridge stacks, and three flat roofed dormers to the Earsham Street façade. Faced in painted red brick with a plat band below the first-floor windows, and a high plinth. Four first floor original leaded mullion transom windows to Broad Street front, the rest being sashes in flush frames in replacement of the originals, flat arches. At ground floor, former garage, and butcher's shop with wood fronts. Earsham Street façade of seven bays with a centrally placed six-panelled door with an arched fanlight (now blank) in a wooden case with Doric columns and an open pediment.

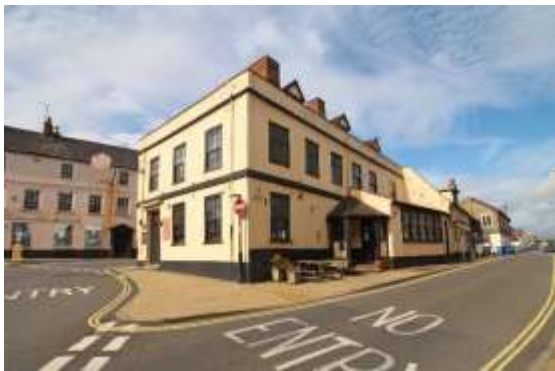
*Broad Street and Market Place facades of The Three Tuns, No.2 Earsham Street*

Nineteenth and early twentieth century photographs show this flanked by three twelve pane sashes to each side, similar to those surviving above. Mid twentieth century pub facias now partially occupy the ground floor. Three bay Market Place façade with remodelled ground floor. This formerly had a central entrance door in a surround with fluted ionic columns flanked by windows with carved surrounds with pilasters. Interior: barrel vaulted ceiling with original plaster enrichments and cornice, well with date 1540 and old cellars dating from the earlier building which was destroyed in the 1688 fire. Nos.2 to 40 (even) form a group. Bettley, J, and Pevsner, N, *The Buildings of England, Suffolk: East* (London, 2015) p.154. Honeywood F, Morrow P & Reeve C, *The Town Recorder, A History of Bungay in Photographs* (Bungay, 1994) p62& 201. Reeve C, *Bungay Through Time* (Stroud, 2009) p18.

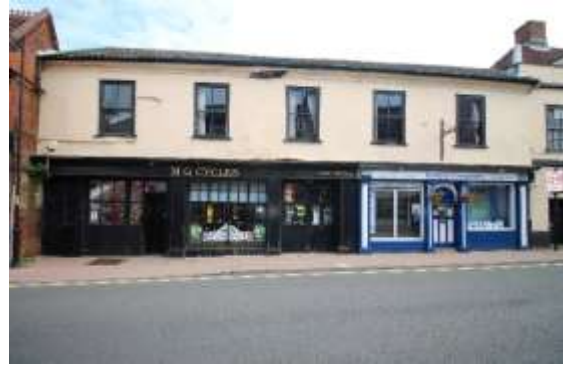
*Nos.2a & 2b Earsham Street*

*Nos.2a & 2b Earsham Street.* A pair of shops with a painted and rendered brick façade above a continuous early to mid-twentieth century shop facia. Rear elevation faces Broad Street. The shop front replaces sash windows shown on c1910 photographs, however the present shop facia was extant by mid 1920s. Formerly part of the Three Tuns and shown as part of the Inn on the 1905 1:2,500 Ordnance Survey map. Shown as separate premises on the 1927 1:2,500 map. Five hornless plate glass sashes at first floor level. Shallow pitched roof with twentieth century black tile roof. Moulded eaves cornice. Shallow pitched black pan tile roof. The listing status of this range is not entirely clear.

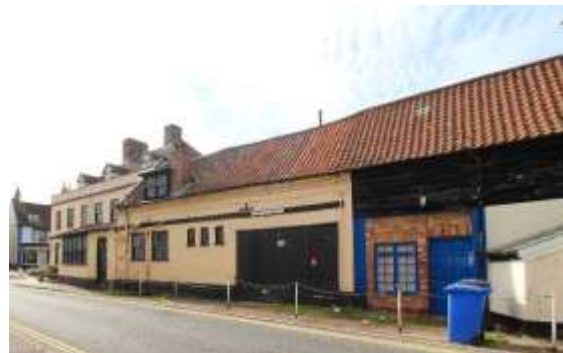
*Broad Street façade of Nos.2a & 2b Earsham Street*

To the rear is a second range which fronts onto Broad Street. This was again once part of the Three Tuns and was probably originally stabling. This is of a single storey and has a red pan tile roof. In two sections the southern part of painted brick with a dog tooth cornice. Two small pane sash windows and a single flat roofed dormer containing two small pane sashes. Northern end partially weather-boarded. Honeywood F, Morrow P & Reeve C *The Town Recorder, A History of Bungay in Photographs* (Bungay, 1994) p62.

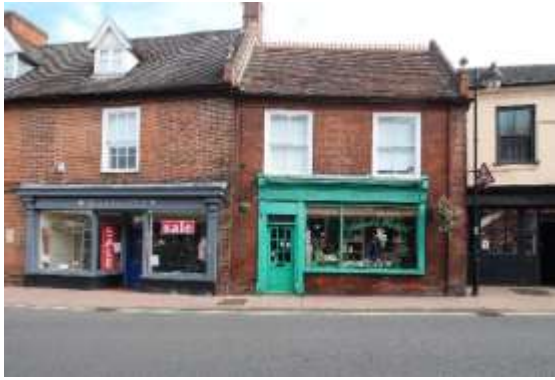
*No.4a Earsham Street*

*No.4a Earsham Street.* A structure of c1870 consisting of a shop with living accommodation above which replaced a timber-framed gabled building which is shown on early photographs. Of two storeys and two bays and faced in red brick with a red plain tile roof and terracotta ridge pieces. Southern gable with finials and dentilled cornice. Its present façade is radically different from that shown in Edwardian photographs, which show a central canted bay window at first floor level and a central doorway flanked by two small pane sashes below. Four light horned plate glass sashes at first floor level. Dentilled eaves cornice. Early to mid-twentieth century shop facia, with late twentieth century partially glazed door inserted post 1977 within the original facia. Reeve C, *Bungay Through Time* (Stroud, 2009) p38.

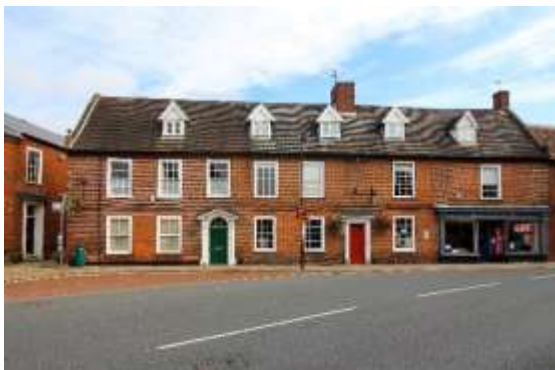
*Nos. 4-8 (even) Earsham Street*

*Nos.4-8 (even) Earsham Street* (grade II). Seventeenth and early eighteenth century, of two storeys and an attic, five gabled dormers. Red brick, part with dark headers, first floor band, plinth tile roof, part renewed. Main roof has gable coping with shoulder carrying stone ornament. Seven windows, at first floor and one blank panel, sash, with glazing bars and flush frames. Nineteenth century painted wood shop facia to No.4. No.6, six panelled door in wooden case, with panelled pilasters and a mutular cornice. No.8, six-panelled door in mutular Doric wood case with panelled reveals, arched radial bar

fanlight, 3/4 columns triglyphs and open pediment. The rear range of No.8 is painted and is visible from both Broad Street and Cork Bricks. It is slightly lower in height and has a symmetrical façade to Cork Bricks with a central doorway. Black pan tiled roof, dentilled brick eaves cornice and casement windows. Nos.2 to 40 (even) form a group. Bettley, J, and Pevsner, N, *The Buildings of England, Suffolk: East* (London, 2015) p.154.

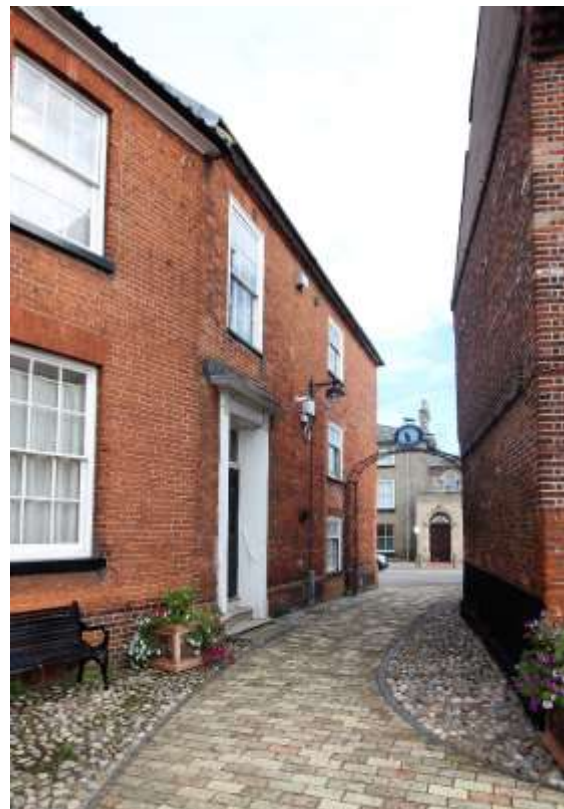
*No.10 Earsham Street*

*No.10 Earsham Street.* A red brick two and three storey structure of mid to late eighteenth century date formerly part of the service range of the grade II listed No.12 Earsham Street. Simple wooden doorcase and hornless sash windows. The listed status of this range is not clear.

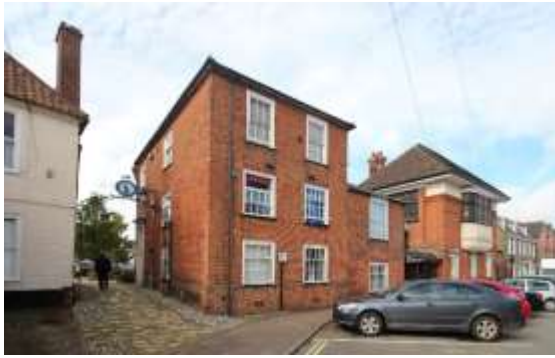
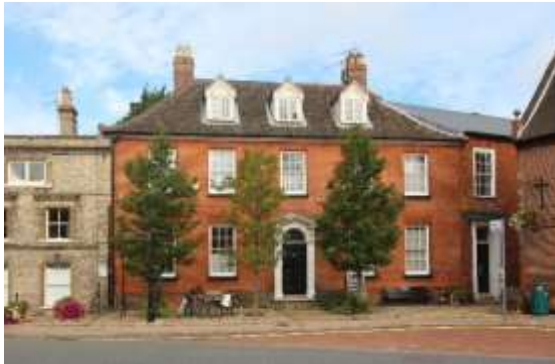
*Earsham House, No.12, Earsham Street*

*Earsham House, No.12 Earsham Street including No.1a Broad Street (grade II). Eighteenth century two storey, attic, and basement, three pedimented dormers. Red brick, small wood cornice, modern tiles. Plinth. Five windows, sash, with glazing bars and flat arches. six-panel door in wood case with enriched pilasters, radial bar fanlight, consoles, and open pediment. Fine arts and crafts vernacular rear range of 1892 fronting onto Broad Street now part of the Council offices. Red brick with a hipped roof over wide projecting eaves. Fine oriel window at first floor level with mullions and a transom containing leaded lights. This housed a billiard room on the first floor and was designed by Bernard Smith with fittings by MFC Turpin and WB Simpson. The fine pargetted decoration is by Daymond and Son. Bettley, J, and Pevsner, N, *The Buildings of England, Suffolk: East* (London, 2015) p.154-155.*

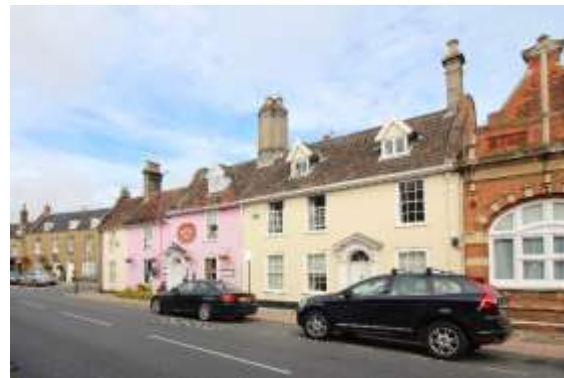
*No.18 Earsham Street* (grade II). Part of the same structure as Nos.20 & 22 (even). Of mid to late Seventeenth century date, and of two storeys with an attic. Red pan tile roof covering with two gabled dormers. Gault brick chimneystacks, that shared with No.20 partially rendered. Painted stucco, façade to Earsham Street. Twelve light hornless sashes within flush frames. Two Dutch gables. Six-panelled door with semi-circular radial fanlight, set within a doorcase with panelled reveals, pilasters, and an open pediment. Nos. 2 to 40 (even) form a group.

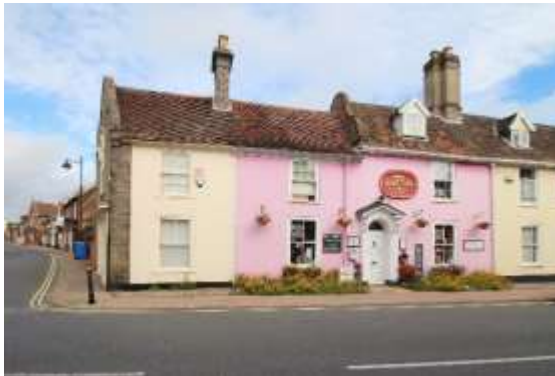
Nos.20-22 (even) Earsham Street

*Nos.20-22 (even) Earsham Street and outbuilding to rear of No.22* (grade II). Part of the same structure as No 18. Probably of mid to late seventeenth century date, two storeys and an attic. Roof to No.22 covered with red plain tiles that to No.20 red pan tiles. These are separated by a partially rendered Dutch gable of possible seventeenth century date. Projecting eaves, and tall gault brick ridge stacks. No.20 with a single gabled dormer containing small pane casement windows. Painted stucco façade to Earsham Street. Six, twelve-light hornless sash windows at first floor level within flush frames. Mid to late nineteenth century horned plate-glass sashes to ground floor. Six-panelled door to No.20, with semi-circular fanlight the radial bars of which have been removed (see No.18). Set within doorcase with open pediment supported on brackets.

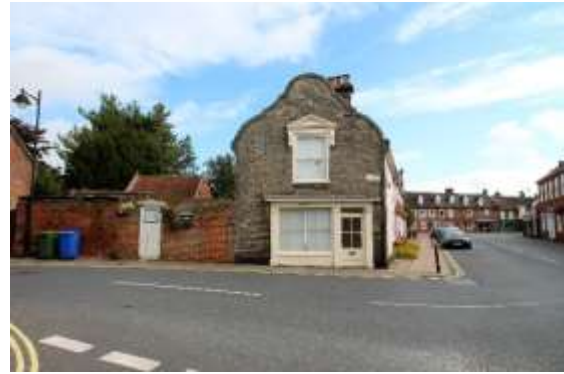
*The Chaucer Street façade of No.22 Earsham Street*

The western or Chaucer Street façade of No. 22 is of mid nineteenth century date and of gault brick with painted stone dressings. Dutch gable, and wooden shop fascia. The First floor has a centrally placed plate-glass sash window with a pediment supported on console brackets. Single storey red brick outbuilding with red pan tile roof to rear probably of early nineteenth century or earlier date. Nos. 2 to 40 (even) form a group.

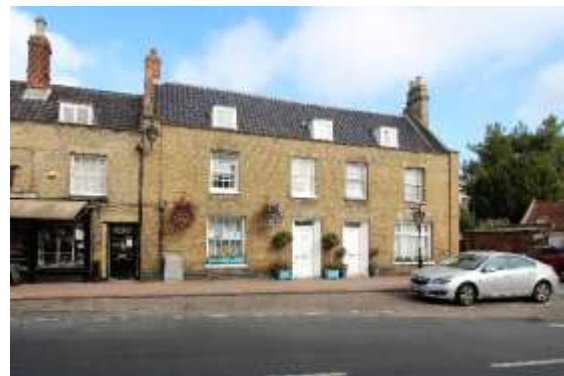
*Nos.24-26 (even) Earsham Street* (grade II). A semi-detached pair of houses of probably seventeenth century date with early to mid- nineteenth century alterations. Of two storeys with attics. Red brick, with symmetrical nineteenth century Suffolk yellow brick façade to Earsham Street; parapet with stone coping and corner pilasters. Black pan tile roof covering, with three, flat roofed, casement dormers. Gault brick stack to gable of No.24 red brick stack to that of No.26. Four bays wide. Sixteen-light hornless sash windows beneath wedge shaped lintels. Pair of six panelled doors in centre with lozenged fanlights, Doric one quarter radius columns to the reveals of the doors. The ground floor window to No.24 has been replaced with a casement and its lintel rebuilt. This property was formerly the town post office. For the late nineteenth century rear wing of No.24, see No.1 Chaucer Street. Nos. 2 to 40 (even) form a group. Honeywood F, Morrow P & Reeve C, *The Town*

*Recorder, A History of Bungay in Photographs* (Bungay, 1994) p63.

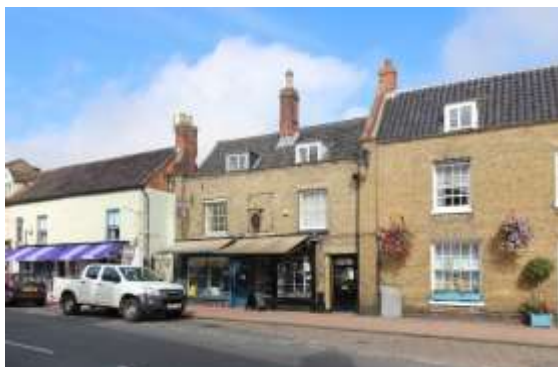
*Nos.28-30 (even) Earsham Street* (grade II). Mainly of seventeenth century date but with an early to mid-nineteenth century façade. Of two storeys and an attic. Two dormers with original leaded casements. Suffolk yellow brick front. Pan tiles. Two windows and blank centre panel, sash, with glazing bars and flat arches. Partially glazed six-panelled door flanked by one quarter radius Doric columns in reveals, beneath a flat arch. Wooden shop fascia, the left-hand section only being evident on early twentieth century photographs. Nos.2 to 40 (even) form a group.

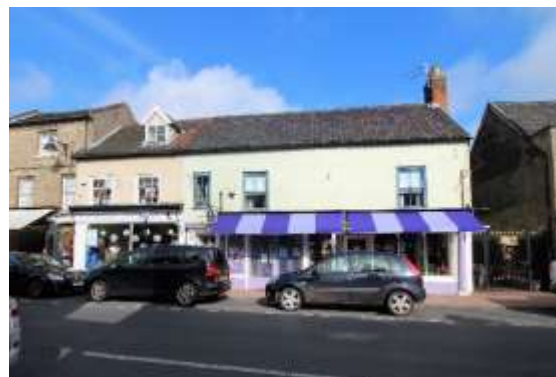
*Nos.32-36 (even) Earsham Street* (grade II). Eighteenth century two storey and attic, one gabled dormer. Stucco on brick, lined and painted. Pantiles. Five windows, sash, some with glazing bars and flush frames. Fine early nineteenth century wooden shop fascia with three Doric columns and entablature, modern glass. Smaller modern shop front, left. Nos. 2-40 (even) form a group. Reeve C, *Bungay Through Time* (Stroud, 2009) p44.

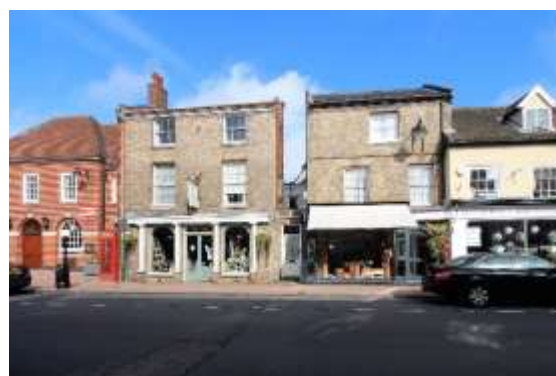
*Nos.38-40 Earsham Street and telephone box*

*No.38 Earsham Street* (grade II). Late eighteenth or early nineteenth century, of three storeys and two bays, red brick with Suffolk white brick façade to Earsham Street, gauged wedge-shaped lintels, and glazing bars to sash windows. Later nineteenth century shop fascia. Nos.2 to 40 (even) form a group. Reeve C, *Bungay Through Time* (Stroud, 2009) p46.

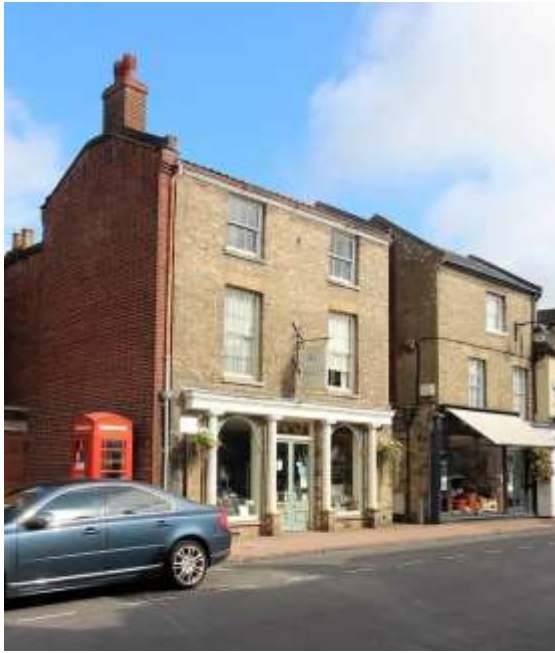
No.40 Earsham Street (grade II). Probably of early nineteenth century date and built of red brick with a Suffolk white brick façade of three storeys and two bays, gauged flat arches and glazing bars to sash windows. The building's listing description describes the fine shop fascia as being of nineteenth century date. It has fluted Greek Doric three quarter radius columns below a wooden entablature, central entrance with fanlight with gold leaf figures, and arched window each side with ornamental spandrels. The fascia does not however, appear on late nineteenth century photographs of the building. Nos. 2 to 40 (even) form a group. Reeve C, *Bungay Through Time* (Stroud, 2009) p46.
