#### Appendix 4: Structures that make a positive contribution to the Conservation Area

The character and appearance of the Conservation Area are shaped by the structures and spaces within it. This appendix contains a list of the built structures which have been identified as making a positive contribution to the Conservation Area (as per section 4. *Positive Contributors* of the CAAMP). The list contains designated as well as undesignated structures. The list is illustrated on maps in the CAAMP.

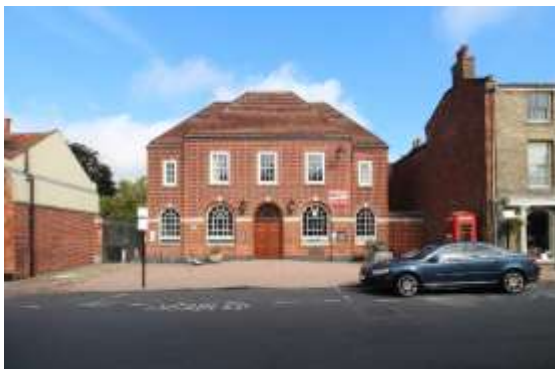
No.42 Earsham Street

No.42 Earsham Street. Built as a post office C1938-40 and attributed by *The Buildings of England* to David N Dyke. A good example of interwar classical design. Clad in red brick with stone dressings. Plain tile roof. Two storeys and five bays with three bay central breakfront. Arched openings with keystones to the ground floor. Central pair of panelled double doors beneath semi-circular fanlight. Flanking the doors are c1940 small pane metal casements. Small pane wooden sashes to first floor. The structure occupies the site of the former Bungay Grammar School which occupied the site from c1580 to c1925. Its forecourt undisturbed since the demolition of the Tudor school is possibly of considerable archaeological interest. Bettley, J, and Pevsner, N, *The Buildings of England, Suffolk: East* (London, 2015) p.154.

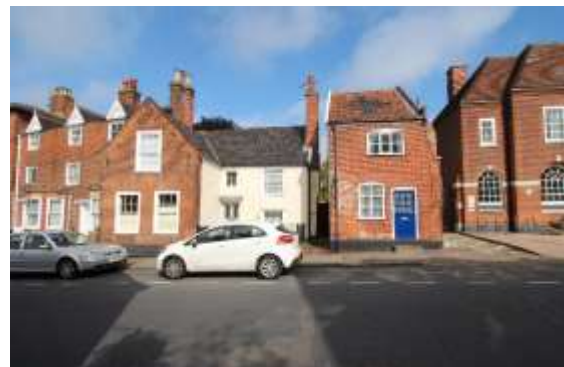
No.44 Earsham Street

No.44 Earsham Street. An early nineteenth century terraced house formerly attached to the hall of Bungay Grammar School but now free standing. Red brick, which was formerly rendered, with external joinery sympathetically replaced late twentieth century. Edwardian photographs show that the first-floor window was formerly of three lights with small leaded panes within. The door had glazed upper panels as today.

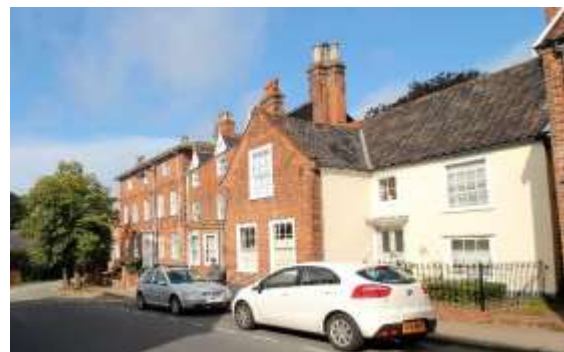
No.48 Earsham Street (grade II). Probably C18, L-plan, red brick with gauged flat arches, part rendered and lined. Plinth. Tiles and pantiles. Front

gable with tumbled foot. Flush frame sash window with glazing bars. Entrance at angle with fielded lower panel to door.

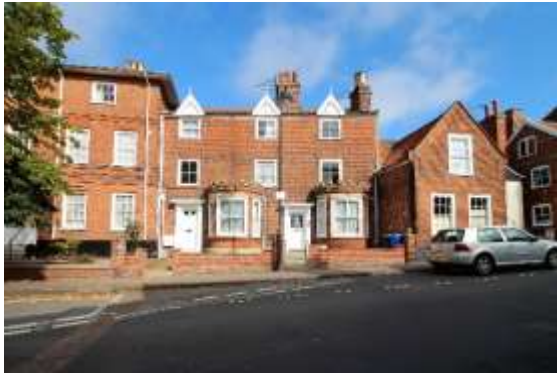
Nos.50-52 (even) Earsham Street

Nos.50-52 (even) Earsham Street. A pair of red brick terraced houses probably of early nineteenth century date. Left hand house of two bays and three storeys, right hand house of a single bay. Four light plate-glass sashes to first floor beneath wedge shaped gauged brick lintels. Similar windows above with later barge-boarded dormers above. Crenelated bow windows to ground floor with curved four light sashes. (Nb. These are not shown on c1900 photographs but are on views of c1914). Panelled doors with glazed upper lights within simple wooden door surrounds. They form part of a good group with the grade II listed, St Mary's House, No.54, Earsham Street and No.44.

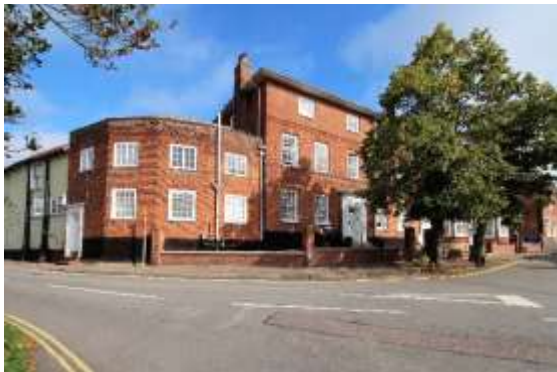
St Mary's House, No.54, Earsham Street (grade II). A substantial mid-eighteenth century townhouse, formerly known as Linden House. Of three storeys with a later infill wing to the left disguising a two-storey service range which fronts onto Outney Road. Used as a school between 1891 and 1966 and now (2017) a residential home for the elderly. Principal range of red brick with a five-bay symmetrical façade the floors separated by plat bands. Wide eaves soffit. Hipped Welsh slate roof. Twelve light hornless sashes in flush frames beneath wedge shaped gauged brick lintels. Plinth.

Eight-panelled door in wooden case with fluted Doric pilasters triglyphs and fret dentil cornice. Wing, to left partly seventeenth century. House built by Giles Borrett. Good early nineteenth century red brick serpentine wall fronting Outney Road. Nos. 54, 56, wing adjoining, walls, and ancillary building together with the bridge over the river Waveney form a group. Bettley, J, and Pevsner, N, *The Buildings of England, Suffolk: East* (London, 2015) p.154. Reeve C, *Bungay Through Time* (Stroud, 2009) p41.

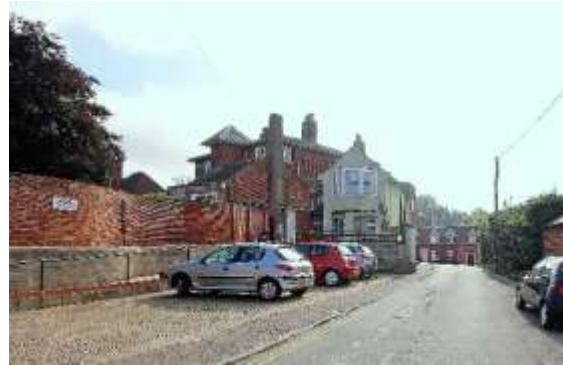
Outney Road elevation and serpentine wall of St Mary's House, No.54, Earsham Street

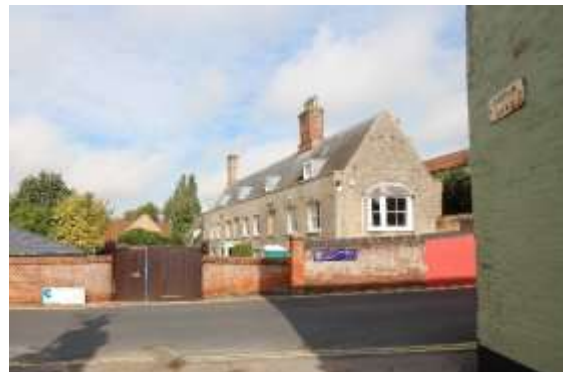
Waveney House, No.56 Earsham Street (grade II). A substantial early seventeenth century house of two storeys and an attic set at a right-angle to Earsham Street with rear elevation facing Outney Road and a front elevation facing towards the River Waveney. The house was bought by John Scott in 1811. In 1827 roof thatched and extensively restored and altered by J B Scott, author of *An Englishman at Home and Abroad*, who records that at this date the building was being prepared for his occupation. His architect, according to *The Buildings of England*, was Jeremiah Bottwright. The house was partially re-cased in the early nineteenth century in Suffolk white brick. It has a steeply pitched Welsh slate roof with four flat roofed dormers, the lower section of the roof is hidden behind a parapet with cope, stone gable. Seven windows at first floor on river front and centre blank panel over porch, sash, with

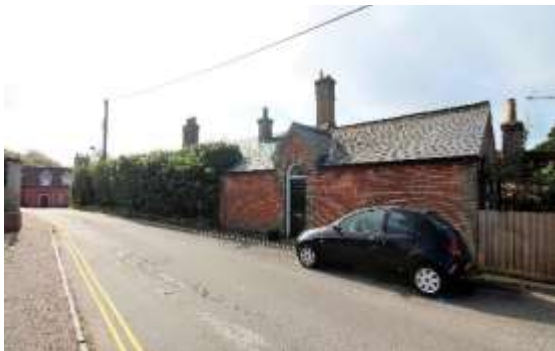
*Outney Road elevation of Waveney House, No.56 Earsham Street*

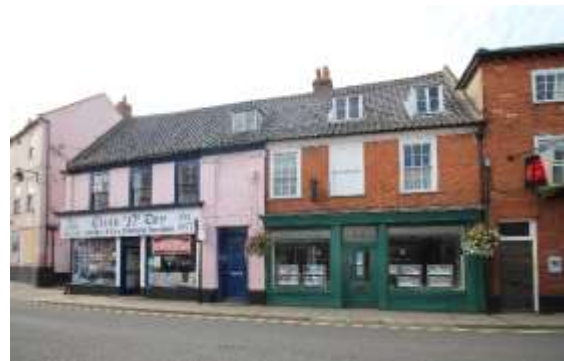
*Nos.1-3 Earsham Street* (grade II). An eighteenth-century house, now converted to shops. Of two storeys and an attic, with three dormers set within a black pan tiled roof. Red brick, with a coved cornice. A pair of two storey brick pilasters with stucco caps flank the central entrance, with a blank panel above at first floor level. Six twelve-light sashes with flush frames. Central six-panelled door (No.1) with lozenge fanlight and case with reeded architrave and roundels. Twentieth century shop fascia to No.1, and an early nineteenth century wood shop front, to No.3 with a central entrance and pilasters. The section to the left of the door is a later addition to the original fascia. Nos.1 to 19 (odd) form a group. The rear section of the plot on which this building stands is within the scheduled area of the

Castle complex. Reeve C, *Bungay Through Time* (Stroud, 2009) p34.

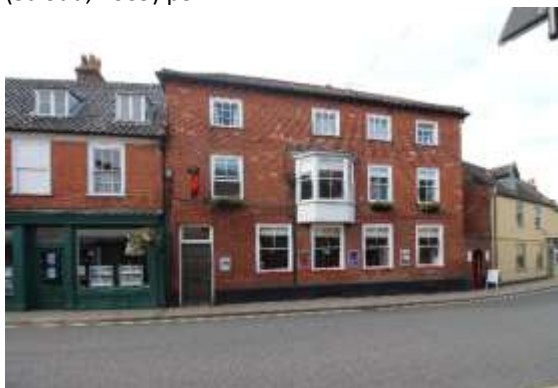
*No.5 Earsham Street* (grade II). An early nineteenth century red brick structure with a hipped pan tile roof. Slightly projecting plinth. Brick toothed cornice. Four windows sash with flush frames and flat arches. Three-light sashed wooden canted bay to the first floor flanked by four-pane plate-glass sashes. Nine-light sashes to second floor windows. Modified plate-glass sashes to ground floor. Later twentieth century panelled door with fanlight and flat arch. Former garden entrance to right now leading into a c2010 top-lit single storey addition. Nos.1 to 19 (odd) form a group. The rear section of the plot on which this building stands is within the scheduled area of the Castle complex.

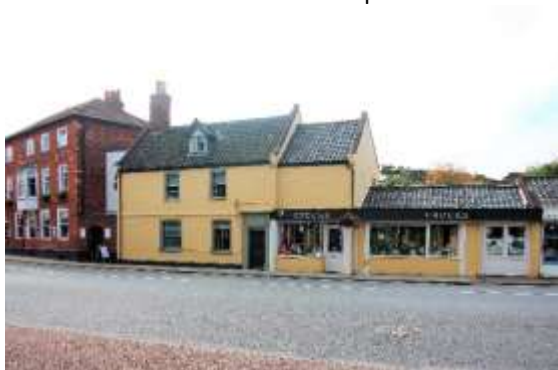
*No.7-9 Earsham Street*

*No.7 Earsham Street* (grade II). A house and shop of eighteenth and early nineteenth century date. Of two storeys and an attic and faced in painted brick. First floor platt band, plinth, black pan tiled roof. Two sash windows to each floor with glazing bars and flush frames, cambered arches to ground floor windows. Four-panelled door in stucco case with consoles. Modern shop fascia in small wing on right-hand end. Nos.1 to 19 (odd) form a group. The rear section of the plot on which this building stands is within the scheduled area of the Castle complex.

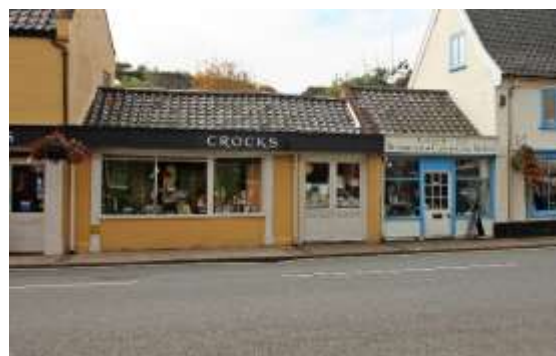
*Nos.9-11 Earsham Street*

*Nos.9-11 (odd) Earsham Street* (grade II). Probably of early nineteenth century date, and of a single storey with shallow pitched black pan tiled roofs. No.9 has an early nineteenth century wooden shop fascia with pilasters. No.11, nineteenth century wooden shop fascia with glazing bars and a central entrance. Nos.1 to 19 (odd) form a group. The rear section of the plot on which this building stands is within the scheduled area of the Castle complex.

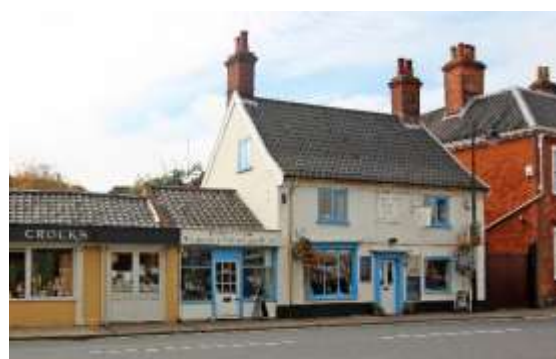
*No.11-13 Earsham Street*

*No.13 Earsham Street* (grade II). An eighteenth century house of two storeys and an attic, with a façade of three bays. Now a shop. Painted red brick with a black pan tile roof. Coved cornice; twentieth century attic window in eastern gable. At first floor level two windows with flush casements flanking a central blind panel. Early nineteenth century shop front, and four-panelled door in a painted wooden surround with reeded pilasters and roundels. Nos.1 to 19 (odd) form a group. The rear section of the plot on which this building stands is within the scheduled area of the Castle complex.

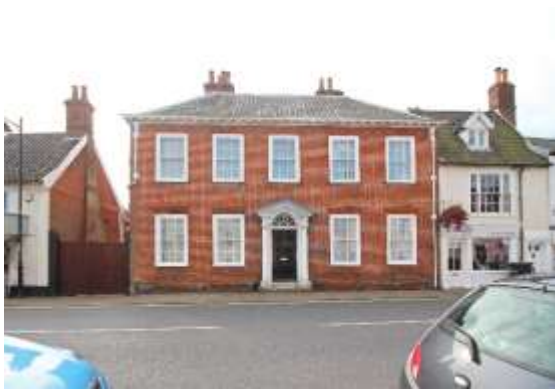
*No.15 Earsham Street* (grade II). A substantial house with the date 1807 on its surviving original lead rainwater heads. Of two storeys and five bays with a distinguished symmetrical classical façade to Earsham Street. Red brick, plinth, and a wooden mutular cornice. Hipped black pan tile roof. Symmetrical five bay classical façade with twelve-light hornless sashes which are set within flush frames beneath wedge shaped brick lintels. Centrally placed six-panelled door, with panelled reveals to wooden case, arched radial bar fanlight, Doric columns and open pediment. Nos.1 to 19 (odd) form a group. The rear section of the plot on which this building stands is within the scheduled area of the Castle complex. Bettley, J, and Pevsner, N, *The Buildings of England, Suffolk: East* (London, 2015) p.154. Reeve C, *Bungay Through Time* (Stroud, 2009) p36.

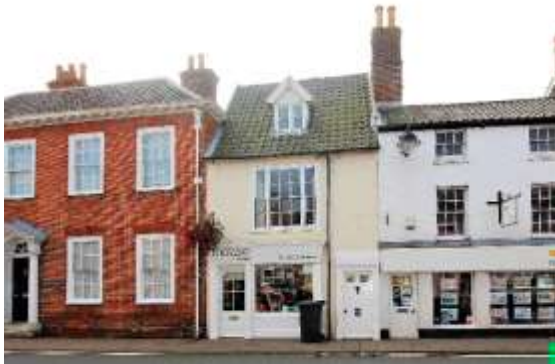
*No.17 Earsham Street* (grade II) Early eighteenth century, two storey and attic, gabled dormer, pantiles. Brick, painted. three-light sash window with flush frame and glazing bars. Early nineteenth century shop front with pilasters, modillion cornice (covered), and modern glazing. Separate six-panelled door in wood case. Nos.1 to 19 (odd) form a group. The rear section of the plot on which this building stands is within the scheduled area of the Castle complex.

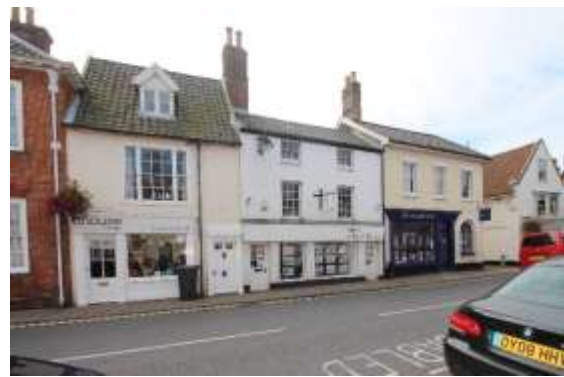
*No.19 Earsham Street* (grade II). Probably of later eighteenth or early nineteenth century date. Painted brick façade of three storeys and two bays. Twelve-light sash windows with glazing bars and gauged flat arches, at first floor level. Six-light sashes above. Shallow pitched pan tile roof, tall red brick ridge stack. Late twentieth century shop front. Nos.1 to 19 (odd) form a group. The rear section of the plot on which this building stands is within the scheduled area of the Castle complex.

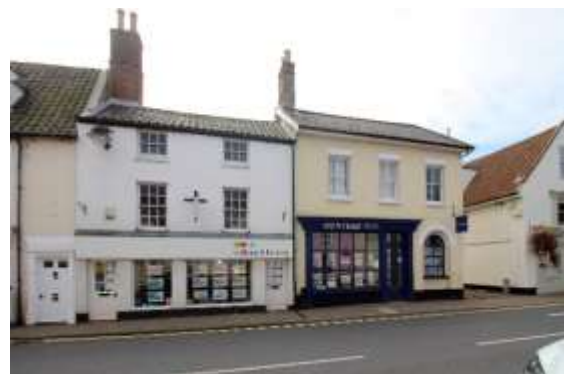
*No.21 Earsham Street*

*No.21 Earsham Street*. A mid nineteenth century two storey three bay commercial building. Painted gault brick with horned plate glass sashes to first floor. Ground floor right-hand bay has arched former door opening which is now converted to a window. Shallow pitched black pan tile roof with gault brick ridge stack. Simple wooden shop fascia of sympathetic design. Gabled return elevation has decorative bargeboards. The rear section of the plot on which this building stands is within the scheduled area of the Castle complex.

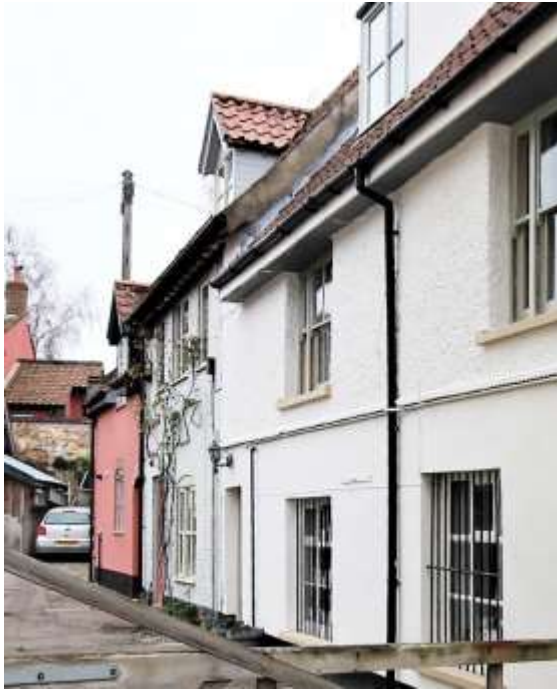
*Nos.23-27 (odd) Earsham Street*

*Nos.23-25 Odd Earsham Street.* A pair of altered c1800 cottages standing in a private courtyard to the rear of No.29. No.23 rendered and of a single storey with an attic lit by a gabled dormer. Late twentieth century window joinery. No.25, two storeys of painted brick with casement windows and a weatherboarded gabled dormer. The rear section of the plot on which this building stands is within the scheduled area of the Castle complex.

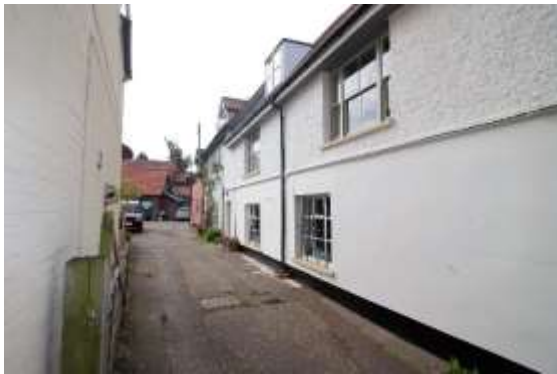
*No.27 Earsham Street*

*Nos 27 & 29 Earsham Street.* A later eighteenth century dwelling with a rendered gable end to the Street containing a shop fascia (No.29). Cantled bay at first floor level replacing a sash window shown on c1900 photographs, four-light plate-glass sash above. Red pan tiled roof with flat topped dormers and overhanging eaves. Principal elevation of No.27 to yard with roughcast to first floor and painted plaster below. Tripartite plate glass sash windows. Honeywood F, Morrow P, & Reeve C *The Town*

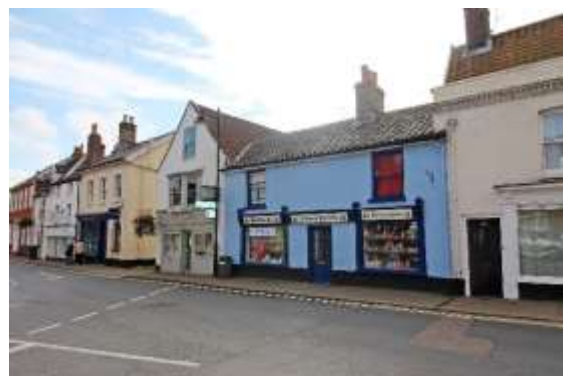
*No.31 Earsham Street*

*No.31 Earsham Street.* A mid nineteenth century symmetrical painted brick façade with two, horned, plate-glass sashes at first floor level. Black pan tile roof with gault brick ridge stack. Central partially glazed door flanked by shop facias. Historic photos show the building with small pane sashes to the first floor and ground floor left, the ground floor window having a wedge-shaped lintel. The rear section of the plot on which this building stands is within the scheduled area of the Castle complex.

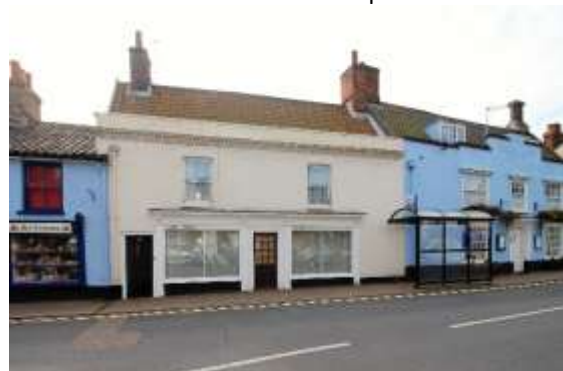
*No.33 Earsham Street*

*No.33 Earsham Street (grade II).* Of eighteenth-century date with a late nineteenth century shop front. Two storey, painted brick, with a stone coped parapet. Shaped dentilled and egg and dart brick cornice. Pan tiles. Two plate-glass sash windows

beneath cambered arches. Possibly the public house known as the Butchers Arms listed in the 1909 town rates book. The rear section of the plot on which this building stands is within the scheduled area of the Castle complex.

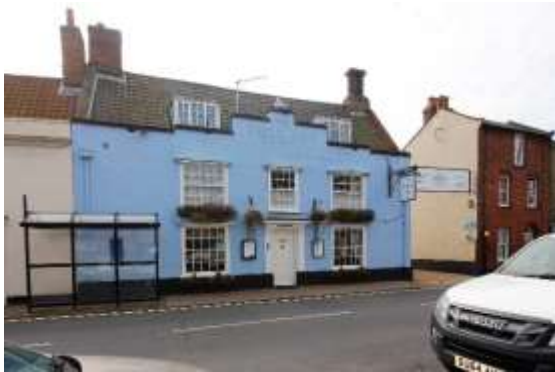
*The Castle Inn, No.35 Earsham Street*

*The Castle Inn, No.35 Earsham Street.* Public house, formerly known as the White Lion. Reputedly an inn since the seventeenth century or earlier. Early nineteenth century roughcast rendered brick façade which is capped by a parapet which has been reduced in height, and an early to mid-twentieth century stepped pediment surmounted by a stone lion.

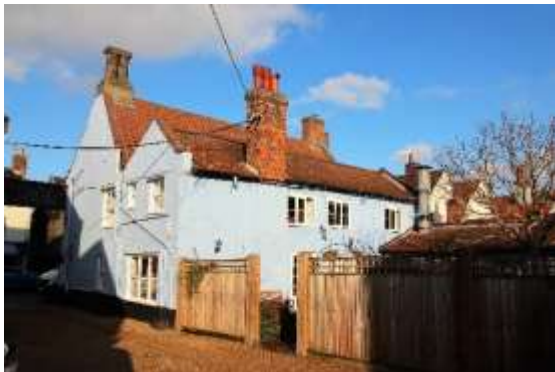
*Rear range of The Castle Inn, No.35 Earsham Street*

Small pane horned sash windows to the ground floor with similar hornless windows above. Six-panelled door, set within simple wooden doorcase with console brackets. Window above inserted in early to mid-twentieth century. Black pan tile roof with two large flat roofed dormers. Twin gabled return elevation, the front gable crowned by massive gault brick stack with two octagonal flues. Two, small late-twentieth century horned sashes to the front range, and three casements to lower rear range. Further red brick ridge stack of late nineteenth or early twentieth century date. A re-fronting of an early eighteenth century but much altered building. At the rear facing the Castle is a lower parallel range with a red pan tiled roof and nine light casement windows which dates from c1800.

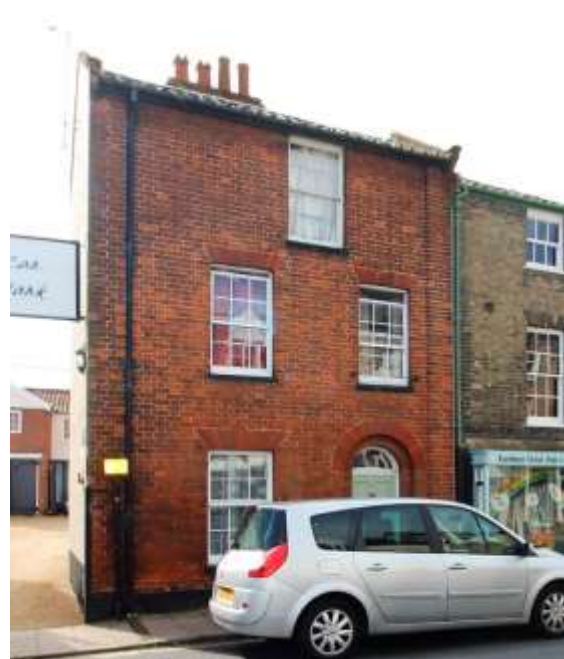
*No.37 Earsham Street*

*No.37 Earsham Street.* A red brick dwelling of c1830-40 with a two bay three storey principal façade. Two storeys rear elevation. Pilaster to right of door. Panelled front door recessed within arched opening. Simple semi-circular radial fanlight. Wedge shaped lintels to hornless sash windows and stone sills. Some sashes replaced. Red pan tile roof covering and massive red brick chimneystack. Rear elevation facing the Castle is rendered and painted with four-light plate-glass sashes. Two storey outshot with a red pan tile roof probably of contemporary date. The rear section of the plot on which this building stands is within the scheduled area of the Castle complex.

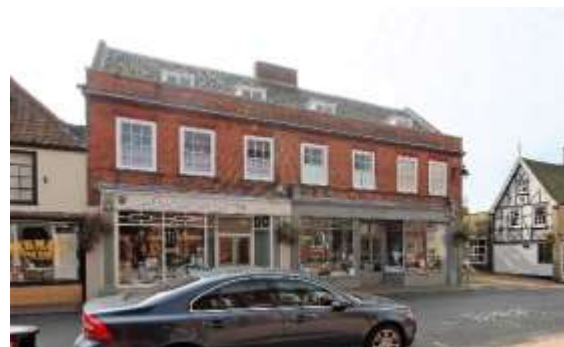
*No.49 Earsham Street* (grade II). Next to No 41. Probably of early eighteenth century date, and of two storeys and an attic. First floor stuccoed, lined and painted and containing two flush frame sash windows with glazing bars. Red pan tiled roof containing two gabled dormers with late twentieth century casement windows. Passage under left with a six-panelled door. Twin square bayed shop front. Nos.39, 41, 49, 55 to 61 (odd) and Nos.65 to 73 (odd) form a group. The rear section of the plot on which this building stands is within the scheduled area of the Castle complex.

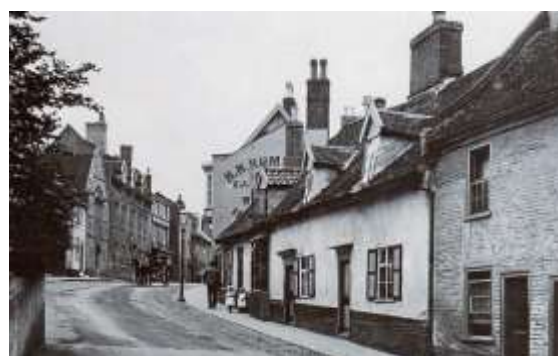
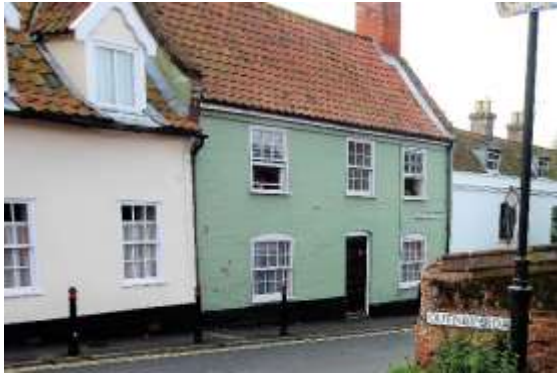
*Nos.61, 65, & 67 Earsham Street from Outney Road.*

*Nos.61-67 (odd), Earsham Street* (grade II). A picturesque terrace of three single storey cottages with attics, formerly four dwellings. Red pan tile roof with black pan tile insets forming a decorative geometric pattern. Seven gabled dormers with decorative bargeboards on the Earsham Street roof face containing mostly late twentieth century casement windows. Edwardian views show only three dormers at that time. Of timber framed construction but faced in painted plaster. Twelve-light sash windows with glazing bars and flush frames. Nos.61, 65 and 67, have wood doorcases. No.61, a six-panelled door, the rest have twentieth century four-panelled doors. Nos.39, 41, 49, 51, 61 (odd) and Nos.65 to 73 (odd) form a group.

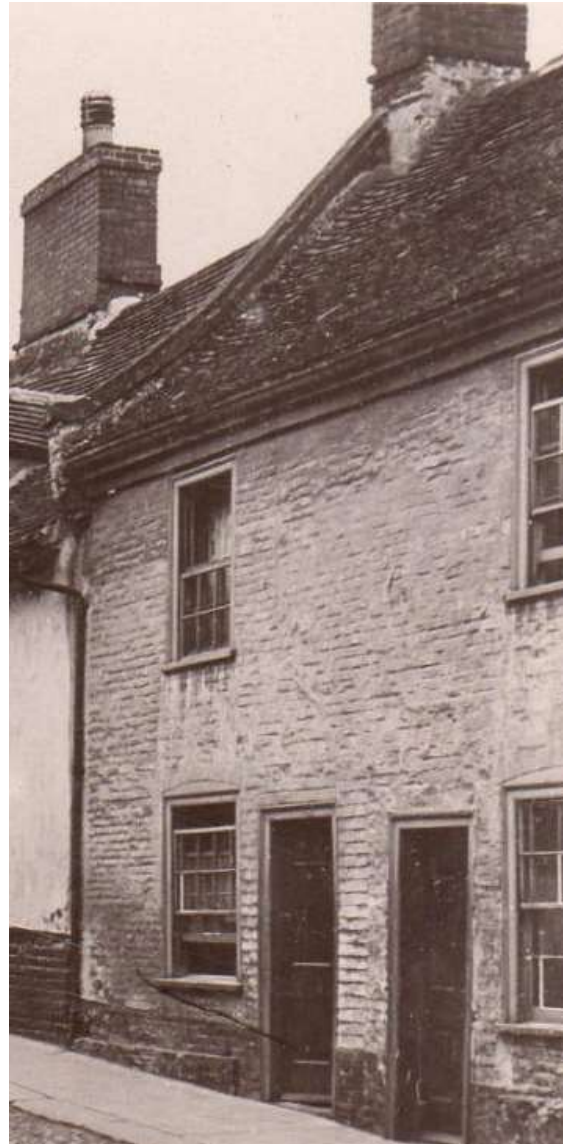
*Nos.69-71 (odd), Earsham Street*

*Nos.69-71 (odd), Earsham Street (grade II).* House, formerly three cottages of eighteenth century date, two storey with a lime washed brick façade. Standing on the corner of Castle Lane. Considerably altered since present listing description drafted. Front range facing Earsham Street formerly two cottages with a third in the rear outshot. Earsham Street façade formerly with two small pane sash windows to each floor with flush frames cambered arched lintels to ground floor. Six panelled door in a flush frame, formerly with a similar door to its immediate left. Inserted window immediately above. Roof formerly plain tiled but now covered with red pan tiles. Gabled return elevation to Castle Lane with two sashes. Rear elevation and two storey gabled rear outshot (formerly a separate small cottage No.1 Castle Lane) also visible from Castle Lane. Nos 39, 41, 49, 51, 61 (odd) and Nos.65 to 73 (odd) form a group.

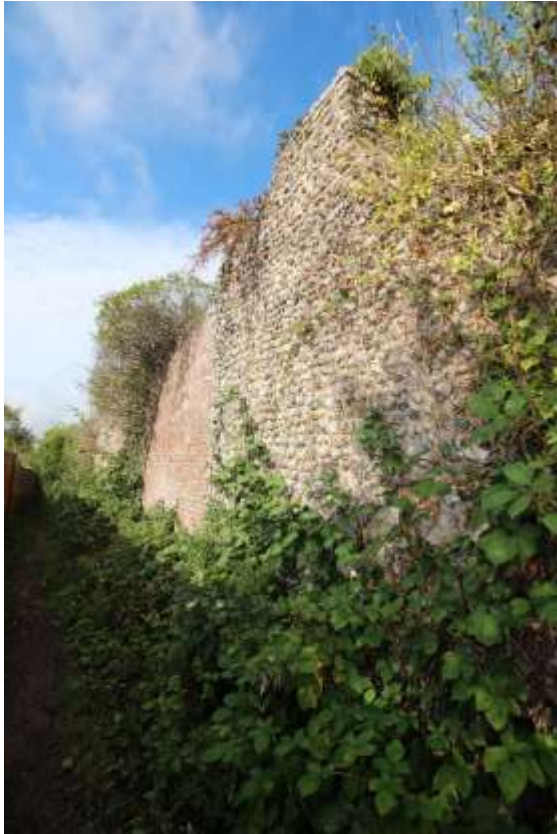
*Folly tower, grounds of Scott House, Earsham Street*

*Folly tower and curtain wall at southern end of lawn.* Probably built c1839 for John Scott to the designs of John Whiting. Garden building and walls designed as a picturesque ruin fronting a short bridleway from Castle Lane to the river. Built of flint rubble with sections of red brick infill and designed in the manner of the Castle's outer defences. Bettley, J, and Pevsner, N, *The Buildings of England, Suffolk: East* (London, 2015) p.155.

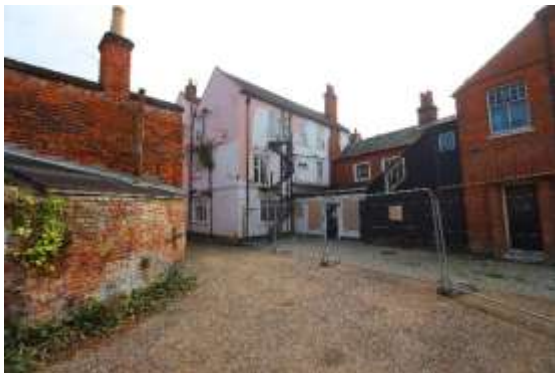
*No.2 Market Place*

*No.2 Market Place and former Odd Fellows Hall to rear* (grade II). An early eighteenth century former coaching inn which was until 2015 known as the Kings Head Hotel. It consists of two parallel ranges with a long rear wing facing a courtyard. The Market Place façade is of early eighteenth century date, and of three storeys and seven bays. Of painted red brick, with a plinth and a dentilled brick eaves cornice. Black pan tiles to roof and a single red brick ridge stack. Seven hornless twelve-light sash windows at first floor level with flush frames and flat arched lintels. Four similar windows to the second floor and six to the ground floor. Off-centre Six-panelled door in wooden Doric case with pilasters, a keyed architrave and a pediment. Return elevation with twin gables. Rear elevation with twelve-light hornless sashes to first and second floors.

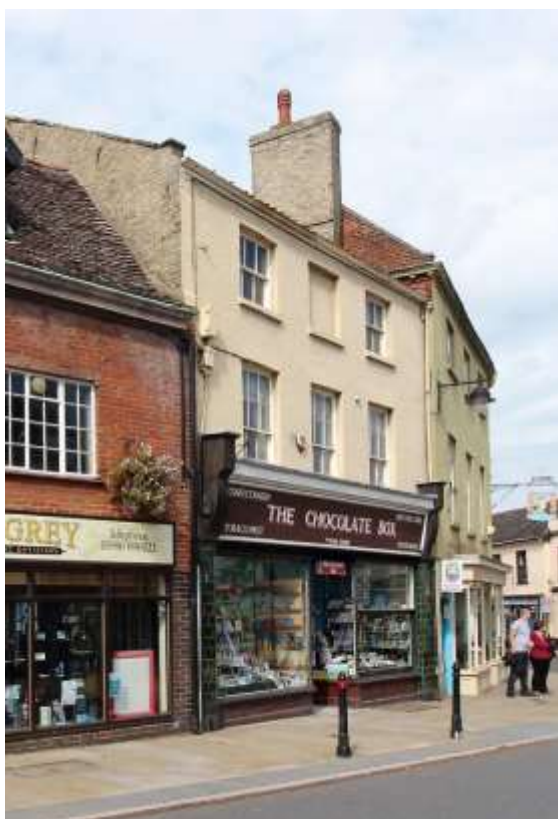
*No.4 Market Place* (grade II). Early nineteenth century, with a Market Place façade of three storeys and three bays. Hornless sash windows to first and second floors with flat arched lintels. Slightly projecting wooden shop fascia with a central entrance Glazing bars to shop fascia shown on early twentieth century photos now removed. Brick, limewashed. Wide passage under, left, with a four-panelled door. Pan tiled roof, brick toothed eaves band. Nos, 2 to 16 (even) form a group. The rear section of the plot is within the scheduled area of the Castle complex. Reeve C, *Bungay Through Time* (Stroud, 2009) p14.

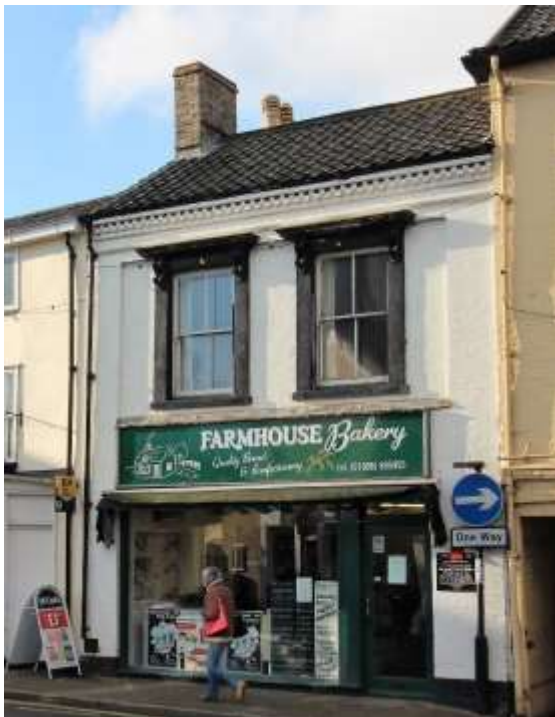
No.10 Market Place

*No.10 Market Place* (grade II). Probably of early nineteenth century date, with a three storey and three bay façade to the Market Place, brick,

limewashed, three twelve-light hornless sashes at second floor level with flush frames. The first floor windows have had their glazing bars removed. Stuccoed flat arched lintels with keys. Wide cart opening to left. Early nineteenth century wooden shop front, to right with slender reeded pilasters and entablature. Low pitched pan tiled roof. Long two storey rear range of c1800. Red brick with a red pan tiled roof, possibly originally a warehouse. Nos. 2 to 16 (even) form a group. The rear section of the plot on which this building stands is within the scheduled area of the Castle complex. Honeywood F, Reeve C, & Reeve T, *The Town Recorder, Five Centuries of Bungay at Play* (Bungay, 2008) p144.

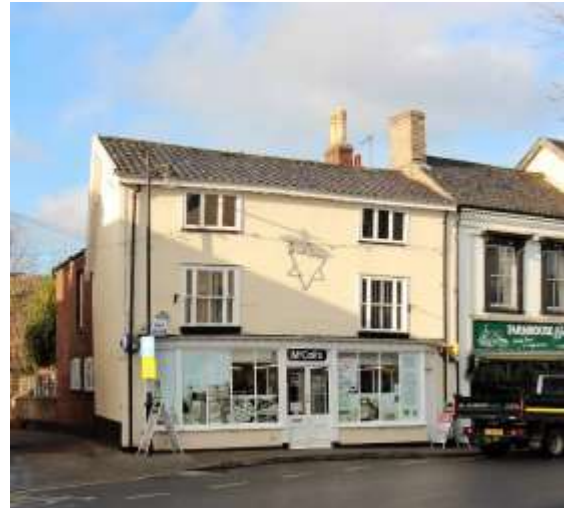
*No.12 Market Place*

*No.12 Market Place.* Former public house, now a shop, front range probably of mid-nineteenth century date. Painted brick with a black pan tile roof. Gault brick stack. Dentilled brick eaves cornice plain pilasters and heavy classical surrounds to first floor windows. Four-light horned sashes. Twentieth century shop fascia. The Bell Inn closed c1920. The building plays an important and positive role within the setting of the grade II listed Nos.10 & 14 Market Place. The rear section of the plot on which this building stands is within the scheduled area of the Castle complex. Reeve C, *Bungay Through Time* (Stroud, 2009) p11. Honeywood F, Reeve C, & Reeve T, *The Town Recorder, Five Centuries of Bungay at Play* (Bungay, 2008) p144.

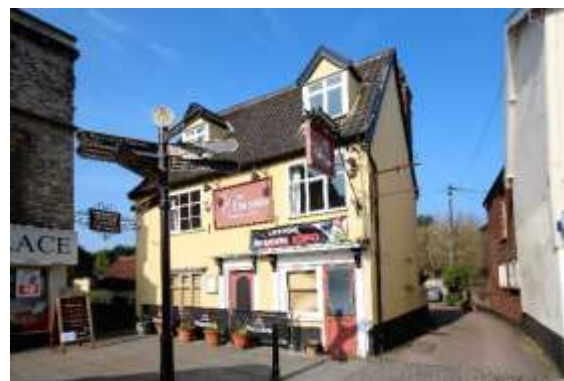
*No.14 Market Place* (grade II) An early nineteenth century shop of three storeys, two, three-light casement windows at second floor level with flush frames. Two, three-light flush frame sash windows at first floor level. Stucco painted. Low pitched black pan tiled roof. Coupled mutules to eaves. Early nineteenth century shallow projecting splay ended wooden shop front running the full width of the ground floor, with central double doors and a mutular entablature. Red brick two storey rear range. Nos.2 to 16 (even) form a group. The rear section of the plot on which this building stands is within the scheduled area of the Castle complex.

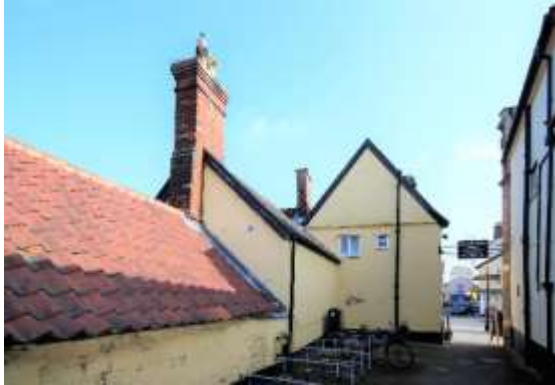
*The White Swan, No.16 Market Place* (grade II). Former public house, empty 2018. A c1800 painted stucco façade to a much earlier structure, its flush frame casement windows are those shown on c1900 photos. Two storeys with attics. Glazed central front door beneath hood. Small wooden pub fascia to right containing secondary entrance door also survives from c1900 photos. Black pan tiled roof with two gabled mullion transom casements (pan tiles renewed). Rear outshot with massive red brick chimneystack. Long single storey outbuilding range to the rear with a red pan tile

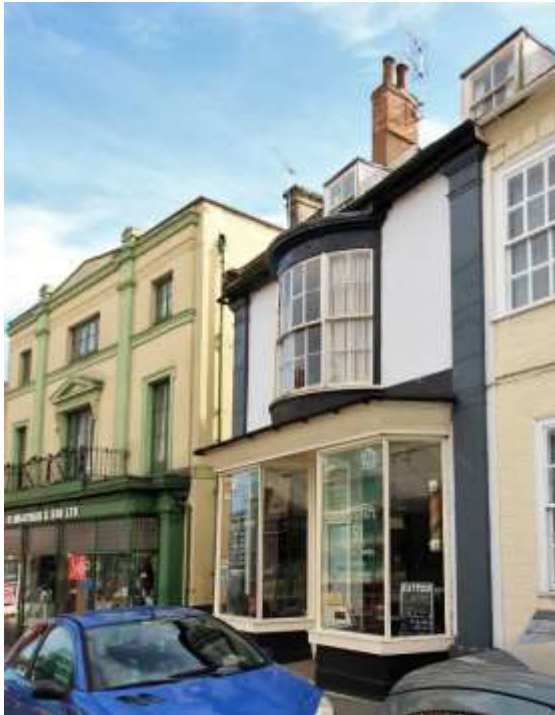
*No.5 Market Place* (grade II). Three storey early to mid-nineteenth century classical façaded shop, which is prominently located at the head of Broad Street. Three bay principal façade the bays separated by pilasters. Central bay pedimented. Sill band below second floor windows. The central first floor walk-in window also has a pediment resting on scrolled brackets. Good cast iron balcony. Shop fascia to ground floor with pilasters and projecting central section. Old photographs show the centre of the pediment and the capitals to the pilasters embellished with plaster laurel wreaths. Return elevation of a single bay to Trinity Street. Large addition to rear right (behind No.2 Trinity Street) with octagonal lantern. See also Nos.2 & 2a Trinity Street.

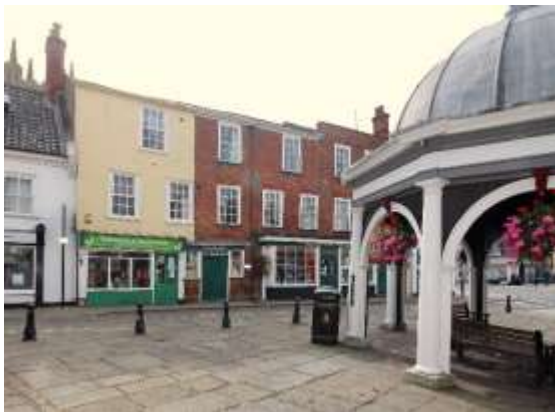
*No.13 Market Place*

*No.13 Market Place.* A mid-nineteenth century painted red brick structure with a parapeted gable to the Market Place. Four bay return elevation to Cross Street. Single horned plate-glass sash to first floor and shop fascia with pilasters below. Cross Street elevation of four narrow bays with a dentilled brick eaves cornice and a single central casement window with a shallow arched brick lintel to the first floor. Blocked doorway and window to ground floor left, and two twentieth century casement windows. All with shallow arched brick lintels. Single storey rear outshot containing a door and a casement window. Red pan tile roof. Forms an important part of the setting of neighbouring listed structures.

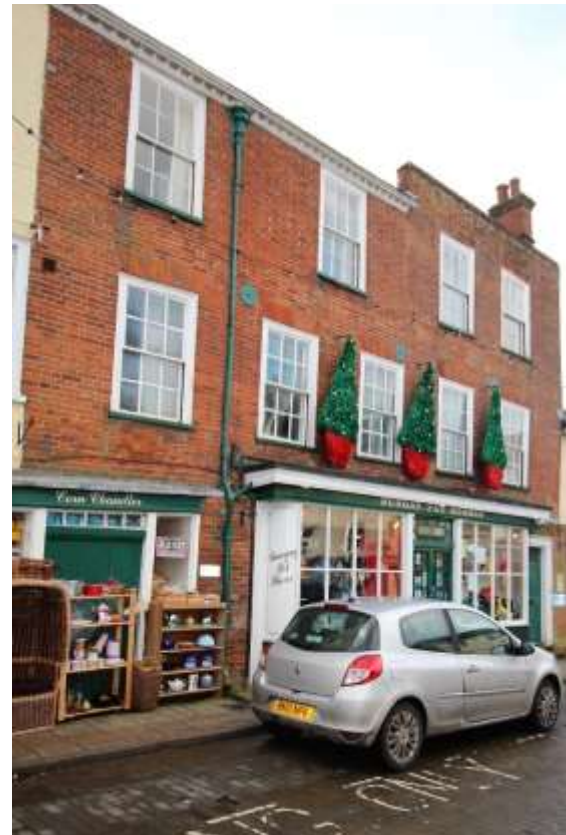
*Nos. 9 & 11 Market Place* (grade II). An early eighteenth century building on a prominent corner site. Of two storeys with attics which are lit by gabled sash dormers. Colour-washed brick. Red plain tile roof covering. Principal elevation of six bays and a return elevation of four. Flush framed twelve-light hornless sashes beneath rusticated cambered arches to first floor. Entrance door with fanlight and wood case. Mainly modern shop fronts. Originally one building. Essentially part of the old market. Nos. 1 to 11 (odd), Nos. 11A, 13 and Nos. 17 to 21 (odd) form a group together with the Butter Cross.

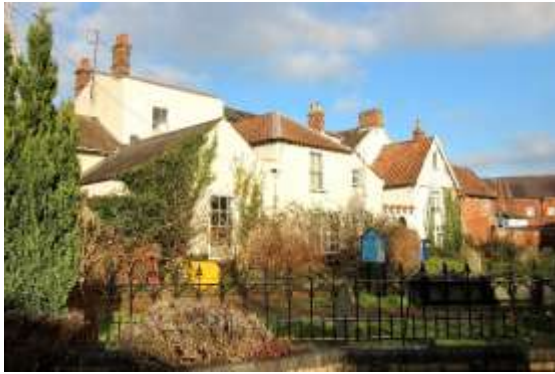
*Nos.17-21 (Odd) Market Place*

The Saint Mary's Churchyard elevation is highly picturesque and plays an important role in the setting of the grade I listed Saint Mary's Church. Crenelated wall to courtyard with arched central door opening. To the rear of No.17 a rendered and weatherboarded gabled addition of two storeys with attics and a red pan tile roof. Parapet of Nos.19-21 continued on churchyard elevation and partially over return elevation to Saint Mary's Street, second floor window a late nineteenth century horned plate-glass sash. Nos.19-21 appear to have two outshots, to No.21 a gabled Welsh slate roofed structure and No.19 a two-storey rendered range with casement windows and a red pan tile roof. Nos.1 to 11 (odd), Nos. 11 A, 13 and 17 to 21 (odd) form a group together with the Butter Cross.

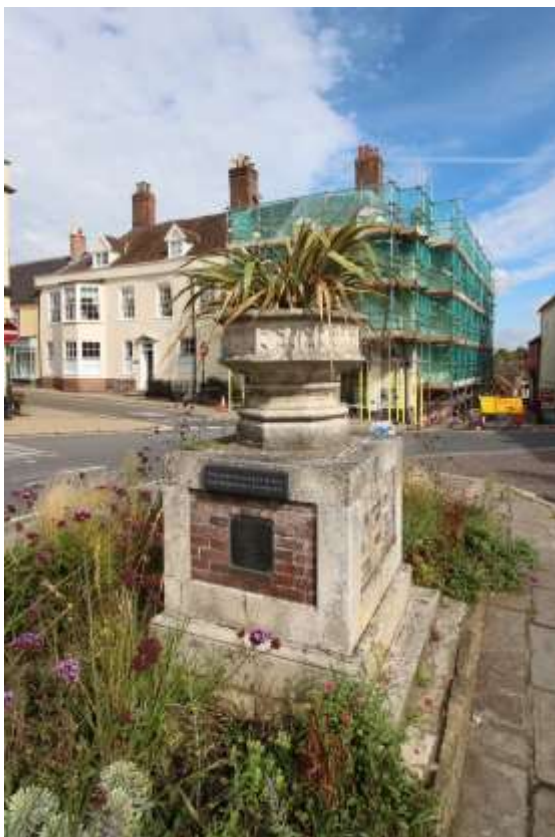
*Memorial in Market Place*

*Memorial in Market Place.* Former font erected in this location c2004. Its square-section brick plinth on a stone base remains from a lamp standard of 1933 which was originally topped by a weather vane commemorating the legend of the Bungay Black Dog. This lamp standard now stands just to the west. Brass plaque commemorating the legend of the Black Dog and a decorative lead panel depicting putti dated 1812 possibly removed from the Town Pump which stood on this site until c 1933.

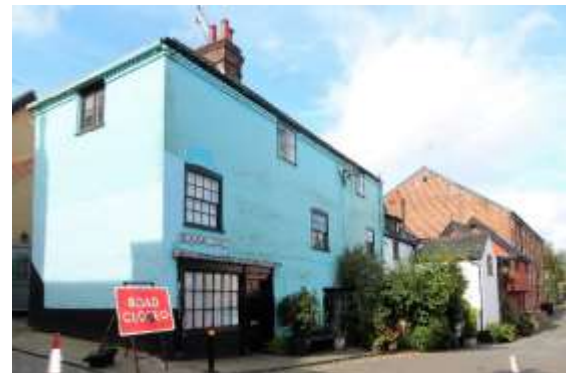
*No.1 Nethergate Street*

*Nos.1 & 3 Nethergate Street.* (grade II) On the corner of Bridge Street. No.1 is an eighteenth-century brick structure of three storeys. Limewashed with a black pan tiled roof which is hipped at its eastern end. Diagonal toothed eaves cornice. Casement windows to second floor with original leaded lights. Sixteen light hornless sashes to first floor beneath cambered lintels. Casement windows to ground floor. Good quality wooden former shop fascia with pilasters, glazing bars, and a six-panelled door near the corner with Bridge Street. No.3 (the lower section to the right). Black pan tiled roof with a single small flat roofed dormer. Projecting gabled wing and casement windows. Nos.1 & 3 form a group with Nos.1 to 5 (odd) Bridge Street

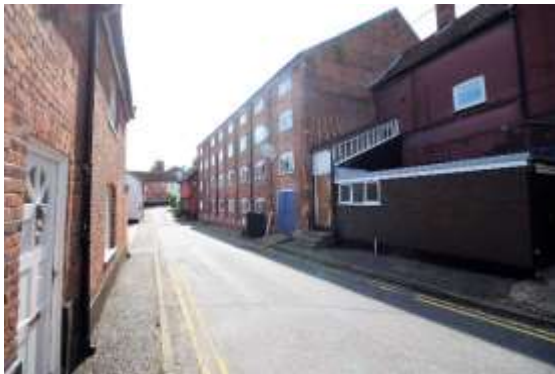
*Former Maltings, Nethergate Street*

*Former Maltings, Nethergate Street.* A former maltings of c1900 date, with elevations to Nethergate Street and a courtyard off Broad Street. A rebuilding of an earlier maltings complex. The present structure postdates the 1885 Ordnance Survey map but is shown on that of 1905. Four storeys to Nethergate Street and two to Broad Street. Red brick with a blue corrugated metal roof. Nethergate Street façade of seven bays divided by pilasters. Casement windows and boarded doors beneath cambered brick lintels. The Broad Street façade has similar casements and is also divided by pilasters.

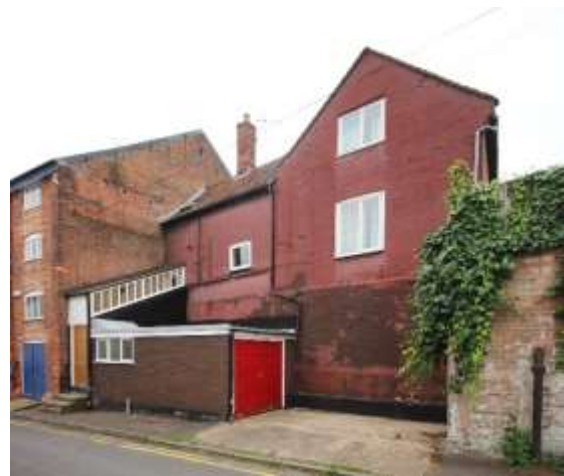
*The Armoury, Nethergate Street*

*The Armoury, Nethergate Street.* House of painted red brick with a red pan tiled roof. Probably of eighteenth-century date and formerly part of a maltings complex (see 1885 1:2,500 Ordnance Survey map). Also used as a regimental armoury for the 2<sup>nd</sup> Volunteer Battalion Norfolk Regiment (see also No.12 Scales Street). Nethergate Street façade of two bays, the right-hand bay gabled. Large blocked arched opening visible behind twentieth century garage addition and scarring for blocked window above. Entrance door at first floor level approached by enclosed flight of steps. All present windows in Nethergate Street façade late twentieth century casements. Return elevation to the garden of the grade II Nos.12-16 Broad Street largely blind.

*Boundary wall to The Armoury.* Mid nineteenth century gault brick wall with decorative panels between rusticated pilasters. Dentilled cornice and projecting plinth. Flanks the Broad Street garden entrance to The Armoury. For 'The Armoury' itself, see No.10a Nethergate Street.

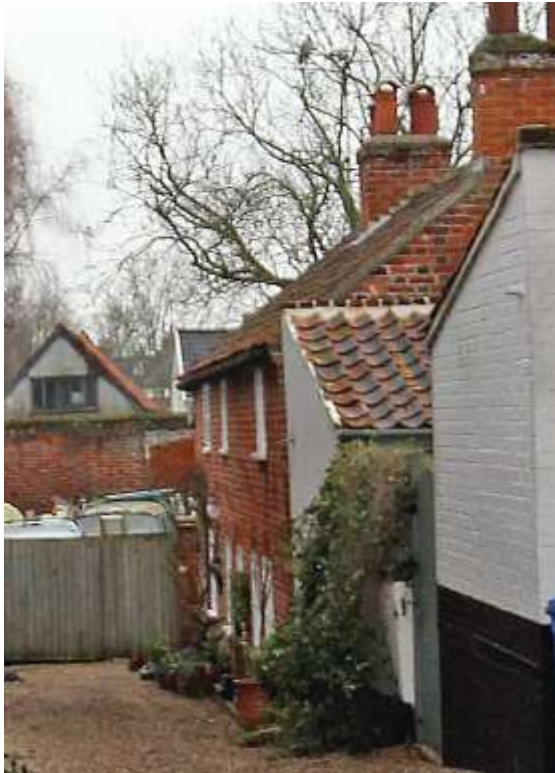
*Nos.8-12 (even), Nethergate Street* A terrace of three c1800 cottages standing at a right-angle to the road within an alley to the rear of Nos.4 & 6. Built of red brick with a red pan tiled roof containing sloping roofed dormers with casement windows. Stack to gable at Nethergate Street end and one central ridge stack. Small pane casement windows beneath cambered brick lintels. Doors with similar lintels.

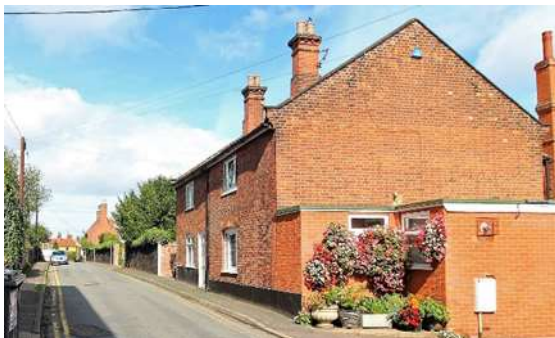
*No. 16 Nethergate Street*

*No.16 Nethergate Street.* A detached red brick dwelling of early nineteenth century date. Formerly two houses. Black pan tiled roof with decorative ridge pieces. Tall decorative ridge stacks. Late twentieth century six-panelled door and casement windows within original openings. Flat-arched brick lintels. Late twentieth century flat roofed addition to right and rear.

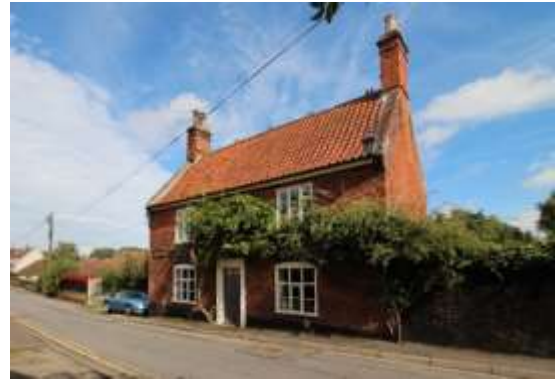
*No. 18 Nethergate Street*

*No.18 Nethergate Street.* C1800 detached red brick cottage. Two storeys and three bays, symmetrical façade with a centrally placed wooden doorcase with reeded pilasters and rectangular medallions. Casement windows with mullions and transoms. Raised plat-band. Steeply pitched red pan tile roof and overhanging eaves, simple wooden eaves cornice. Brick stacks rising from each gable.

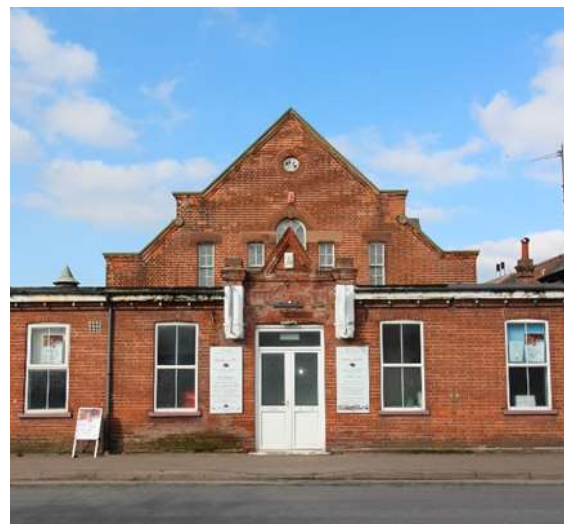
*The Chaucer Club*

*The Chaucer Club, No.3 Popson Street.* Former Chaucer Institute built for employees of the Chaucer Press c1908. Prominently located at the corner of Popson Street and Chaucer Street. Red brick principal range with stone dressings in restrained arts and crafts style. Steeply pitched

Welsh slate roof to two storey range and former cottage. Two storey gabled central hall with Venetian window and roundel above in Popson Street elevation, set behind single storey flat roofed range which contains the central gabled entrance door. Return elevation of two storey range has large centrally placed wooden dormer with bargeboards and mullioned and transomed window. Flat roofed range has dentilled wooden eaves cornice and rubbed brick lintels to windows. Two storey range retains small pane sashes, the windows to the single storey range and cottage have however largely been replaced. Former caretaker's cottage with pebble dashed upper section and applied timber framing, bargeboards and large red brick chimneystacks. The Chaucer Press, (now Clays Printing Works) was one of the town's principal employers.

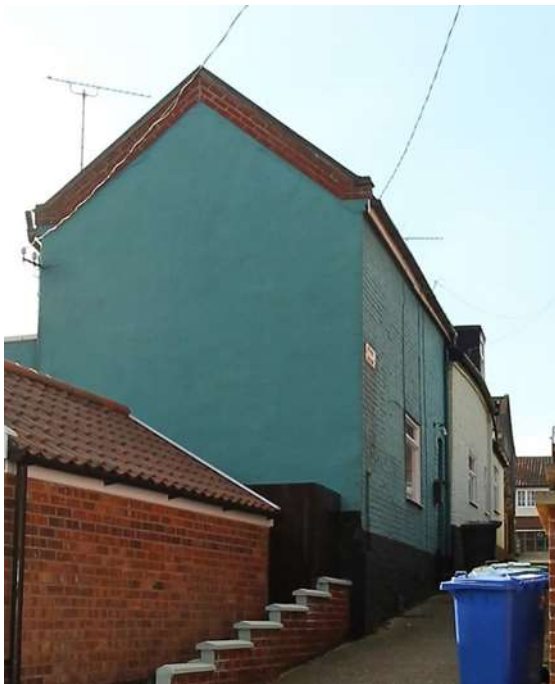
*Rose Cottage and No.4 Stone Alley*

*Rose Cottage and No.4 Stone Alley.* A semi-detached pair of small cottages of probably later eighteenth-century date, which were altered in the later twentieth century. They are of one and a half storeys, and faced in brick which is either painted or rendered. Late twentieth century casement windows. Pan tiled roof. Early twenty first century addition to No.4.

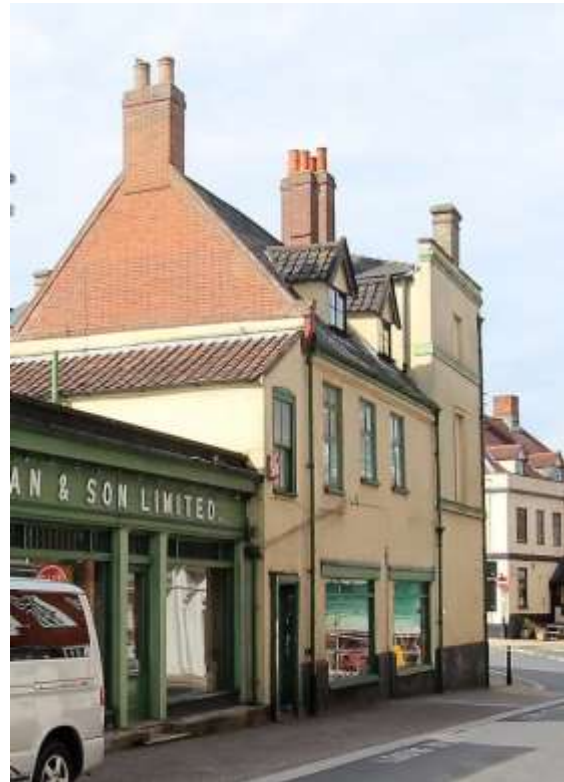
*No.2 Trinity Street and No.5 Market Place.*

*No.2 Trinity Street* (grade II). Seventeenth century and of two storeys with an attic lit by two gabled casement dormers. Limewashed brick, band cut away, plinth. Wooden cornice, black pan tiles, three first floor original mullioned and transomed casements. Six-panelled door in wing, left. Two late twentieth century plate glass shop windows to the ground floor. (See also No.5 Market Place).

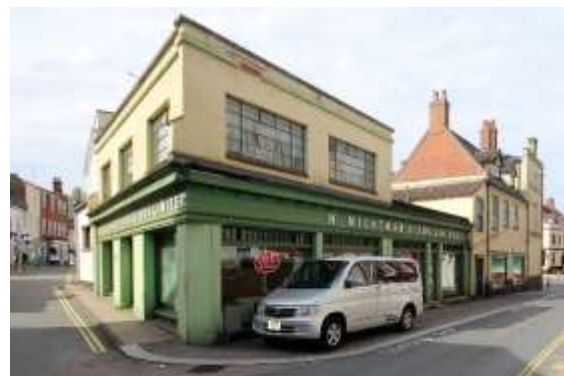
*Nos.2 & 2a Trinity Street with No.5 Market Place in the distance*

*No.2a Trinity Street.* A two storey flat- roofed shop of c1932 with rendered red brick walls and a parapet. Three bay façade to Cross Street, two bays to Trinity Street. Original metal casement windows

to first floor. Linked to No.2 Trinity Street by a single storey flat-roofed range which based on photographic evidence probably pre-dates the two-storey section. Mid-twentieth century shop fascia with pilasters and projecting boxed cornice. Bombed c1940 and partially rebuilt late 1940s. A comparatively rare and unaltered example of its kind for Suffolk. (See also No.2 Trinity Street and 5 Market Place). Reeve C, *Bungay Through Time* (Stroud, 2009) p9.
