#### Appendix 4: Structures that make a positive contribution to the Conservation Area

The character and appearance of the Conservation Area are shaped by the structures and spaces within it. This appendix contains a list of the built structures which have been identified as making a positive contribution to the Conservation Area (as per section 4. *Positive Contributors* of the CAAMP). The list contains designated as well as undesignated structures. The list is illustrated on maps in the CAAMP.

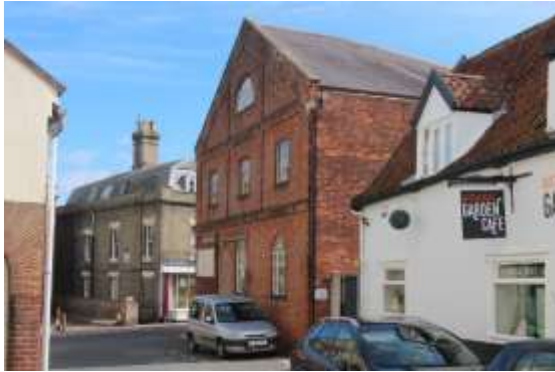
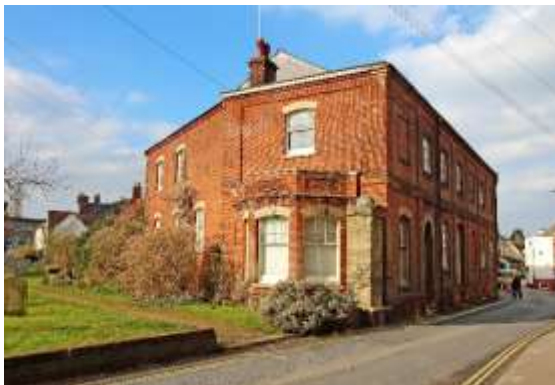
*Owles Warehouse, Cross Street elevation.*

*Owles Warehouse, including No.4 Trinity Street.* Warehouse with attached house of red brick, with a Welsh slate roof. On the corner of Cross Street and Trinity Street. Built c1890 it replaced a large c1730 townhouse. Three bay gabled façade to Cross Street with a Diocletian widow to the gable. Seven bay façade to Trinity Street divided by pilasters rising from a plinth. Platt band above ground floor windows and heavy cornice. Windows and doors set beneath arched lintels, those to the house dressed in stone. House has principal elevation facing out over the churchyard. Four bays with splayed corner to Trinity Street with a canted bay window. A well-preserved industrial building of unusual design. Honeywood F, Morrow P & Reeve C, *The Town Recorder, A History of Bungay in Photographs* (Bungay, 1994) p159.

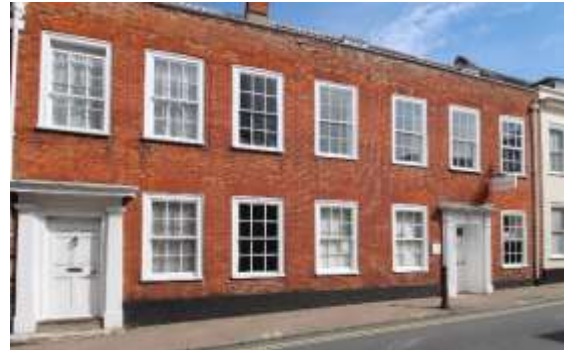
*Nos.1&3 Trinity Street* (grade II). A pair of eighteenth-century houses with a unified seven bay two storey red brick façade to Trinity Street. Attic floor lit by dormers largely hidden behind parapet with a rendered cope. Pan tiled roof. Two false windows painted to look like sashes. Twelve-light hornless sash windows within flush frames, and beneath flat arches. Where windows have been replaced the replacements have horns. Lead rainwater heads. No.1 has a six-panelled door in wooden Doric case. No.3 with a six-panelled door, panelled reveals, fluted pilasters, frieze with swag enrichment and centre medallion head. Nos.1 to 19 (odd) form a group.

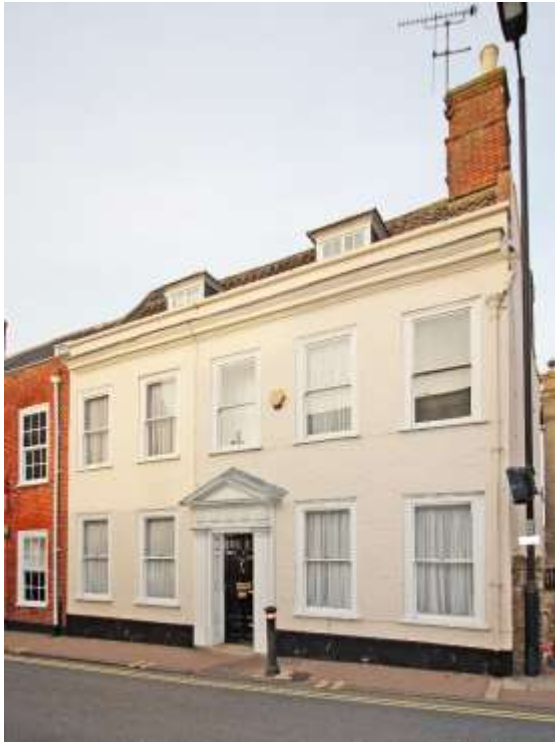
*No.5 Trinity Street* (grade II). Eighteenth century, of two storeys with a colour-washed red brick façade. Moulded cornice and parapet. Black pan tiled roof. Symmetrical façade of five bays. Windows now later nineteenth century horned plate-glass sashes. Original flush frames with flat-arched lintels. Eight-panelled front door in a wooden case with fluted Doric pilasters, panelled reveals, triglyphs and a fret dentilled pediment. Gabled cross-wing containing fine staircase to rear. Twentieth century flat-roofed addition. Nos.1 to 19 (odd) form a group.

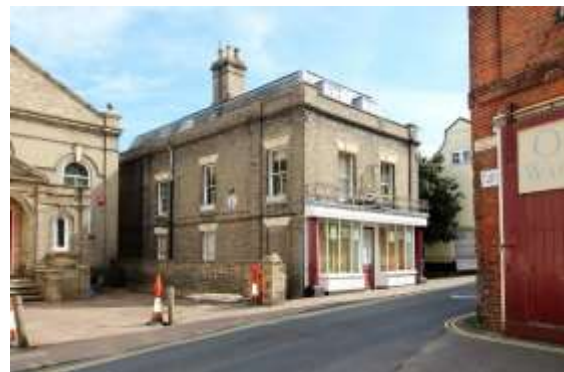
*Former Wesleyan Methodist Chapel, Trinity Street*

*Former Wesleyan Methodist Chapel, Trinity Street and boundary wall to Borough Well Lane.* Former Wesleyan Methodist Chapel with basement schoolrooms built 1836, re-fronted and refitted 1904. Repaired after 1940 bomb damage, in 1948. Closed 1976, when some fittings were removed to Emmanuel Church. Façades to Trinity Street and

Borough Well Lane which are well preserved and retain the bulk of their original joinery and stained glass. Its Trinity Street façade terminates views along Cross Street. Pedimented gault brick façade to Trinity Street of three bays with corner pilasters capped by ball finials. Three arched casement windows with pronounced keystones. Pedimented projecting single storey porch. Elevation to Borough Well Lane of an additional storey and faced in red brick. Tall nineteenth century gault brick boundary wall to Borough Well Lane of considerable townscape value. Red brick retaining walls to rear of lesser interest. Honeywood F, Morrow P, & Reeve C, *The Town Recorder, A History of Bungay in Photographs* (Bungay, 1994) p17 & 27. Bettley, J, and Pevsner, N, *The Buildings of England, Suffolk: East* (London, 2015) p.157.

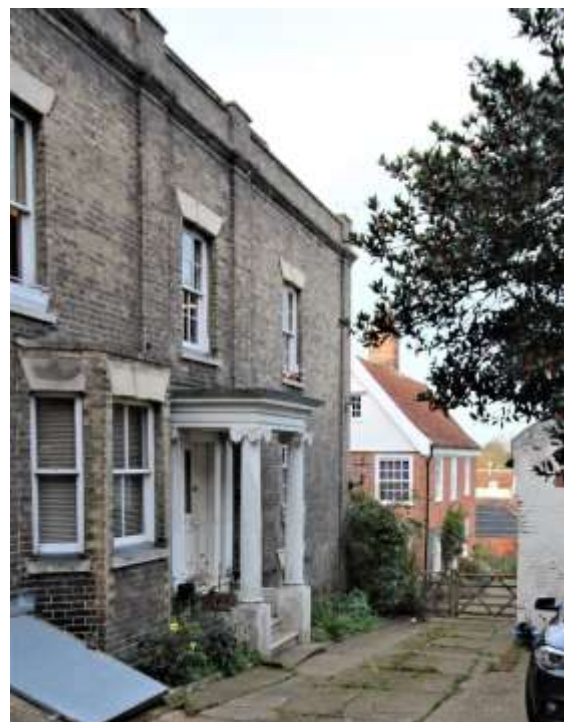
*Nos.7 & 9 Trinity Street*

*No.7 Trinity Street and outbuilding (grade II).* House and shop of c1830-40. Two storeys and an attic, with a slate mansard roof containing two dormers. Faced in gault brick with moulded cornice, and a parapet with cope. Original shop front to Trinity Street façade with modern glazing, flanked by fluted Greek Doric columns, and entablature over which is "crinoline" balcony railing. Two plate-glass sashes above. Return elevation with house entrance. Central Ionic porch with twelve-light sash above flanked by pilasters. Cantilevered single storey bay to left. Further pilasters to corners and twelve light sashes to outer bays. Rear elevation to Borough Well Lane with pilasters and twelve light sash windows. Nos.1 to 19 (odd) form a group. Subsidiary features include a single storey painted red brick outbuilding with replaced red pan tile roof covering. Elevation to Trinity Street heavily altered in mid twentieth century. Bettley, J, and Pevsner, N, *The Buildings of England, Suffolk: East* (London, 2015) p.157.

*No.9 Trinity Street.* An altered eighteenth century detached dwelling standing at a right-angle to Trinity Street behind No.7. The house backs onto Borough Well Lane. Red brick with a partially rendered gable end. Sixteen-light sashes in heavy moulded frames. Three-bay two storey entrance façade with central doorway. Replaced red tile roof and central ridge stack. Rear elevation to Borough Well Lane with high basement storey. Red brick partially rendered with casement windows.

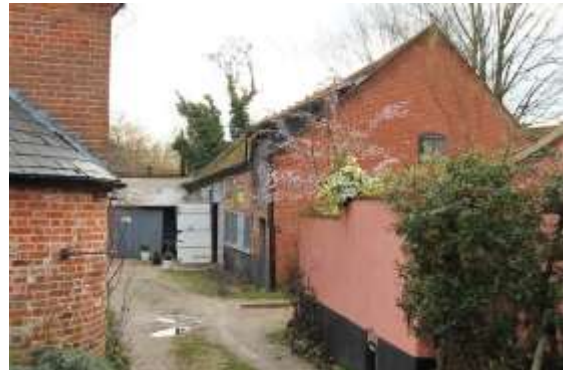
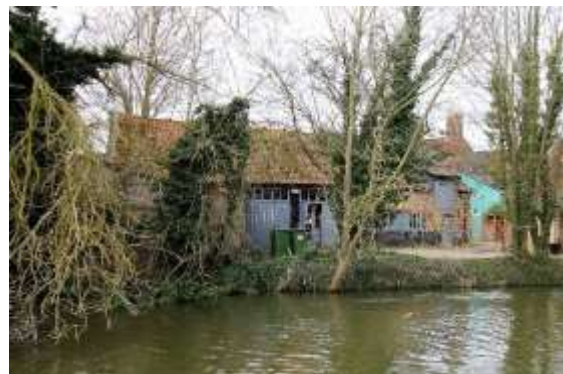
*Outbuilding in Wharf Yard, Bridge Street* Nineteenth century workshop range on the western side of Wharf Yard. Of one and a half storeys and built in red brick, the lower section tared, red pan tile roof. Boarded doors. Boarded taking-in door to loft space and large central doors to river. Gabled return elevation to Bridge Street with first floor casement window. Single storey projecting range at southern end with corrugated roof. Probably a curtilage structure to the grade II listed No.48 Bridge Street.

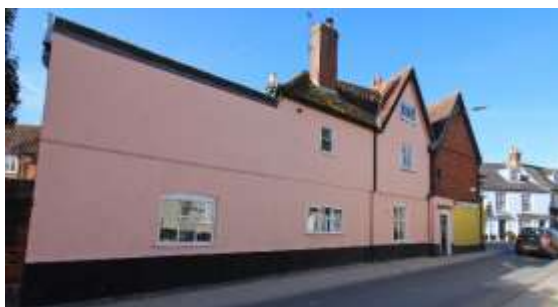
*No.2 Lower Olland Street*

*No.2 Lower Olland Street (grade II). Early seventeenth century. This building interlocks with Nos.1 and 3 Upper Olland Street, qv, and incorporates part of a sixteenth century structure. Of two storeys and an attic. Tiles and pan tiles. Mock half timberwork painted on cement rendering. three-light casement window within gable, two-light casement at first floor level, mullioned and transomed casement to ground floor. Six-panelled door (entrance under left of No.56 St Mary's Street) with architrave convex frieze and cornice. 2'storey wing, left, brick, painted, includes small casement at each floor. No.2 forms part of a group with No.56 St Mary's Street and Nos. 1, 3 & 3a Upper Olland Street. *Subsidiary structures.* Fine panelled red brick garden wall to south fronting onto Lower Olland Street. Dentilled cornice beneath semi-circular brick cap. Blue brick embellishments.*

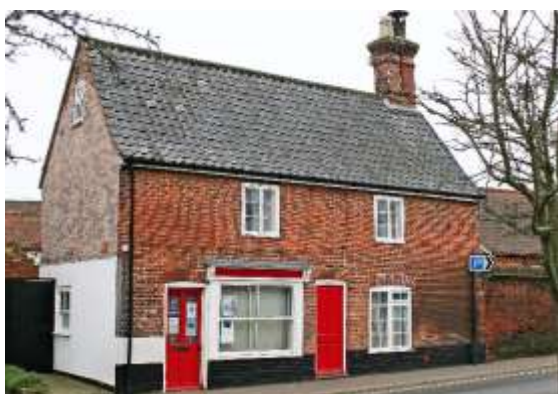
*No.4 Lower Olland Street*

*No.4 Lower Olland Street. Two cottages, latterly house and shop. Red brick with a steeply pitched black pan tiled roof. Possibly late eighteenth century. Well preserved later nineteenth century shop fascia to southern end of a single bay. Two centrally opening casements to first floor which are possibly of nineteenth century date flanking a central blind recess. Southern return elevation partially rendered with replaced windows. Door and widow openings to ground floor with cambered brick lintels. Ground floor window at northern end now a late twentieth century four pane casement. Northern elevation rendered. Single storey rear range.*

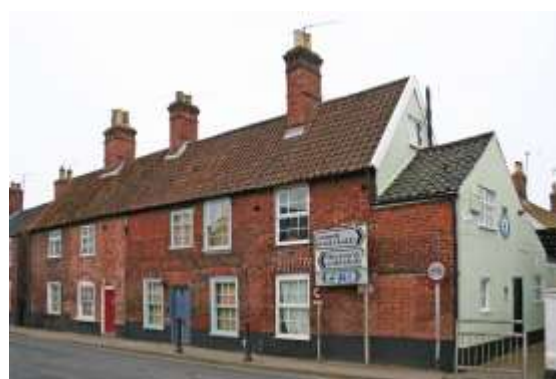
*Nos.10-16 (even) Lower Olland Street*

*Nos.10-16 (even) Lower Olland Street, including No.1a Turnstile Lane. A substantial later*

eighteenth-century range at the southern corner of Turnstile Lane. Red brick, now partially rendered, with a red pan tiled roof. Dentilled brick eaves cornice. Turnstile Lane elevation gabled and rendered with largely late twentieth century casement windows. Four-panelled door. Blocked door opening in northern end of Lower Olland Street elevation. Poor quality late twentieth century windows in original openings. No.12 with twelve-light hornless sashes beneath flat arched lintels. Four-panelled door with a single, nineteenth century casement window above. No.14 has a nineteenth century wooden casement at first floor level and one sixteen-light sash. Four-panelled door. Cambered brick lintels. No.16 now entered from southern return elevation but with blocked opening on Lower Olland Street façade. Cambered brick lintel to ground floor window. Late twentieth century casement to ground floor and possibly nineteenth century casement above.

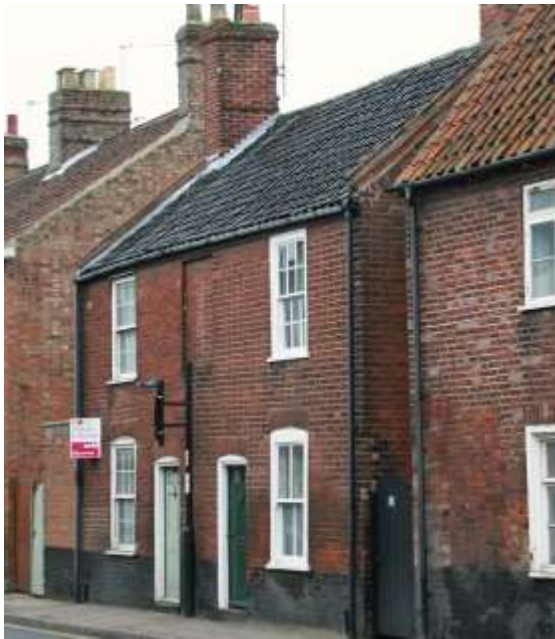
*Nos.18 &20 (even) Lower Olland Street*

*Nos.18 &20 (even) Lower Olland Street.* A semi-detached pair of early nineteenth century cottages. Red brick with a black pan tiled roof. Three bays wide with, at first floor level, a blind central panel flanked by sash windows. Twelve-light hornless sash window to first floor of No.18 probably the only original survival. The other windows are late twentieth century ones of varying designs. Six panelled front doors.

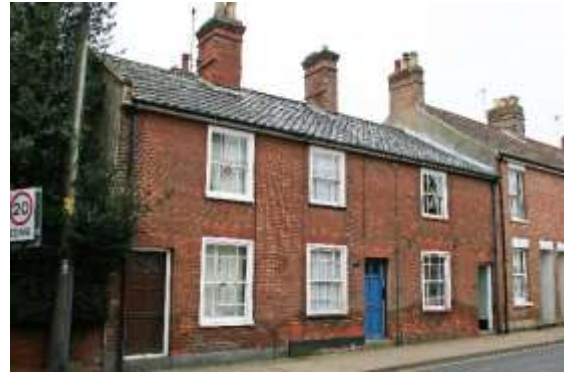
*Nos.30-34 (even) Lower Olland Street.* A well-preserved row of three small terraced houses of mid-nineteenth century date. Red brick with a black pan tiled roof. Entrance to No.30 within a passage way accessed from a doorway at the far north of the Lower Olland Street elevation. Six-panelled door to No.32 with glazed upper lights. Late twentieth century panelled door to No.34. Horned sashes with margin lights and flush frames to ground and first floors. Ground floor openings with flat arched lintels.

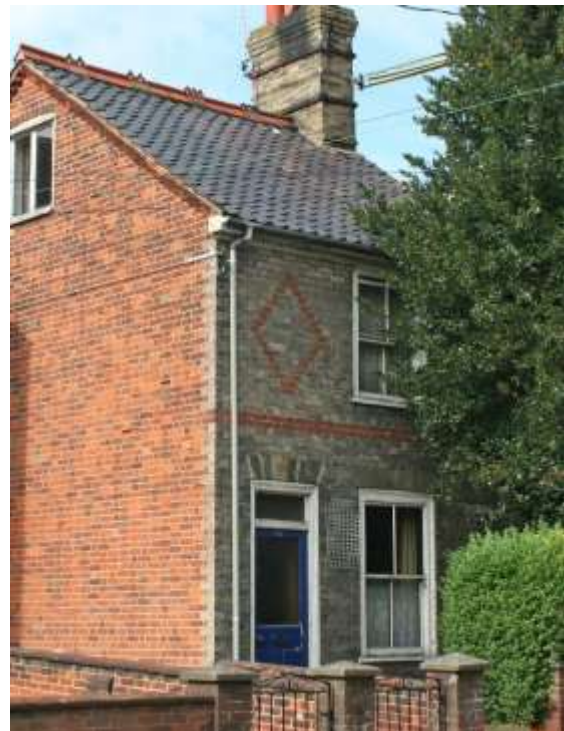
*No.36 Lower Olland Street*

*No.36 Lower Olland Street.* A small late nineteenth century cottage which is set back from the road. Red brick, with a gault brick façade with red brick embellishments. Original horned plate-glass sashes survive to Lower Olland Street. Later twentieth century partially glazed front door. Pan tiled roof.

*Subsidiary Structures* Low red brick boundary wall to Lower Olland Street with square-section piers.

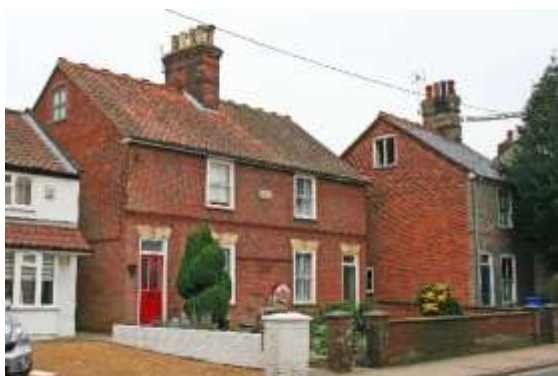
*'Laurel Villas', Nos.38-40 Lower Olland Street*

*'Laurel Villas', Nos.38-40 (even), Lower Olland Street.* A semi-detached pair of cottages of 1893 built of red brick with blue brick embellishments and stone dressings. red pan tiled roof with central ridge stack rising from the spine wall. Four-pane horned plate-glass sash windows and partially glazed front doors. Dentilled eaves cornice, string course, and tile panel to centre. Single storey twentieth century additions to rear. *Subsidiary Structures* Contemporary low red brick boundary wall with square-section piers to Lower Olland Street and northern boundary.

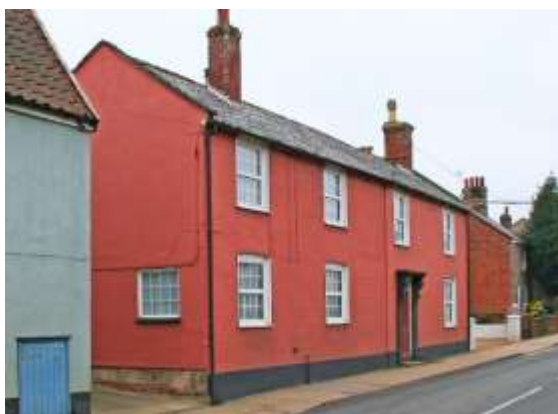
*No.48 Lower Olland Street*

*No.48 Lower Olland Street.* Four bay two storey house of possibly mid to late-eighteenth century date. Painted, and partially rendered red brick façades and a black pan tile roof. Dentilled eaves cornice. Doorcase with hood supported by decorative console brackets. Six-panelled door with rectangular fanlight above. Plinth. Late twentieth century uPVC windows in original openings. Cambered arched lintels to ground floor openings. Catslide roof over lower section to rear.

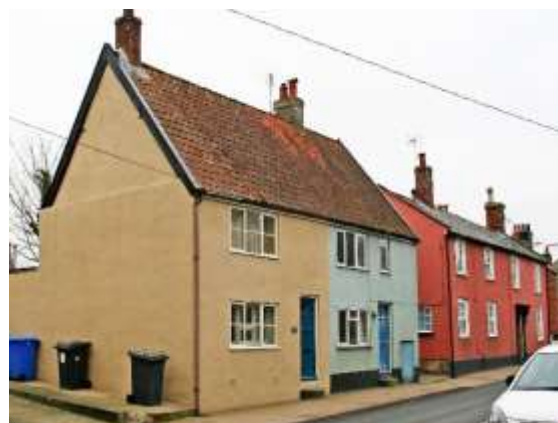
*Nos.52 & 54 Lower Olland Street*

*Nos.52 & 54 Lower Olland Street (grade II).* An early seventeenth century dwelling now altered and subdivided. Of two storeys and an attic, timber-framed and plastered with a plinth. Steeply pitched red pan tiled roof. Later twentieth century casement windows and doors. Old photographs show that it was thatched until c1920. Return elevations blind. Nos.46, 48, 52, 58 and No.60 form a group

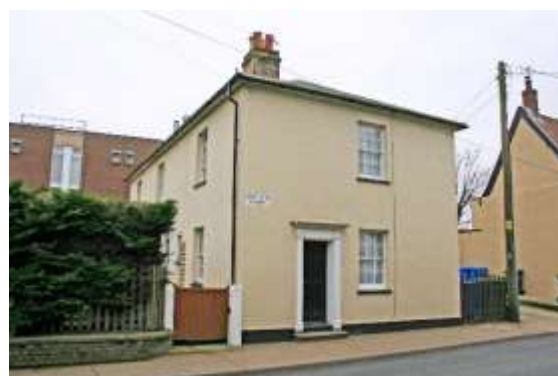
*Nos.58 & 60 Lower Olland Street*

*Nos.58 & 60 Lower Olland Street (grade II).* Early nineteenth century of two storeys and three bays, standing at a right-angle to the road. Principal façade to south. Suffolk white brick with stone lintels, now mainly covered with stippled later twentieth century rendering. Hipped Welsh slate roof. Six-panelled doors in wooden cases with mutular cornices. Twelve-light hornless sashes with stone sills set back significantly from façades. Northern return elevation to yard with casement windows. Entrance to No.58 on northern elevation.

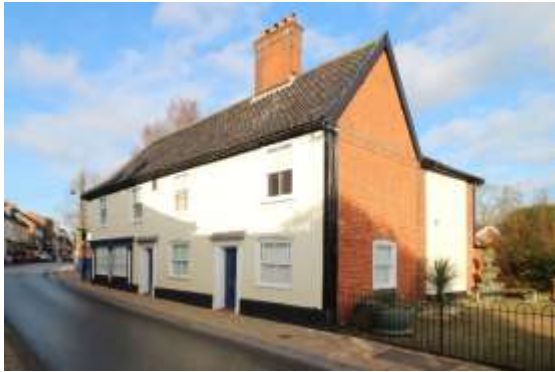
*Nos.1-3 (odd), Lower Olland Street* (grade II). The former Angel public house, in use as such from the early nineteenth century, the pub closed in 2009. Seventeenth century timber-framed, now with a stuccoed, and largely early nineteenth century façade. lined and painted, coved cornice, black pan tiled roof covering. Four-bay principal façade with plate-glass sashes within flush frames. Two early nineteenth century six-panelled doors in wooden cases with mutular cornices. Former pub fascia with small pane casements. Honeywood F, Reeve C, & Reeve T, *The Town Recorder, Five Centuries of Bungay at Play* (Bungay, 2008) p164.

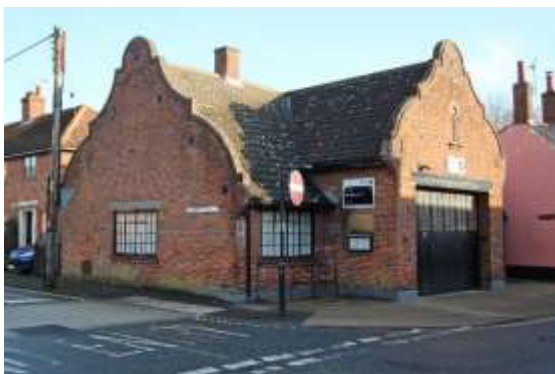
*No.29 Lower Olland Street*

*No.29 Lower Olland Street.* Former fire station built in 1930, of red brick over a concrete plinth. Single storey with decorative Dutch gables to return elevations and central section of entrance façade. Black concrete pan tile roof. Concrete lintels and small pane metal framed casement windows. Original top lit folding doors. A stylish and externally little altered piece of interwar design. According to research by Christopher Reeve the architect was Frederick J Meen of Beccles, the contractors Bedwell of Bungay and the cost £800. Honeywood F, Morrow P & Reeve C, *The Town Recorder, A History of Bungay in Photographs* (Bungay, 1994) p69.

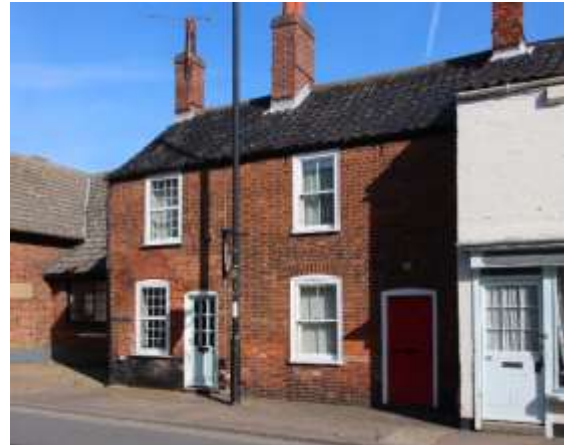
*Nos.31-33 (odd) Lower Olland Street*

*Nos.31-33 (odd) Lower Olland Street.* A pair of red brick terraced house of c1800 with a black pan tiled roof. Cambered arched lintels to window openings. External joinery replaced in the late twentieth century. Straight joint between the two properties.

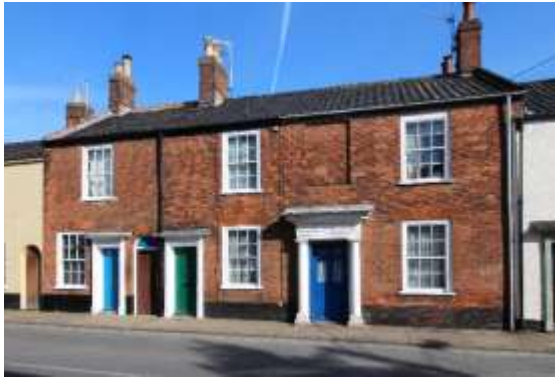
*Nos.35-37 (odd) Lower Olland Street*

*Nos.35-37 (odd) Lower Olland Street.* A pair of red brick terraced houses of c1800 both now painted. No.35 with a mid to late nineteenth century shop fascia, and a replaced partially glazed door. Twelve-light hornless sashes. Black pan tiled roof. Simple pilastered doorcase to No.37 and arched passage entrance.

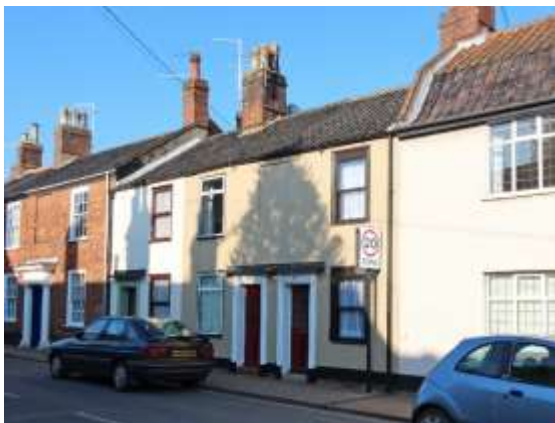
*Nos.41-45 (Odd) Lower Olland Street* (grade II). Later eighteenth or early nineteenth century, of two storeys, red brick, black pan tiled roof. Six bay façade with replaced sash windows within flush frames to each floor. Flat arched lintels to ground floor. Nos.41 and 43 have six-panelled doors in wooden cases with pilasters. No.45, a six-panelled door within an altered wooden doorcase with Doric pilasters. Blind recess above. Arched passage between Nos.41 and 43,

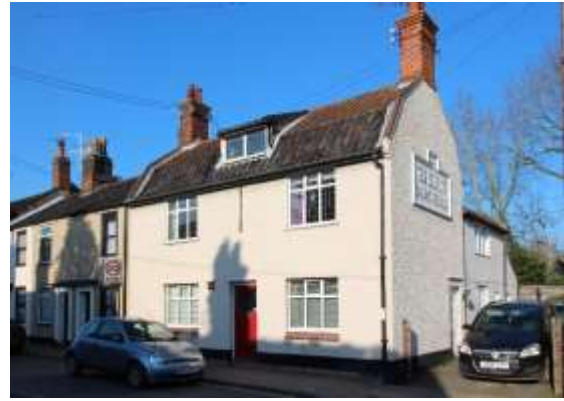
*No.53 Lower Olland Street*

*No.53 Lower Olland Street*. The former Ship Inn. A public house from 1791 or earlier, renovated and rendered 1923 when the fenestration was also altered. Closed 1980s. Red pan tiled gambrel roof with a single flat roofed dormer. Roughcast façades with leaded casement windows to first floor. Ground floor windows have had the leaded panes removed. Central partially glazed front door. Lower rear range possibly of early nineteenth century date. Red pan tiled roof. Casement windows. Honeywood F, Reeve C, & Reeve T, *The Town Recorder, Five Centuries of Bungay at Play* (Bungay, 2008) p166-167.

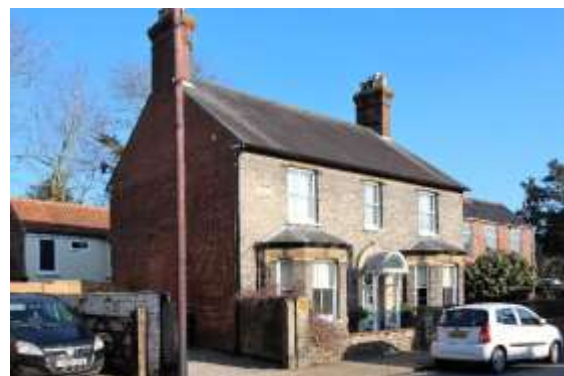
*No.55 Lower Olland Street*

*No.55 Lower Olland Street and outbuilding to rear*. A later nineteenth century villa of red brick, with a gault brick façade and stone dressings. Symmetrical three bay façade, with canted bay windows to the ground floor flanking a central arched entrance. Partially glazed four-panelled door. Horned plate-glass sashes above. Welsh slate roof. Original joinery preserved throughout. Decorative wooden porch with leaded glass. *Subsidiary Structures* Two storey rendered outbuilding with a red pan tiled roof probably of nineteenth century date. Front boundary wall gault brick with square sectioned piers.

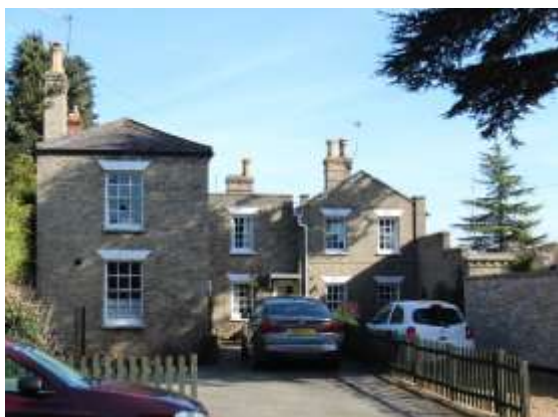
*Nos.61 & 63 Lower Olland Street*

*Nos.61 & 63 Lower Olland Street. A semi-detached pair of houses of mid nineteenth century date. Possibly originally one villa but map evidence suggests it has been divided since at least 1905. Two storeys. L-shaped, No.61 within projecting range at northern end with a hipped Welsh slate roof. Good Doric doorcase. Twelve-light hornless sashes beneath painted stone flat-arched lintels with rusticated panels. No.63 has parapet hiding roof and gable to southern bays. Twelve-light hornless sashes. *Subsidiary Structures.* Tall mid nineteenth century gault brick wall springing from entrance façade of No.63.*

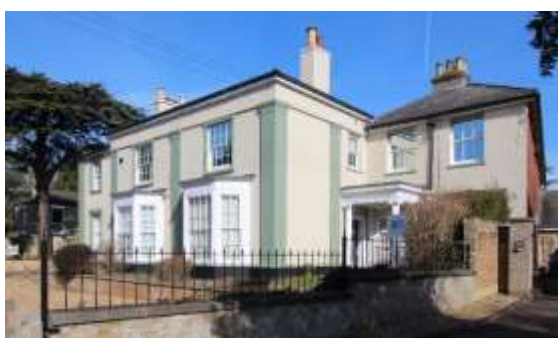
*Dunelm House, No.65 Lower Olland Street*

*Dunelm House, No.65 Lower Olland Street (grade II). Formerly known as Olland House. An early nineteenth century stuccoed villa which was last used as a private house c1930. Principal range of two storeys and two bays with three full-height pilasters, an eaves entablature, and a hipped Welsh slate roof. First floor with two sixteen-light hornless sashes and moulded cases. Wooden canted bay windows with small pane hornless sashes beneath. To the left (north) a later twentieth century recessed bay with pilasters and similar sashes which*

*occupies the site of a former conservatory. To the right a later recessed bay with an Ionic porch. Door with glazed upper panels. In the nineteenth century the home of the Walker family owners of the Staithe Maltings. Honeywood F, Morrow P, & Reeve C, *The Town Recorder, A History of Bungay in Photographs* (Bungay, 1994) p104.*

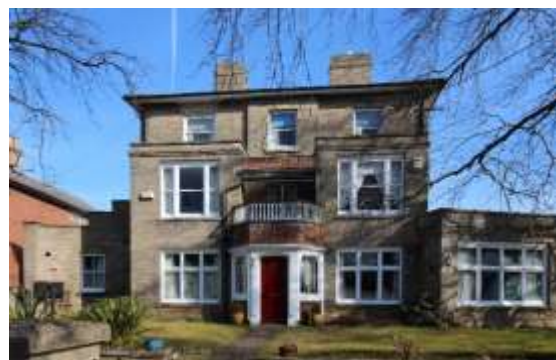
*No.67 Lower Olland Street*

*No.67 Lower Olland Street. A detached mid to late nineteenth century gault brick villa with considerable later alterations and additions. Standing at the corner of Wingfield Street. Central block of three storeys and three bays with a hipped Welsh slate roof. Central breakfront. Third floor with plate-glass sashes beneath flat-arched lintels. Two storey bay windows with parapets to outer bays. Later canted entrance porch of red brick with a wooden balustrade. Single storey c1900 addition with casement window to south. To north a lean-to range disguised by a gault brick wall with a stepped parapet and plate-glass sash to the street. Poor quality flat roofed and slate roofed single storey late twentieth century additions to south and rear. *Subsidiary Structures.* Good nineteenth century boundary wall to Wingfield Street of tarred cobble with red brick dressings containing ER post box. Rebuilt gault brick wall to Lower Olland Street with square-section piers.*

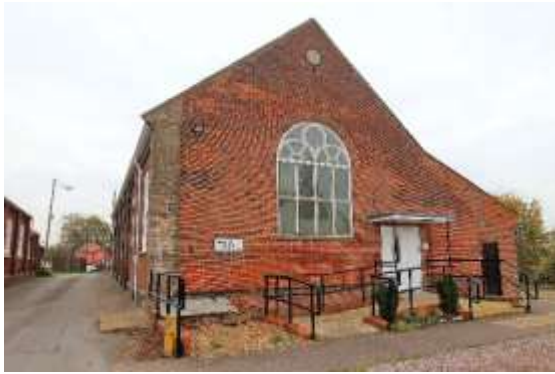
*Former Sunday School, Rose Lane*

*Former Sunday School and lecture Hall, Rose Lane . Sunday School associated with Upper Olland Street Congregational Church built. 1867-69 to the designs of R.M. Marsden for Charles Stokes Carey. Red brick with gault brick dressings and pilasters. Traceried window in north gable and Twentieth century doorway. Return elevations with twelve-light hornless sashes and gault brick pilasters. Black pan tiled roof. Rear addition with wooden glazed roof and leaded coloured lights. Lecture rooms to rear of c1898 designed by JO Rees. Red brick with stone dressings. A prominently located structure at the junction with Rose Lane. Bettley, J, and Pevsner, N, *The Buildings of England, Suffolk: East* (London, 2015) p.151. Honeywood F, Morrow P, & Reeve C, *The Town Recorder, A History of Bungay in Photographs* (Bungay, 1994) p15 & p23.*

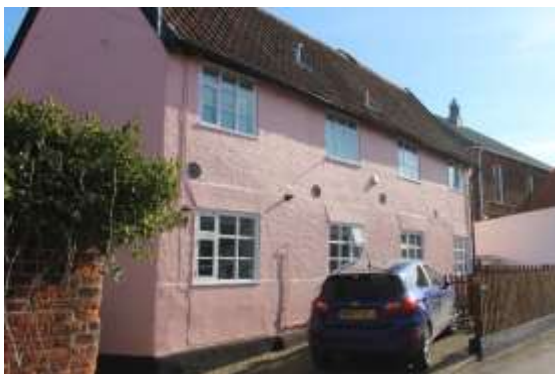
*Nos.5 & 9 Rose Lane*

*Nos. 5 & 9 Rose Lane. A pair of cottages of late eighteenth century date, which are now a single dwelling. Painted red brick with mullioned and transomed casement windows and a red pan tiled roof. Ground floor windows have rendered flat-arched lintels. Blocked doorway. Rendered northern return elevation. Substantial rendered rear range with a red pan tiled roof with a red brick ridge stack and single storey lean-tos.*

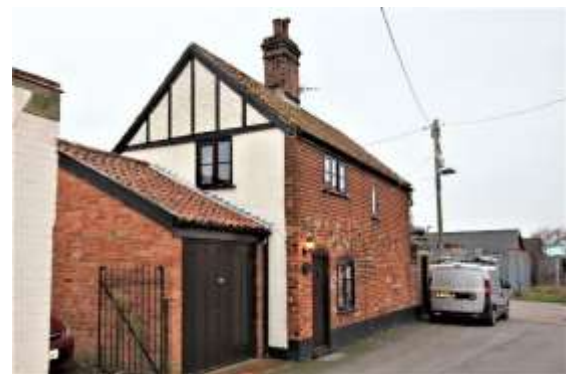
*The Bakery, Rose Lane*

*The Bakery, Rose Lane. A former semi-detached pair of cottages now converted to a single dwelling. Early nineteenth century. Red brick with a red pan tile roof. Rendered return elevation with twentieth century decorative half-timbering to gable. Casement windows and boarded door. The ground floor door and window openings to the right-hand property have been blocked but are still readable. Late twentieth century garage.*

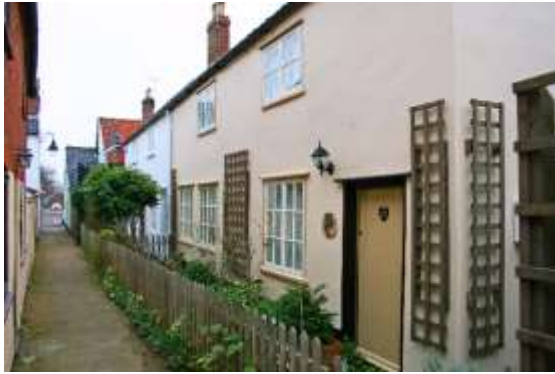
*Nos.7 9 (Odd) Turnstile Lane*

*Nos.7-9 (Odd) Turnstile Lane.* A terrace of four probably early nineteenth century cottages which were converted to two in the late twentieth century. Rendered façades with twelve-light casement windows and boarded doors. Red pan tiled roof, red brick ridge stacks.

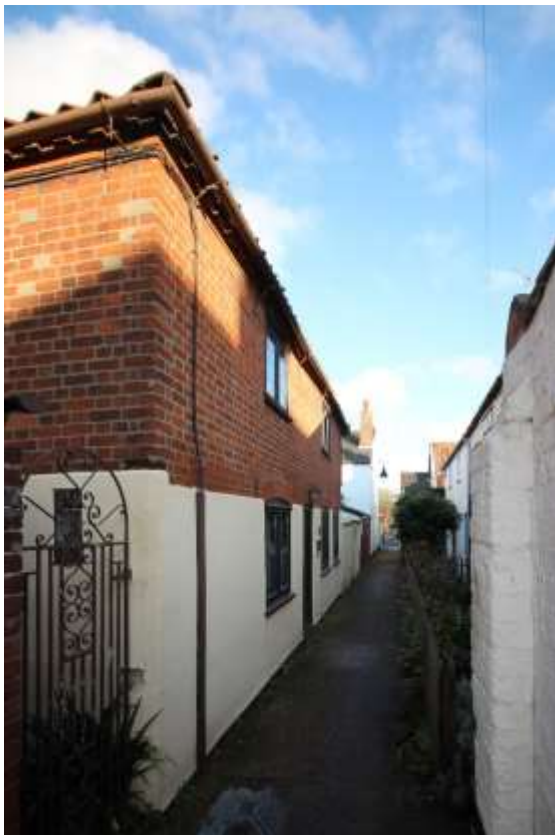
*Nos.8 & 10 Turnstile Lane*

*Nos.8 & 10 Turnstile Lane.* The remaining section of what was once a courtyard of probably eight early nineteenth century dwellings. The surviving range appears now to form two houses but was probably originally four. Red brick, now partially rendered and with a red pan tiled roof. Dentilled brick eaves cornice. The remaining four cottages were demolished in the mid twentieth century.

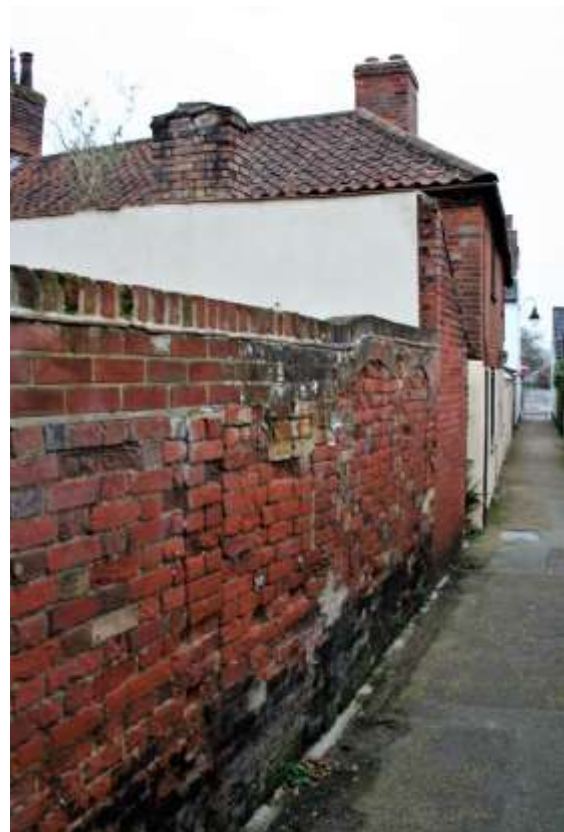
*Wall to west of No.8*

*Outbuilding and Wall to west of No.8.* Red brick boundary wall on the north side of Turnstile Lane, incorporating the remains of a partially demolished former cottage. Probably of early nineteenth century date. The structure was partially demolished after the publication of the 1970 Ordnance Survey map.

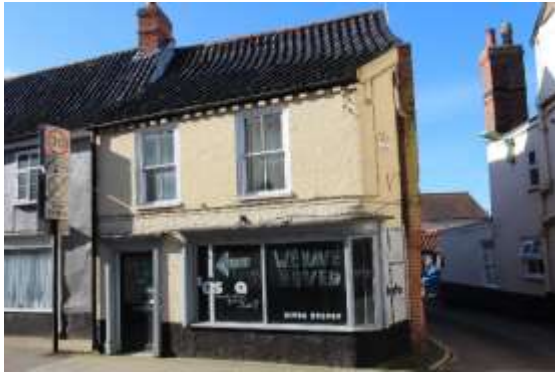
*No.2 Upper Olland Street* (grade II). A seventeenth century structure with a nineteenth century façade of painted brick. Standing on the southern corner of Quaves Lane. Black pan tiled roof, dentilled eaves cornice, red brick chimney stack. First floor windows now plate-glass hornless sashes. Early nineteenth century wooden doorcase and shop fascia with pilasters and delicate entablature. Nos.2 to 10 (even), 14, 16 and Nos.20 to 24 (even) form a group. Honeywood F, Morrow P, & Reeve C, *The Town Recorder, A History of Bungay in Photographs* (Bungay, 1994) p185.

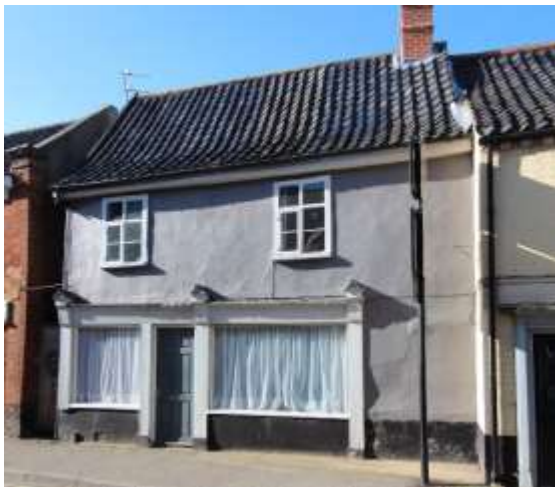
*No.4 Upper Olland Street* (grade II). Eighteenth century, of two storeys with a painted stucco façade. Two flush framed mullioned and transomed casements at first floor level. The shop fascia is not of nineteenth century date as suggested in the listing as it does not correspond to that in c1900 photographs. Six-panelled door. Black pan tiled roof. Nos.2 to 10 to late-(even), No.14, 16 and Nos.20 to 24 (even) form a group. Honeywood F, Morrow P, & Reeve C, *The Town Recorder, A History of Bungay in Photographs* (Bungay, 1994) p185.

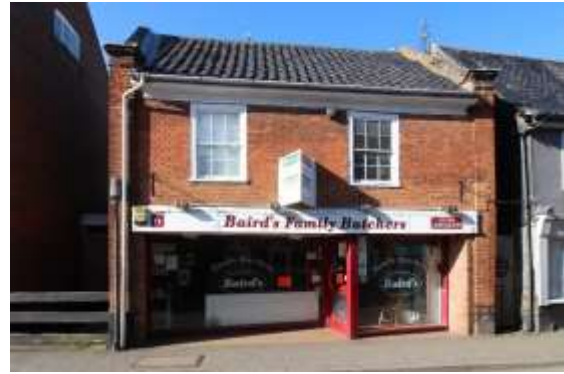
*No.6 Upper Olland Street* (grade II). Early eighteenth century, two storey, red brick. Black pan tiled roof, tumbled gables, and a coved cornice. Full height corner pilasters with moulded caps. Two bay street façade with hornless twelve-light sash windows to the first floor within flush frames. Late twentieth century shop front. Nos.2 to 10 (even) Nos.14, 16 and Nos.20 to 24 (even) form a group

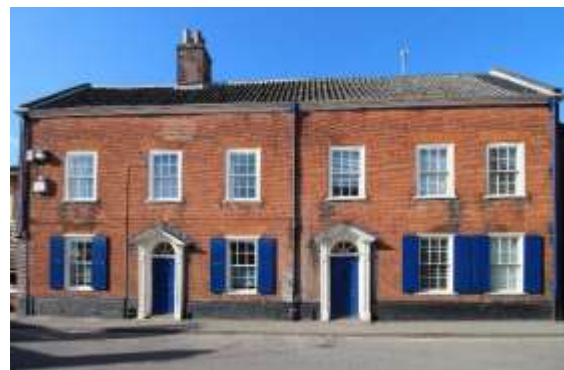
*Nos.8-10 (even) Upper Olland Street* (grade II). A pair of eighteenth-century houses of two storeys, faced in red brick with a tarred plinth. Black pan tiled roof. Each house of three bays with three hornless twelve-light sashes to the first floor. Flush frames and flat arched lintels. Panelled shutters to ground floor hornless sash windows. Two, six-panelled doors within wooden cases with arched radial-bar fanlights, panelled pilasters, and dentilled open pediments. Nos.2 to 19 (even), 14, 16 and Nos.20 to 24 (even) form a group.

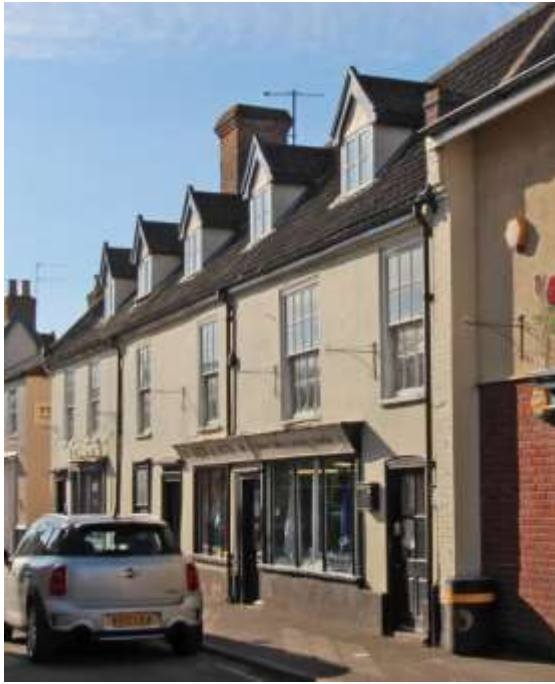
*Nos.14-16 (even) Upper Olland Street*

*Nos.14-16 (even) Upper Olland Street (grade II).* An early eighteenth century block of two storeys and an attic. Five identical gabled dormers with bargeboards and casement windows. Six-bay façade of painted stucco over a plinth; red pan tiled roof. Twelve-light hornless sashes within flush frames at first floor level. No.14, six-panelled door in wooden case with pilasters, mid-twentieth century wooden shop front right. No.16, small early nineteenth century shop window with cornice. Nos.2 to 10 (even), 14, 16, and Nos.20 to 24 (even) form a group.

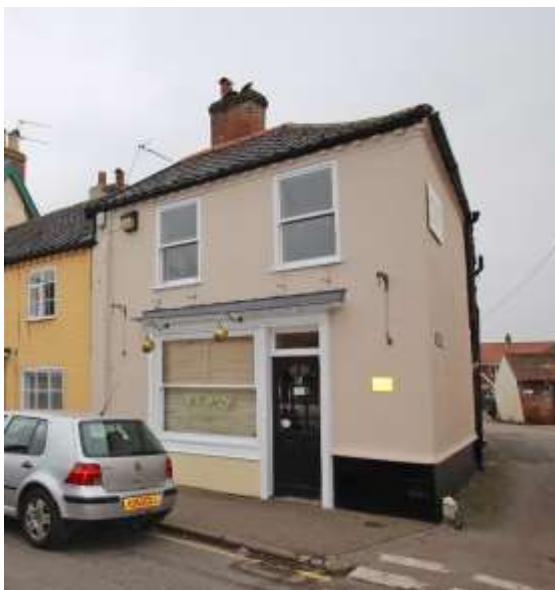
*No.18 Upper Olland Street*

*No.18 Upper Olland Street.* A mid nineteenth century shop on the southern corner of Rose Lane. Rendered and painted red brick with a black pan tiled roof. Dentilled eaves cornice, plinth. Upper Olland Street façade has a nineteenth century shop facia with reeded pilasters, containing a late twentieth century partially glazed door. Plate glass sashes with horns above. Rose Lane elevation with twentieth century casement windows. Rear gable also visible from Rose Lane, this has a canted bay window at ground floor level.

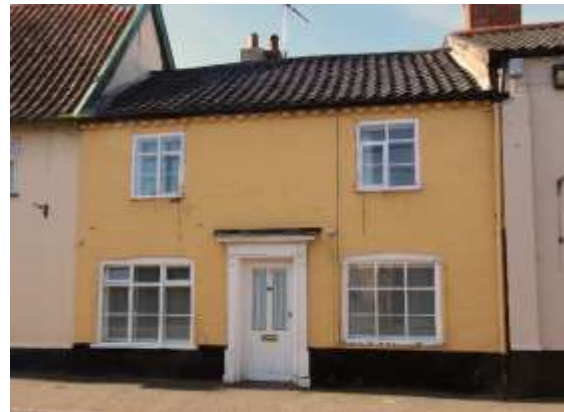
*No.20 Upper Olland Street*

*No.20 Upper Olland Street (grade II).* Eighteenth century with a two storey, three bay symmetrical façade of painted brick. Black pan tiled roof. Dentilled brick eaves cornice. Two flush casements at first floor level. Central doorcase with pilasters and a dentilled cornice. Partially glazed four-panelled door flanked by two six-light casements beneath cambered brick arches. The left-hand casement is slightly wider than its lintel and replaces a late nineteenth century pub facia. Formerly the Greyhound Inn (closed 1913). Honeywood F, Reeve C, & Reeve T, *The Town Recorder, Five Centuries of Bungay at Play* (Bungay, 2008) p99 % 154.

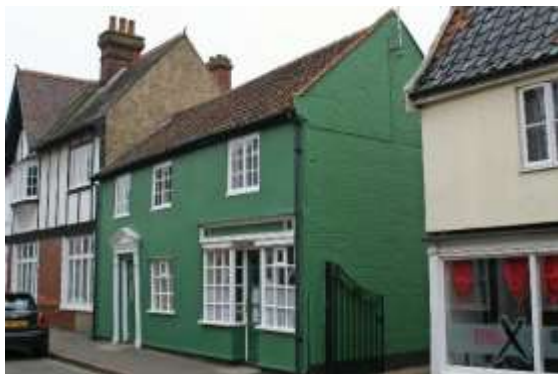
*No.26 Upper Olland Street*

*No.26 Upper Olland Street.* Probably of early nineteenth century date but much altered. Painted and rendered red brick. Red pan tiled roof. Three small pane casement windows to first floor. Late twentieth century pedimented doorcase and shop fascia. Whilst much of the external joinery has been replaced the openings correspond to those shown on early twentieth century photographs. The building has significant group value with neighbouring properties.

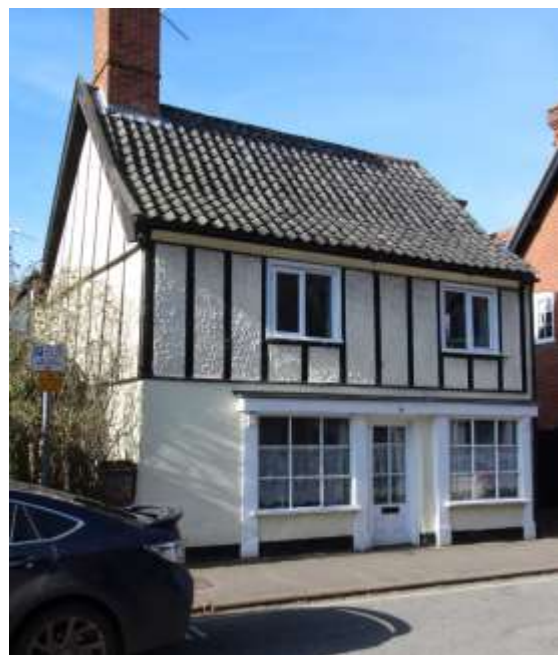
*No.30 Upper Olland Street*

*No.30 Upper Olland Street (grade II).* Seventeenth century, of two storeys and an attic, stucco, with

applied half-timbering, steeply pitched black pan tiled roof, cove cornice, two late twentieth century casements at first floor level. The ground floor detailing recorded in the statutory list has now gone including the doorcase, shop fascia and casement window. Late twentieth century shop fascia. Thin red brick at base of chimney shaft. Twin gabled northern return elevation. Early casement within front gable. Nos.30 to 34 (even), Emmanuel church and Nos.38 to 52 (even) form a group.

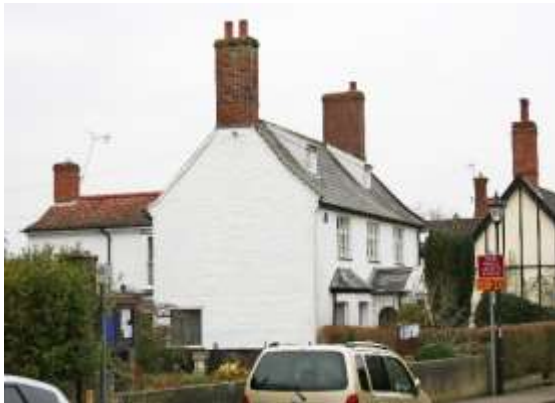
*White House, No.32 Upper Olland Street* (grade II). A detached late eighteenth century house with later nineteenth century alterations. Until c1885 the manse for the adjoining Congregational Chapel. Altered and extended for William Methuen late nineteenth century. Of two storeys with an attic lit by two casement dormers. Steeply pitched Welsh slate roof, tall red brick chimney stacks with drip bands to gables. Painted red brick with a stuccoed symmetrical three bay façade. Three mullioned and transomed casements at first floor level. Nineteenth century canted bays at ground floor level flanking a six-panelled door reset within a later nineteenth century wooden gabled porch with pilasters. Single storey wing to north. Pan tiled roof slope at rear. Nos.30 to 34 (even), Emmanuel church and Nos.38 to 52 (even) form a group. Honeywood F, Morrow P, & Reeve C, *The Town Recorder, A History of Bungay in Photographs* (Bungay, 1994) p24.

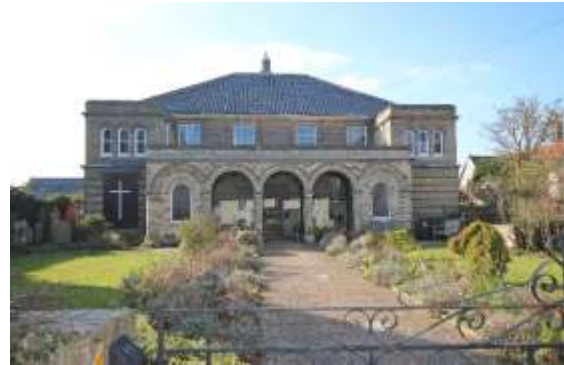
*Emmanuel Church, Upper Olland Street* (grade II). Former Congregational Church now joint Methodist and United Reformed Church. Façade to Rose Lane at rear. C1818 perhaps incorporating parts of an earlier structure of C1699. Altered 1867-69 by R.M. Marsden. Façade altered, and stair turrets added to the designs of Edward Boardman c1885 when the interior was also altered. Sunday School enlarged 1914. Façade moved forward c1979, and additions of 1990. Restrained classical Suffolk white brick façade of 1818 with Italianate embellishments by Boardman including an octagonal columned loggia, and flanking turrets. Hipped, pan tiled roof, with wide eaves supported on coupled brackets. Four possibly early nineteenth century twelve-light hornless sashes, and flat arched lintels at first floor level. Arched plate-glass sashes to stair turrets. Stained and leaded glass at ground floor level. Red brick return elevations visible from Rose Lane. Single storey gothic rear range of 1914 with traceried window in end gable. *Subsidiary Structures* Low gault brick wall to Upper Olland street, for flanking wall to south see No.34. Good monuments including table tombs. Headstones primarily relocated to churchyard border and burial ground re-landscaped as garden. Nos.30 to 34 (even), Emmanuel church and Nos.38 to 52 (even) form a group. Bettley, J, and Pevsner, N, *The Buildings of England, Suffolk: East* (London, 2015) p.151. Honeywood F, Morrow P, & Reeve C, *The Town Recorder, A History of Bungay in Photographs* (Bungay, 1994) p15 & p23. Stell, Christopher, *Chapels and Meeting Houses in Eastern England* (London, 2002) p281.

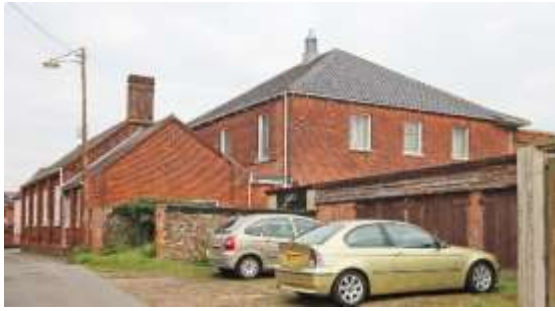
*Rose Lane elevation of Emmanuel Church.*

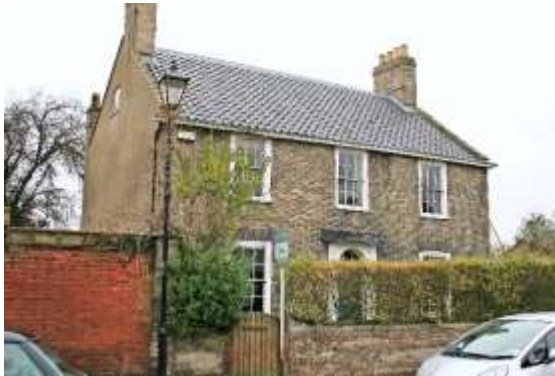
*No.34 Upper Olland Street* (grade II). An early nineteenth century detached villa with a symmetrical classical entrance façade of three bays. Of two storeys with attics lit from within the gabled return elevations. Suffolk white brick façade with a mutular cornice, and a black pan tiled roof. Rear elevation red brick, side elevations rendered. Three twelve-light hornless sashes within flush frames at first floor level. Two further twelve-light sashes with flat arched lintels flanking the doorcase. Six-panelled entrance door with arched patterned fanlight in an enriched wooden case. Northern return elevation highly visible from chapel graveyard. Rear elevation with nineteenth century casements beneath cambered lintels. *Subsidiary Structures* Screen walls to the left and right at a right-angle, each seven feet high with a stone cope, with a side door and blank panel respectively, square section piers. Low brick wall to front. Nos.30 to 34 (even), Emmanuel church and Nos.38 to 52 (even) form a group.

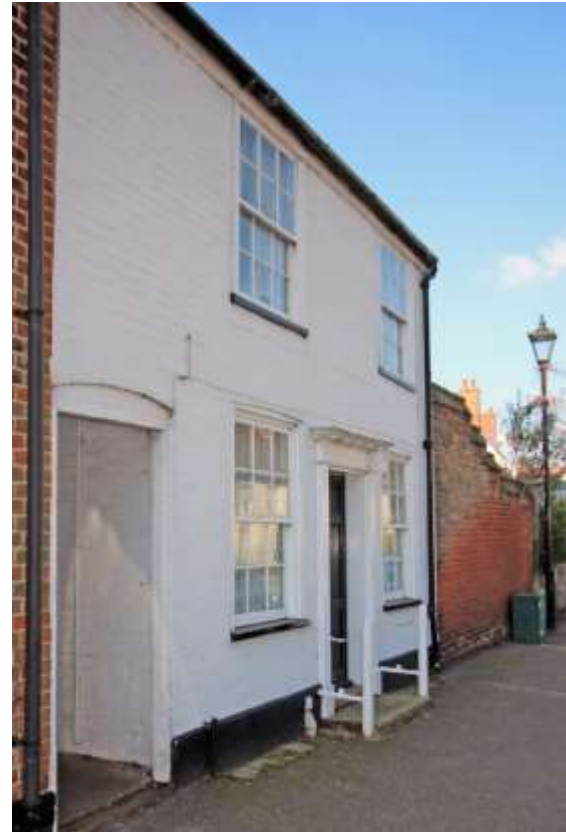
*No.38 Upper Olland Street* (grade II). Eighteenth century, of two storeys and an attic. Limewashed brick with a black pan-tiled roof. Two hornless, flush-framed twelve-light sash windows to each floor, cambered arched lintels to ground floor openings. Six-panelled door in wooden case with roundels and a mutular cornice. Nos.30 to 34 (even), Emmanuel church and Nos.38 to 52 (even) form a group.

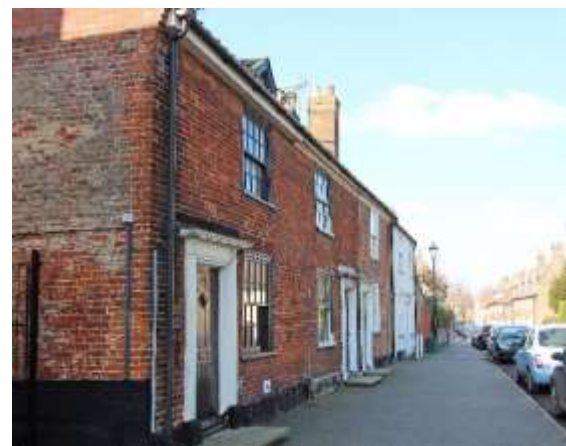
*Nos.40-44 (even) Upper Olland Street* (grade II). A row of three, eighteenth century cottages. Two storeys, Nos.42 & 44 having attics lit by gabled

dormers. Red brick with a plinth, black pan tiled roof. Nos.42 & 44 retain early sixteen-light hornless sashes. No. 40 now has plate glass sashes. Flat arched lintels to ground floor. Six-panelled doors in wooden cases with roundels and mutular cornices. Nos.30 to 34 (even), Emmanuel church and Nos.38 to 52 (even) form a group.

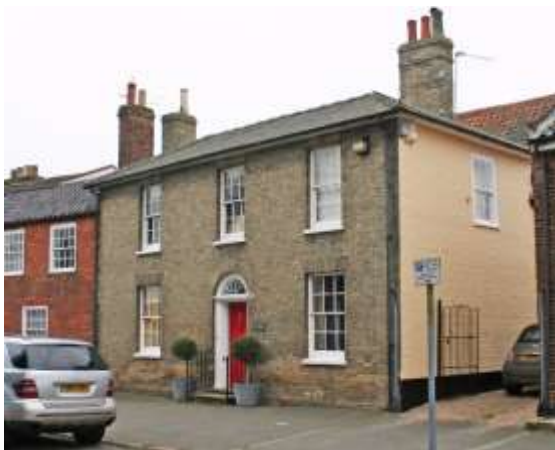
*The Old Maltings, No.46 Upper Olland Street* (grade II). An eighteenth century house with a symmetrical early nineteenth century Suffolk white brick façade. Two storeys and three bays with a hipped Welsh slate roof and projecting eaves. White brick chimney stacks. Twelve-light hornless sashes with flat arched lintels. Six-panelled front door with Greek fluted Doric one quarter radius columns to the reveals, below an arched radial-bar fanlight. Return elevation of painted red brick with a single flush framed sash window to the first floor. Pan tiled portion at rear. Nos.30 to 34 (even), Emmanuel church and Nos.38 to 52 (even) form a group.

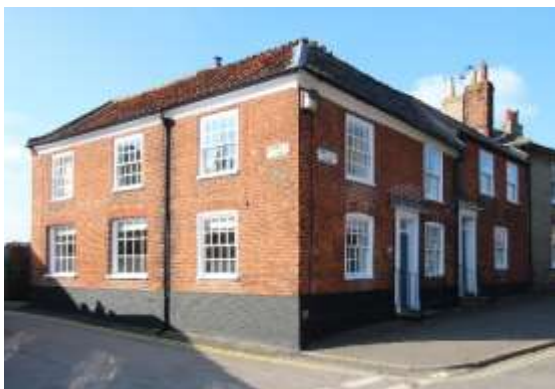
*Nos.48 & 50 Upper Olland Street*

*No.48 Upper Olland Street* (grade II). Eighteenth century red brick house of two storeys. Corbelled eaves and a black pan tiled roof. Two sixteen-light hornless sash windows in flush frames to the first

floor. Single sixteen-light sash with a flat arched lintel to ground floor. Six-panelled door in wood case with fluted pilasters and patterned fanlight. Nos.30 to 34 (even), Emmanuel church and Nos.38 to 52 (even) form a group.

*No.50 Upper Olland Street* (grade II). Early eighteenth century, of two storeys, red brick, with a plinth. On the corner of Boyscott Lane. Black pan tiled roof covering to Upper Olland Street, red to Boyscott Lane. Upper Olland Street façade of three bays with a coved cornice. 2 windows, flush frame sash, with glazing bars, segmental arches at ground floor. Four-panelled door in wood case-with fanlight and fluted pilasters. Three bay return elevation with a hipped roof. Segmental arched lintels to sash windows. Central ground floor window a larger casement. Largely blind rear gable. Nos.30 to 34 (even), Emmanuel church and Nos.38 to 52 (even) form a group.
