#### Appendix 4: Structures that make a positive contribution to the Conservation Area

The character and appearance of the Conservation Area are shaped by the structures and spaces within it. This appendix contains a list of the built structures which have been identified as making a positive contribution to the Conservation Area (as per section 4. *Positive Contributors* of the CAAMP). The list contains designated as well as undesignated structures. The list is illustrated on maps in the CAAMP.

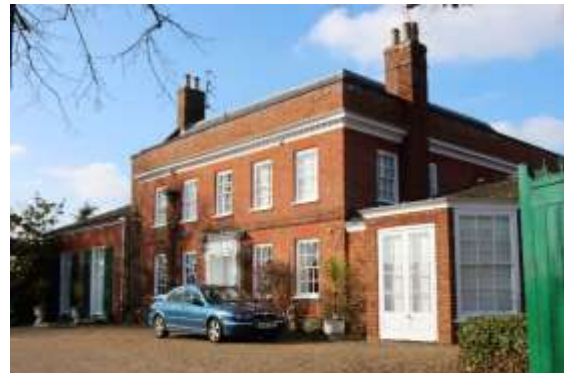
*Rose Hall, No.52 Upper Olland Street* (grade II\*). A late sixteenth century timber-framed house which was re-cased in red brick c1739. Early nineteenth century wing, to the right of a single storey. Main block of two storeys and an attic, two dormer lights. Hipped Welsh slate roof partially hidden behind a parapet. Moulded cornice. Five-bay façade with sash windows within exposed frames, and flat arches, centre window Venetian. Eight-panelled door within a wooden case with panelled reveals, fluted Doric pilasters, triglyphs, and a cornice with fret ornament. At one time the residence of the family of Captain Boycott, the let victim of the Irish Land Leaguers method of attack by isolation, from which the word "boycott" arose. Nos.30 to 34 (even), Emmanuel church and Nos.38 to 52 (even) form a group. Bettley, J, and Pevsner, N, *The Buildings of England, Suffolk: East* (London, 2015) p.158.

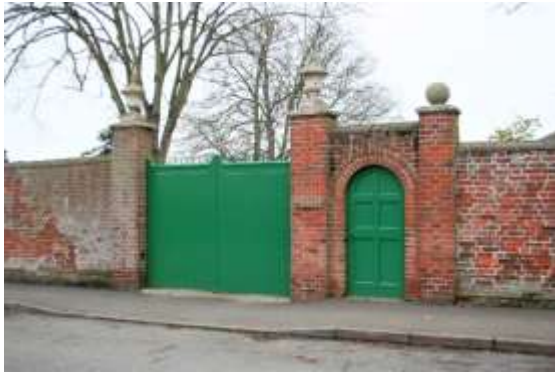
*Front Wall of garden to Rose Hall*

*Front Wall of garden to Rose Hall, No.52 Upper Olland Street (grade II). A later eighteenth century, 7 ft high wall of red brick, with a moulded cope of terra cotta rising to 10 ft on return, with tall square brick piers, one with stone ball on cap, and a pair of stone gadrooned vases on caps, north. Nos.30 to 34 (even), Emmanuel Church and Nos.38 to 52 (even) form a group.*

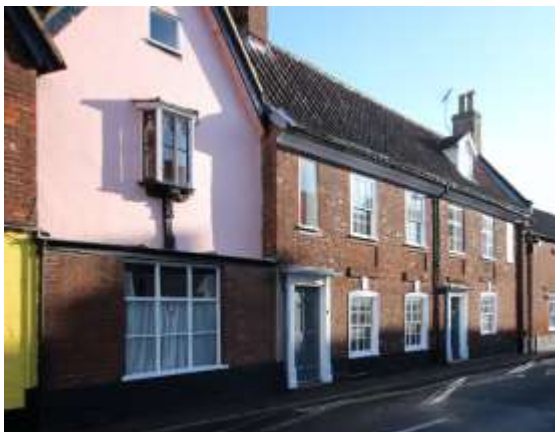
*No.1 & No.3 Upper Olland Street*

*Ashby House, No.1 & Nos.3 & 3a Upper Olland Street, (grade II) Early eighteenth century, of two storeys and an attic. One gabled dormer to No.3a. No.1 has a gabled end bay which is partially rendered. Eighteenth century of two storeys and an attic, one gabled dormer and gabled section to left. No.1 incorporates an older timber-framed structure of which one fully-moulded beamed and joisted ceiling remains in an excellent state of preservation. Gabled section stuccoed. Remainder red brick, plaster core cornice. Black pan tiled roof. interrupted brick band below first floor windows. Four windows in flush frames (two sash and two mullion transom casements) at first floor level, also half window left and half panel right, segmental arches at ground floor with stucco keys. Two six-panelled doors, in wooden cases with pilasters,*

*roundels, and a mutular cornice. Interior: fine enriched early eighteenth century mantel and cupboard with enrichment and 1/4 domed head with shell ornament.*

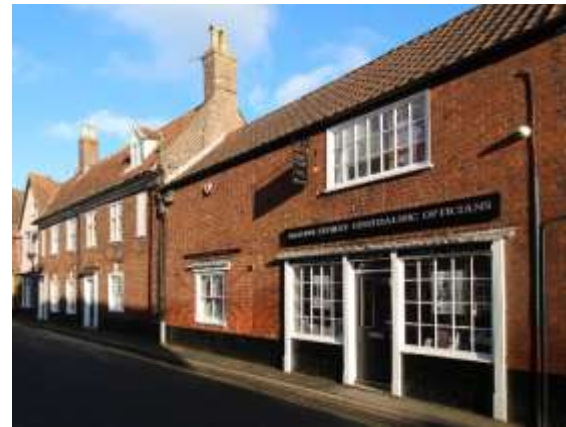
*Nos.1-3a (Odd) Upper Olland Street*

No.3a early nineteenth century, two storey, red brick, shallow pitched red pan tiled roof. Flush Small pane casement at first floor level. Ground floor, flush frame sash, left, and shop front with glazing bars and wood case with channelled pilasters. Nos.1, 3, & 3a form a group with No.2 Lower Olland Street and No.56 St Mary's Street.

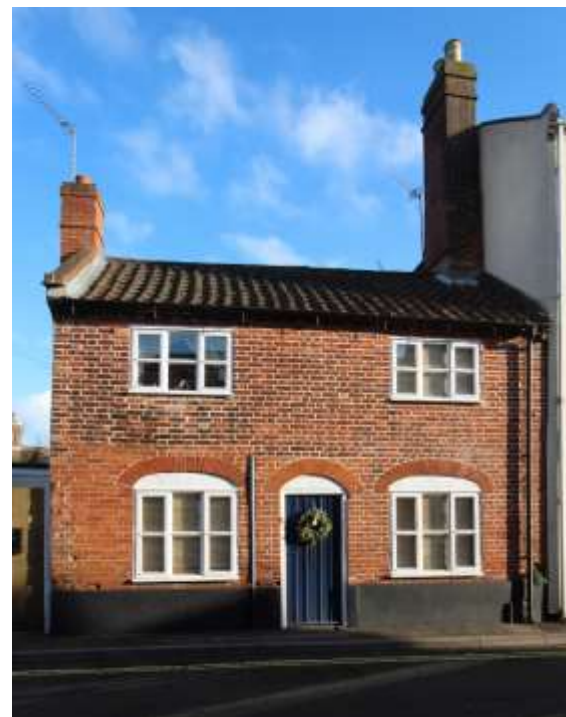
*No.5 Upper Olland Street*

*No.5 Upper Olland Street. A late eighteenth or early nineteenth century cottage of two storeys and three bays. Red brick, with a red pan tiled roof and a plinth. Boarded door and twentieth century casement windows within original openings.*

Ground floor openings beneath segmental arched lintels. Large chimneystack to right-hand gable. Small rebuilt stack to left-hand gable.

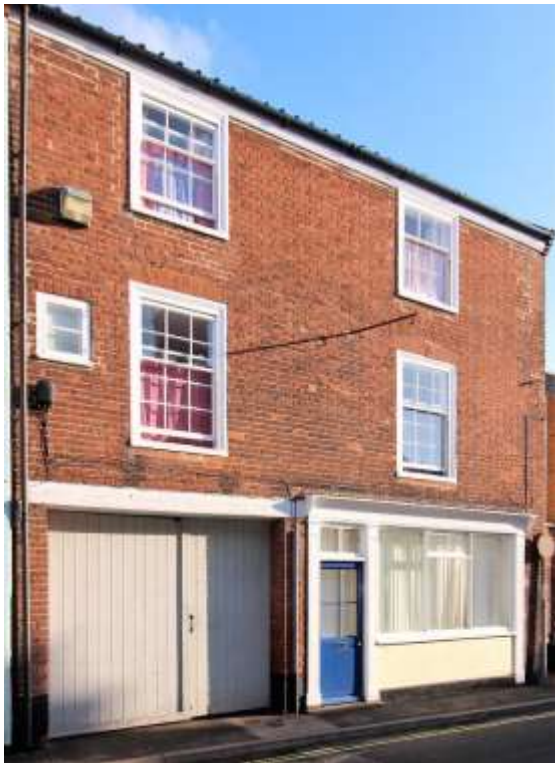
*No.11 Upper Olland Street*

*No.11 Upper Olland Street.* A former public house now converted to flats. Probably of early nineteenth century date. In use as The Queen Public House in the nineteenth and early twentieth centuries. Red brick. Twelve-light hornless sash windows to first floor in flush frames with flat-arched lintels. Nine-light hornless sashes to second floor. Small inserted late twentieth century casement at first floor level. Large yard opening with boarded door to ground floor and a later nineteenth century public house fascia with panelled pilasters. Return elevation to Turnstile Lane partially rendered. Two storey rear wing with casement windows. Honeywood F, Reeve C, & Reeve T, *The Town Recorder, Five Centuries of Bungay at Play* (Bungay, 2008) p152-153.

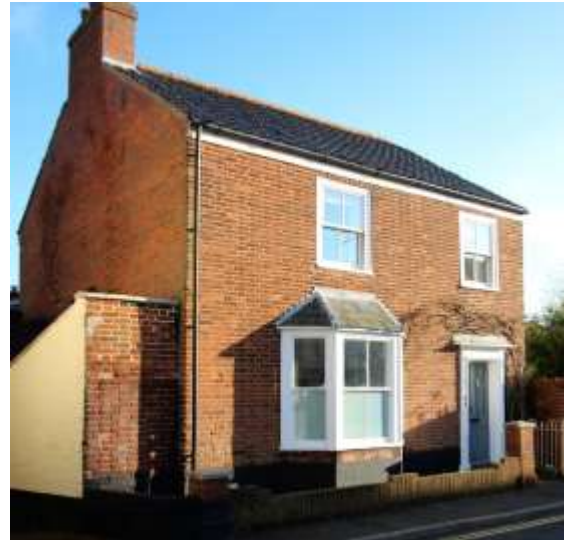
*No.13 Upper Olland Street*

*No.13 Upper Olland Street.* Detached villa of later nineteenth century date. Red brick with a black pan tiled roof. Two bay two storey façade with four pane plate-glass sashes to the first floor. Cantled bay window to ground floor and partially glazed front door within doorcase with pilasters.

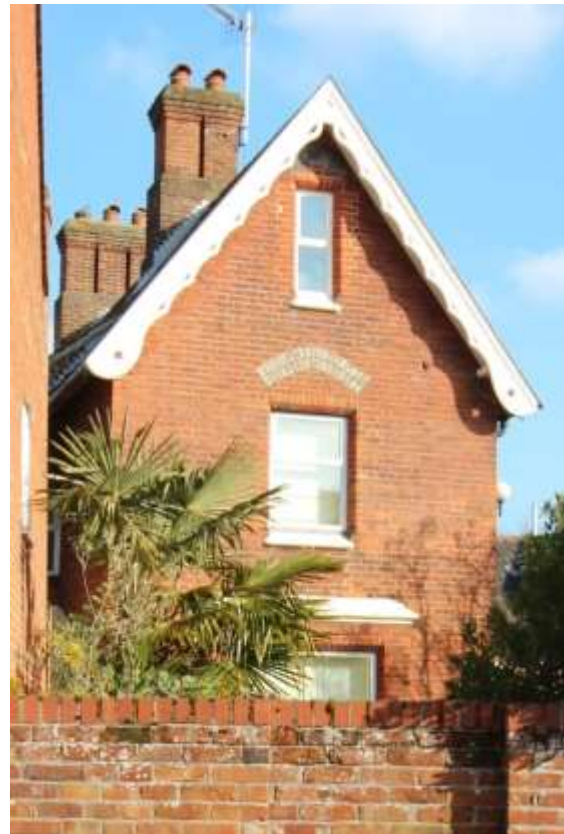
*No.15 Upper Olland Street*

*No.15 Upper Olland Street.* A later nineteenth century detached villa of red brick with white brick dressings. Restrained gothic style with pierced decorative bargeboards. Substantial decorative red

brick chimneystacks with paired flues. Canted bay window to Upper Olland Street façade. Black pan tiled roof with large twentieth century dormer in southern elevation. Most external joinery replaced.

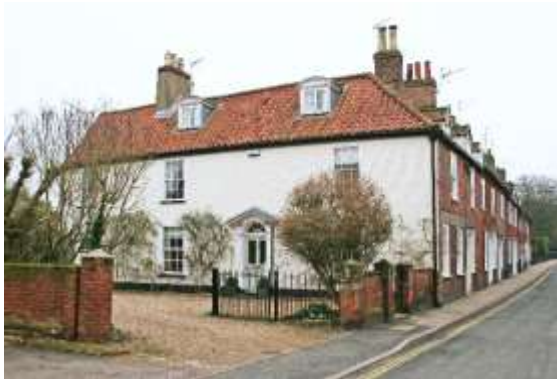
*Nos.21 & 23 Upper Olland Street* (grade II) Eighteenth century double fronted structure. No.21 having its entrance in the north elevation. No.21 rendered with a pedimented doorcase and semi-circular radial fanlight. Partially glazed four-panelled door. Two dormers with shallow curved pediments and casement windows. Hornless twelve-light sashes. No.23 in the western or Upper Olland Street elevation. Eighteenth century. No.23 of two storeys and an attic with a single gabled dormer. Red brick with a red pan tiled roof. A single flush framed hornless twelve-light sash to each floor and a six-panelled door within wooden case with a mutular cornice. Nos.21 to 37 (odd) form a group. *Subsidiary Structures* No.21 has early twentieth century red brick boundary walls to its garden with square section piers.

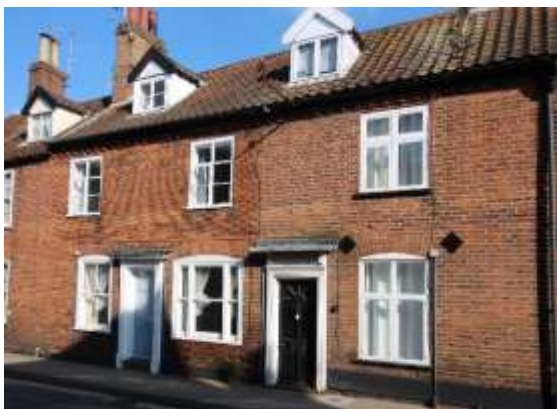
*Nos.25 & 25a Upper Olland Street* (grade II) Pair of attached houses. Eighteenth century of Flemish bond red brick. Black pan tiled roof with brick modillion eaves, two-storeys and an attic. Three casements in flush frames at first floor level. Mainly sashes in flush frames at ground floor, with

cambered arches. No 25A has a wood reeded doorcase with roundels and a six-panelled door. No.25 to the right has a reeded doorcase with roundels and enriched canopy, and a twentieth century panelled door. Two gabled dormers. Formerly the Red Lion Public House. Honeywood F, Reeve C, & Reeve T, *The Town Recorder, Five Centuries of Bungay at Play* (Bungay, 2008) p155.

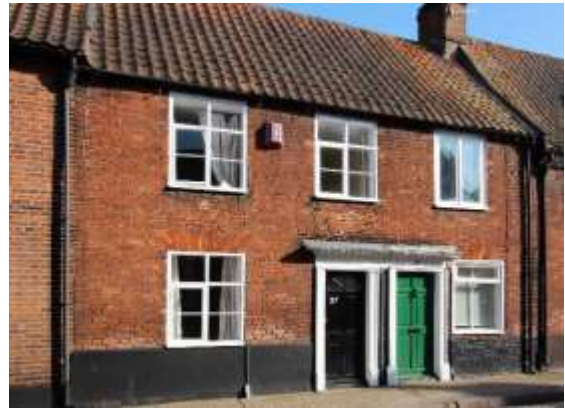
*Nos.27 & 29 Upper Olland Street* (grade II) Eighteenth century pair of cottages of two storeys and an attic. Red brick with a red pan tiled roof. Three-bay façade, with paired front doors to the centre under one enriched cornice. Late twentieth century panelled front doors. Nineteenth century casements to No.27, late twentieth century ones to No.29. Nos.21 to 37 (odd) form a group

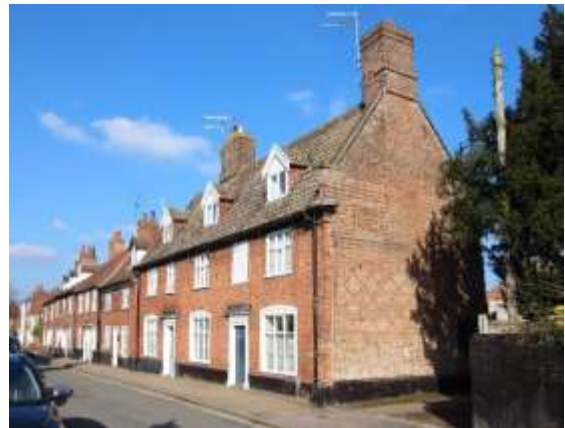
*No.31-35 (Odd) Upper Olland Street* (grade II) Of early seventeenth century date but with an eighteenth century red brick façade of two storeys. Attic lit by four gabled dormers with bargeboards, red pan tiled roof and a coved plaster cornice. No.31 with a symmetrical three bay façade. Central four-panelled door with a blind panel above. Casement windows of probably early nineteenth century date to first floor and ground floor left.

Brick pilasters with moulded caps and bases. Brick lozenge pattern on end wall, and two earlier window openings filled in. Letters RR in wrought iron ties on gable. Eight bay façade with two blank panels, and six casements in flush frames, ground floor windows with segmental arches. No.31, four-panelled door. Nos.33 and 35, 6-panel doors in wood cases. Nos.21 to 37 (odd) form a group.

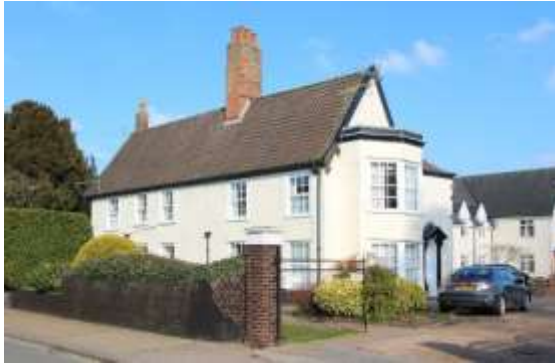
*The Old Vicarage, No.37 Upper Olland Street* (grade II) A substantial multi-phase dwelling with an early seventeenth century range at the rear, and an eighteenth-century front portion. Earlier part of two storeys and attic, timber-framed, with some original doors. Tiles and pan tiles to roof, and on the end gable the initials WAS in wrought iron ties. Front portion, of two storeys and an attic. Brick, and stucco, with a painted plinth. Five hornless twelve-light sash windows to each floor within flush frames. Two storey sashed canted bay window to the southern façade and a six-panelled door with an arched radial bar fanlight. Wooden doorcase with panelled pilasters, consoles, and dentil open pediment. Nos.21 to 37 (odd) form a group.

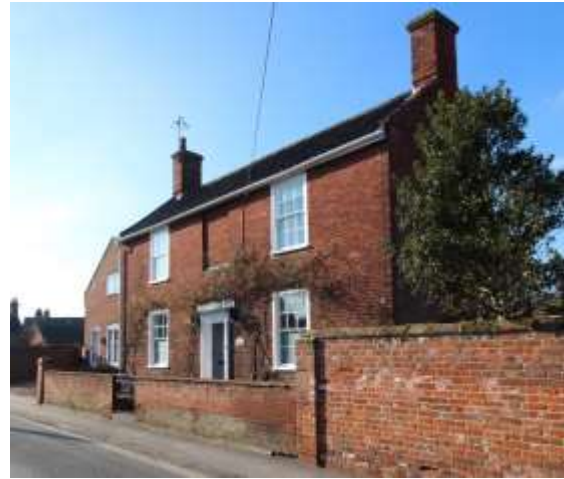
*No.9 Wharton Street*

*The Hollyhocks No.9 Wharton Street and Garden Wall.* A two-storey red brick house of c1820 with a black pan tiled roof. Symmetrical three bay façade with a blind recess above the doorcase. Six-panelled front door. Twelve-light hornless sashes in flush frames. Gabled return elevations largely blind. Low red brick garden wall with taller return section.

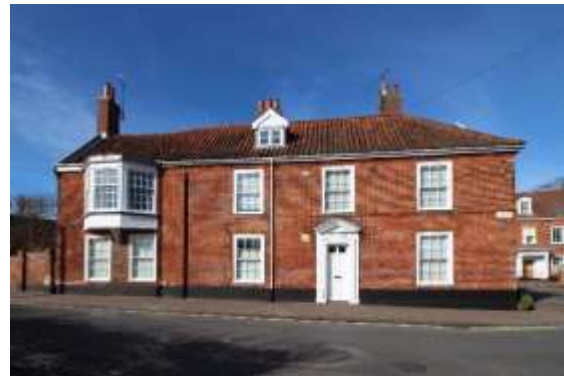
*Nos.11 and 11a Wharton Street*

*Nos.11 & 11a Wharton Street* (grade II). Eighteenth century, two storeys, red brick, with a red pan tiled roof. Formerly one house. No.11 has a three-bay façade with late twentieth century twelve-light hornless sashes within flush frames (mid twentieth century photographs show the house with plate-glass sashes). Flat-arched lintels to ground floor windows. Six-panelled front door, within a pedimented doorcase with an architrave and pronounced multiple keystones. East front is No.18 Trinity Street, qv. No.11a, of L-plan, two storeys with entrance in return elevation. Six-panelled door with an arched radial-bar fanlight. Canted first floor sashed bay, with beneath two twelve-light hornless sash windows within flush frames. These replace the ground floor section of the canted bay shown on c1900 photos. Nos.9, 11a and 11 form a group with Nos.14 to 18 (even) Trinity Street. *Subsidiary Structures* good nineteenth century red brick

garden wall to No.11a. Bettley, J, and Pevsner, N, *The Buildings of England, Suffolk: East* (London, 2015) p.157. Honeywood F, Morrow P & Reeve C, *The Town Recorder, A History of Bungay in Photographs* (Bungay, 1994) p109. Reeve C, *Bungay Through Time* (Stroud, 2009) p65.

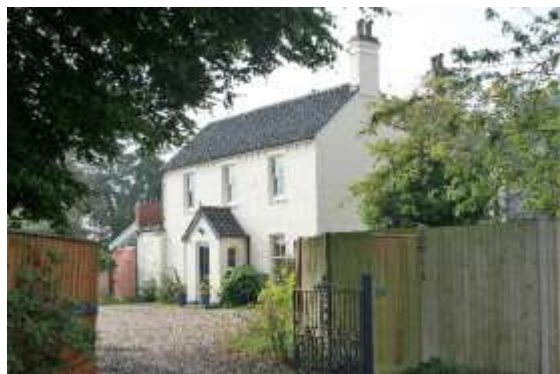
*No.14 Wharton Street*

*No.14 Wharton Street.* Painted brick villa of c1900. Not shown on the 1885 1:2,500 Ordnance Survey map. Black pan tiled roof. Symmetrical three bay, two storey entrance façade with a gabled brick porch and four-light plate glass sashes. Two storey rear wing.

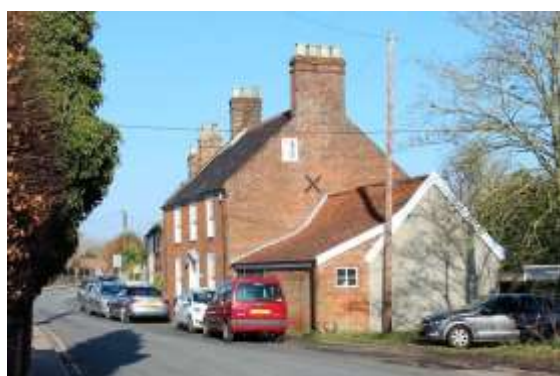
*Wingfield House, No.14 Wingfield Street* (grade II). Early nineteenth century, of two storeys with an attic, casement in gable with tumbled foot. Red brick, painted, band, chamfered toothed eaves cornice. Black pan tiled roof covering. Symmetrical three bay façade with twelve-light hornless sashes in flush frames. Segmental arched lintels to ground-floor windows. Six-panelled front door, with an arched radial bar fanlight. Wooden doorcase with panelled pilasters and a dentilled open pediment.

Nos.5 to 11 (odd) and No.14 form a group. *Subsidiary structures* Red brick cart shed now garage range with boarded doors attached to right. Single storey. Red pan tiled roof possibly a re-front of an earlier structure. Reeve C, *Bungay Through Time* (Stroud, 2009) p88.

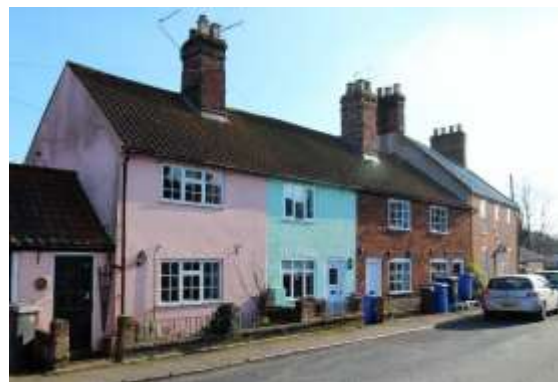
*Nos.16-20 (even) Wingfield Street*

*Nos.16-20 (even) Wingfield Street.* An early nineteenth century red brick terrace, which is now partially painted. Red pan tiled roof and dentilled brick eaves cornice. Casement windows, those to Nos.16 & 18 possibly original. Those to the ground floor beneath segmental arched lintels. Six-panelled doors to Nos.16 & 18. No.20 with a partially glazed door. A further house in the terrace No.22 has been heavily altered and is therefore not worthy of inclusion. Nos.16-20 contribute positively to the setting of the grade II No.14.

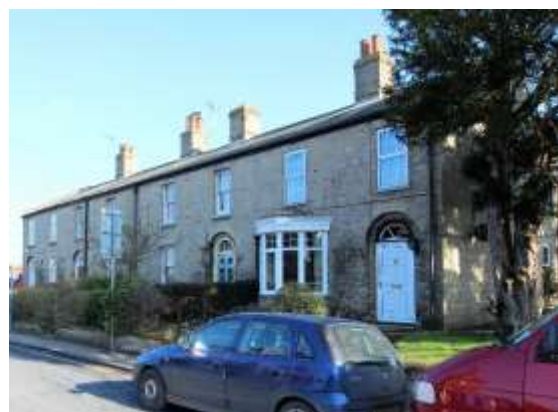
*Nos.38-44 (even) Wingfield Street*

*Prospect Place, Nos.38-44 (even) Wingfield Street.* Gault brick terrace of four houses. Two storeys, each house of two bays. Original hornless twelve-light sashes now only survive to No.42. Flat-arched lintels, stone sills. Front doors within shallow arched recesses, radial fanlights. Six-panelled doors now largely replaced. No.38 with late twentieth century canted bay window.

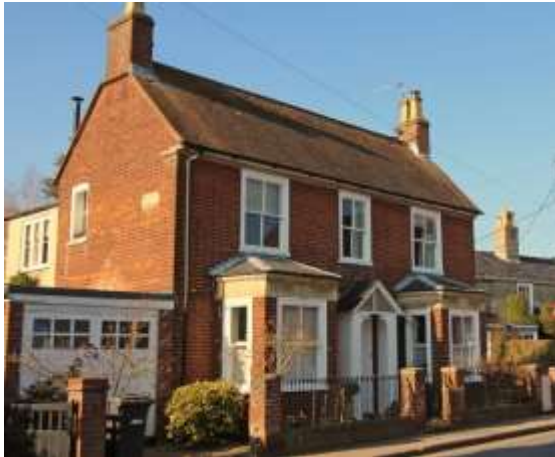
*No.3 Wingfield Street*

*No.3 Wingfield Street, outbuilding, and boundary wall.* A detached villa of c1900 with earlier outbuilding to rear. The outbuilding is shown on the 1885 1:2,500 map, the villa not till that of 1905. Villa red brick with stone dressings and a plain tile roof. Plate-glass sash windows in flush frames. Canted bay windows to ground floor with carved stone lintels to windows and keystones. Gabled wooden porch containing a six-panelled door. Subsidiary structures Attached red brick outbuilding with red pan tiled roof to rear, partially built over stone boundary wall. C1900 red brick dwarf wall and piers to front with decorative railings. Twentieth century flat-roofed garage addition not of significance.

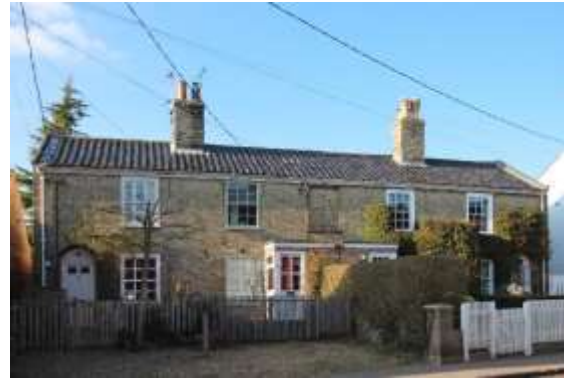
*Nos.5-11 (Odd) Wingfield Street* (grade II). An early nineteenth century two storey terrace. Suffolk yellow brick, black pan tiles. Central blind panel at first floor level flanked by twelve-light hornless sashes within flush frames, flat arches at ground floor. Six-panelled doors in solid frames, set back in reveals, with blank tympana and arches. Nos.5 to 11 (odd) and No.14 form a group.

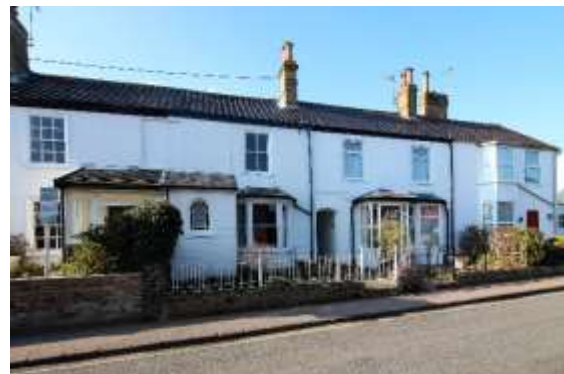
*Nos.13-19 (Odd) Wingfield Street*

*Nos.13-19 (Odd) Wingfield Street.* An early to mid-nineteenth century terrace of painted gault brick with a black pan tiled roof. Probably originally very similar to Nos.5-11. This terrace contributes significantly to the setting of neighbouring listed buildings. No.13 with twelve-light hornless sashes. No.15 with horned plate-glass sashes and Nos.17-19 with later twentieth century casements. Good nineteenth century porch to No.15 with arched window containing red glass margin lights. Late twentieth century porches to other houses not of interest. Subsidiary Structures Late twentieth century boundary walls and railings not of interest.

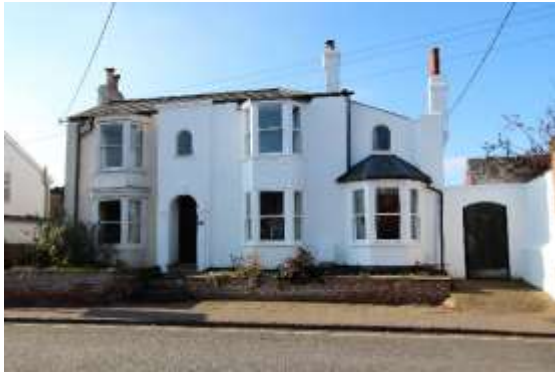
*Nos.21-23 (Odd) Wingfield Street*

*Nos.21-23 (Odd) Wingfield Street and wall.* A mid nineteenth century structure with the appearance, rendered brick with a Welsh slate roof. of once being a single villa, now two dwellings. No.21 retains much of its original appearance and has a canted bay with sash windows to Wingfield Street. The windows to No.23 have been replaced within the original openings. Central arched doorway with pronounced keystone within breakfront. *Subsidiary Structures* High nineteenth century painted brick wall with gate.

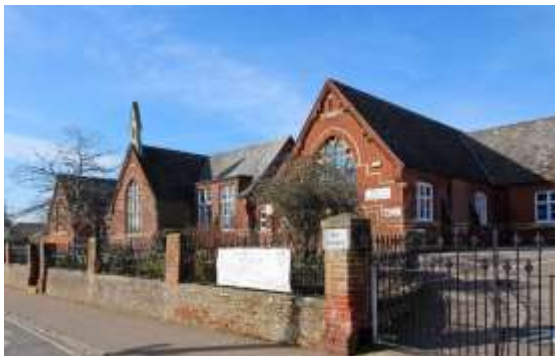
*Bungay Primary School, Wingfield Street*

*Bungay Primary School and boundary wall, Wingfield Street.* A former board school of 1876-77 designed by John Bond Pearce of Norwich. The builder was Robert Morris of Ditchingham. Enlarged c1889. An impressive gothic design of red brick with stone dressings. Welsh slate roof. Symmetrical principal façade with projecting gabled end and central bays. Each gabled section has a large three-pointed arched window with plate tracery. A decorative stone bellcote rises from the central gable apex. Linking range with tall wooden mullioned and transomed casement windows. *Subsidiary Structures* Boundary wall to Wingfield Street of red brick with stone capped square section piers. Decorative iron railings and gates, one pier retaining an early iron lantern. Return walls of red brick with stone cap. Corner piers with carved stone caps and finials. Brown, Hayward, and Kindred, *Dictionary of Architects of Suffolk Buildings 1800-*

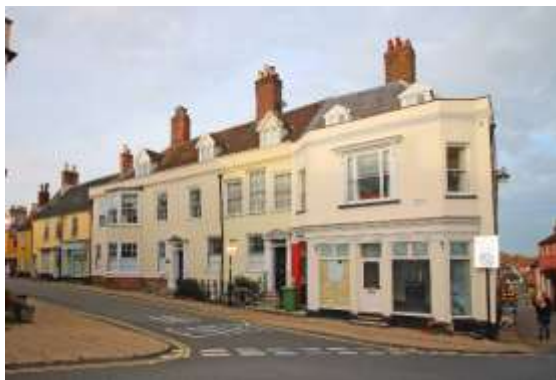
*Nos.2 & 4 Broad Street with No.1 Market Place*

*Cleveland House, No.2 Broad Street, No.4 Broad Street, and Aldeby House No.1 Market Place (grade II).* Of seventeenth century date, with rendered mid eighteenth century façades to Broad Street and Bridge Street. The right-hand section of No.2 was partially remodelled in the nineteenth century and is now numbered as No.1 Market Place. This section has a nineteenth century plain tile roof. Broad Street façade of two storeys, over a basement lit by railing line wells. Attics lit by five gabled dormers on the Broad Street façade which are partially concealed by the parapet. Roof slope part red plain tiles and part Welsh slates. Roughcast on brick, cornice below low parapet. Twelve-light hornless sashes with flush frames, and one three-light, sashed canted bay to No.4. Nos.2 and 4, have six panelled doors with wooden pedimented doorcases. No.1 Market Place with a stuccoed shallow splayed bay projection rising the full height of the façade. Wooden shop front, with Doric pilasters and entablature. The doorway within the shop fascia was formerly in the left-hand bay. Bridge Street façade of No.1 Market Place of two storeys over a high raised basement facilitated by the steep slope of this part of Bridge Street. It formerly had six twelve-light hornless sashes to each floor, but the three left hand bays have had their windows blocked. Parapet, now with cornice partially removed. Gabled dormers. The rear gable of No.1 is prominent in views along Bridge Street. Interior: stop chamfered beam. Honeywood F, Morrow P & Reeve C, *The Town Recorder, A History of Bungay in Photographs* (Bungay, 1994) p65.

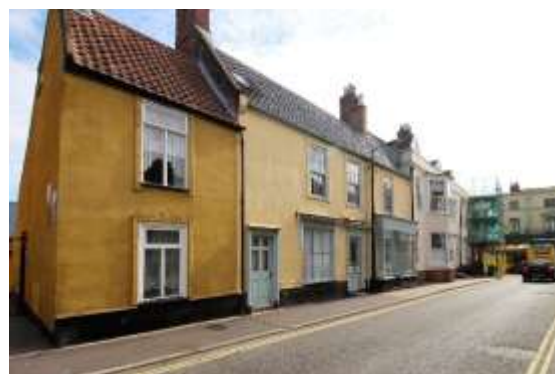
*Nos. 6, 8 & 8a Broad Street*

*Nos. 6, 8 & 8a Broad Street (grade II).* Of eighteenth-century date, No.8a is possibly a later addition. Two storey rendered street frontage, Nos. 6 & 8 having a black pan tile roof, the lower No.8a red pan tiles. Nos. 6 & 8 with three, twelve-light hornless sash windows at first floor level in flush frames with later lugged surrounds. No.8a has one casement at first floor level in a similar lugged surround. No.6 is flanked by two storey pilasters; square bay shop front. Smaller shop window to No.8 and partially glazed door in simple wooden surround. No.8A has an entrance with a modern glazed door in a narrow wooden case and a catslide roof to the rear.

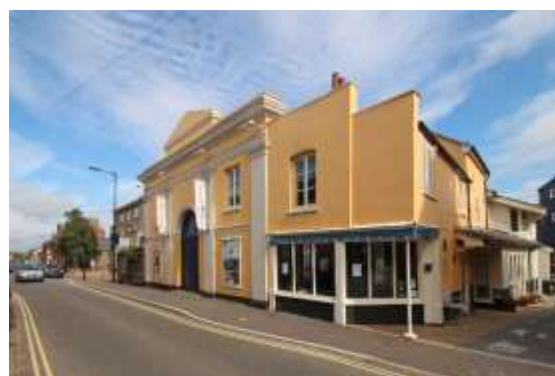
*Fisher Theatre No.10 Broad Street*

*Fisher Theatre No.10 Broad Street (grade II).* Theatre of c1828 built by David Fisher. Converted to a Corn Exchange in 1844 by T Farrow, converted to a cinema c1937. Reopened as a theatre c2001, and restored 2005-6 to the designs of John Putnam. Classical façade of three bays divided by Doric pilasters, with deep entablature above. Pediment and ground floor window openings of c2005. Stucco front with four Doric pilasters and deep entablature. Central arched door opening, first floor band with casement windows above. Welsh slate roof with two large square lanterns which are visible from Broad Street. Single bay two storey stuccoed wing to right, with high parapet. Painted brick two storey right hand return elevation with casement windows. Red brick left-hand return elevation largely blind. Bettley, J, and Pevsner, N,

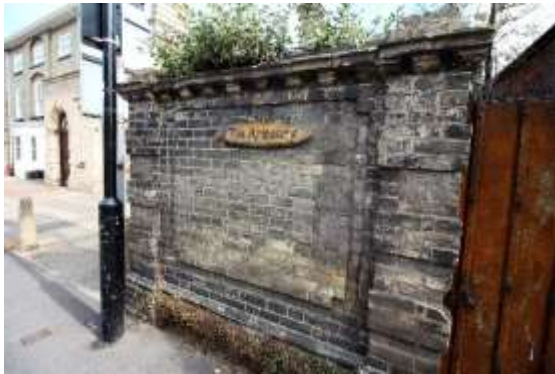
*Boundary wall to The Armoury, Broad Street*

*Boundary wall to The Armoury.* Mid nineteenth century gault brick wall with decorative panels between rusticated pilasters. Dentilled cornice and projecting plinth. Flanks the Broad Street garden entrance to The Armoury. For 'The Armoury' itself, see No.10a Nethergate Street.

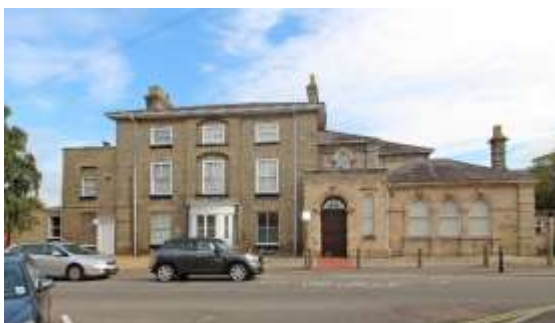
*Nos.12-16 (even) Broad Street*

*Nos.12-16 (even) Broad Street and retaining walls to Nethergate Street and Brandy Lane* (grade II). A substantial early nineteenth century classical townhouse with later wings and an attached later nineteenth century former banking hall. In the mid-nineteenth century, it was the home of the Magitson family but later it became Gurney's, and

finally Barclay's Bank. The house is set back from the building line of the rest of the Street and formerly stood in a courtyard enclosed by elaborate, late nineteenth century railings. The main block is of three storeys, with a Suffolk white brick façade and a hipped Welsh slate roof with overhanging eaves supported on paired brackets. Return elevations of left-hand wing of red brick. The main block has a symmetrical three bay façade with a central breakfront. Three, mid-nineteenth century four-light sash windows at first and second floor levels beneath wedge-shaped lintels. Central window in wide panel with segmental arch over. Main door six-panelled, with panelled linings, reeded architrave and arched radial-bar fanlight, Semi-circular Greek mutular Doric porch, enclosed with a nineteenth century glazed screen, and fluted quasi-columns. Left-hand wing of two storeys. Later nineteenth century bank wing, to right, mainly of a single storey with three arched windows with finely carved keystones with figures of commerce, science, agriculture, and trade. Projecting porch which was partially rebuilt in the twentieth century without its original highly decorative parapet. In the nineteenth century the first-floor windows of the main block had external shutters. Nethergate Street (or garden) façade, rendered with four light sashes. Nineteenth century red brick retaining wall supporting raised garden to Nethergate Street frontage. Bettley, J, and Pevsner, N, *The Buildings of England, Suffolk: East* (London, 2015) p.155. Honeywood F, Morrow P & Reeve C, *The Town Recorder, A History of Bungay in Photographs* (Bungay, 1994) p153.

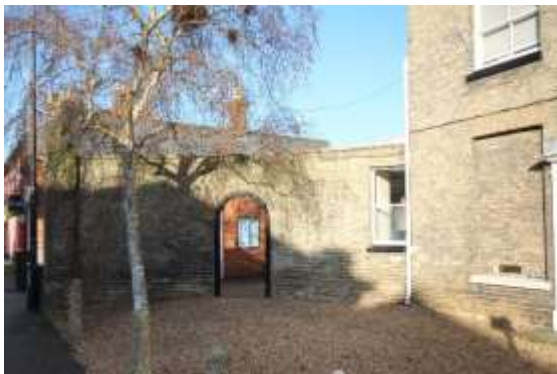
*Forecourt Wall to No.16 Broad Street*

*Forecourt Wall to No.16 Broad Street (grade II). Early nineteenth century, curved on plan, yellow brick screen wall about eight feet high with stone cope and arched doorway, and with square pier with damaged stone finials.*

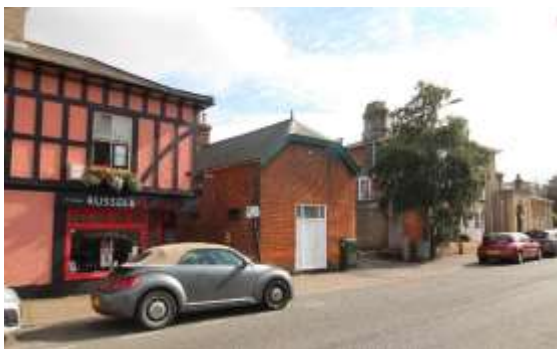
*No.18a, Broad Street*

*No.18a, Broad Street. Stable and coach house of later nineteenth century date. Latterly public library and now a dwelling. Not shown on the 1885 1:2,500 Ordnance Survey map, but on that of 1905. It replaces an earlier structure and was originally built to serve the house now known as 12-18 (even) Broad Street. Red brick with a Welsh slate roof. Four-light casement windows beneath shallow arched brick lintels. Boarded doors. Now converted to domestic use. Two storeys, single bay elevation to Broad Street and four bay return elevation to Brandy Lane. Garden wall earlier incorporated within Brandy Lane elevation. Further contemporary single storey red brick range to the rear. Lean-to garage addition of late twentieth century date. Possibly a curtilage structure to the grade II listed Nos.12-18 (even) Broad Street.*

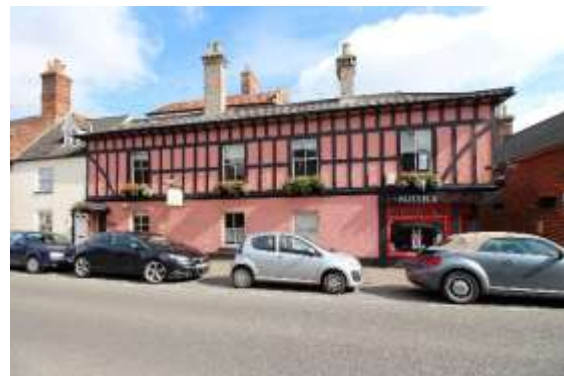
*Oxnead, No.18 Broad Street*

*Oxnead, No.18 Broad Street, range of outbuildings to rear on Brandy Lane, and serpentine wall (grade II). A substantial building with a complex multi-phased building history. Early nineteenth century façades to Broad Street and Brandy Lane with late nineteenth century applied half-timbering, roughcast, and moulded stringcourse, but retaining its original modillion eaves cornice. Broad Street façade of two storeys and four bays with a hipped Welsh slate roof. Tall later nineteenth century gault brick ridge stacks. Horned four-light plate glass sashes to first floor. According to the listing description this formerly had four full-height pilasters. Six-panelled door replaced by a panelled door with glazed upper lights. At the corner of Brandy Lane, a small twentieth century shop fascia. Reputedly an 1876 remodelling, of an earlier structure which escaped the 1688 fire, exposed a fireback with rose portcullis. Three fleurs-de-lys, three lions and part of the Order of the Garter was found, also a window with date 1400. At the rear is a late eighteenth century three storey range of three bays, with a central elliptical brick bay which rises through the full height of the building. Its garden façade has hornless sash windows beneath wedge-shaped brick lintels. Under part of the*

building which has been a wine merchants for a long period are extensive barrel-vaulted cellars of considerable age. *Subsidiary Structures* Good red brick serpentine wall to the rear, probably of early nineteenth century date with later buttresses.

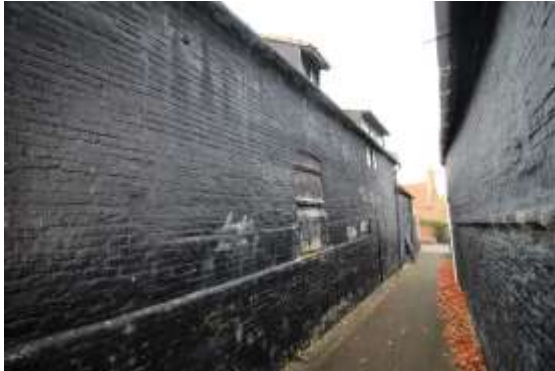
*Brandy Lane elevation of No.18 Broad Street*

Long range of attached outbuildings backing onto Brandy Lane which are probably of early eighteenth century or earlier origins, although at least partially rebuilt. Painted red brick with red pan tile roofs. Range nearest Broad Street of two storeys with boarded taking-in door at first floor level. Twentieth century dormers. Central range of narrow red bricks with a steeply pitched red pan tile roof. Single storey with attic and elaborate tumble or diaper work to gable ends. Blocked taking-in door to gable facing Nethergate Street at attic level. Lean-to addition to garden side. At the Nethergate Street end is an extensive rebuilt structure now with a flat roof and blocked door and window openings to Brandy Lane and a large garage opening to Nethergate Street.

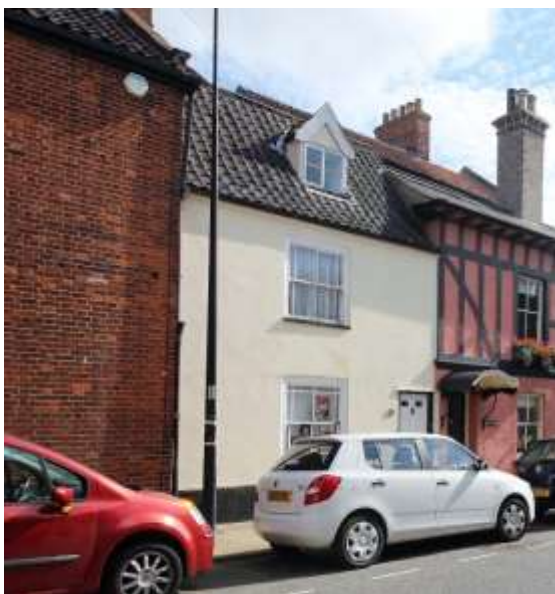
*No.18a Broad Street*

*No.18a Broad Street.* Probably an early to mid-nineteenth century reworking of an earlier dwelling. Its Broad Street façade is rendered with a steeply pitched black pan tile roof. A single horned sash window to each floor with margin lights. Six panelled front door, with glazed upper panels. Gabled dormer with casement window and bargeboards. No.18a forms an important part of the setting of the grade II listed Nos.18 & 20 Broad Street.

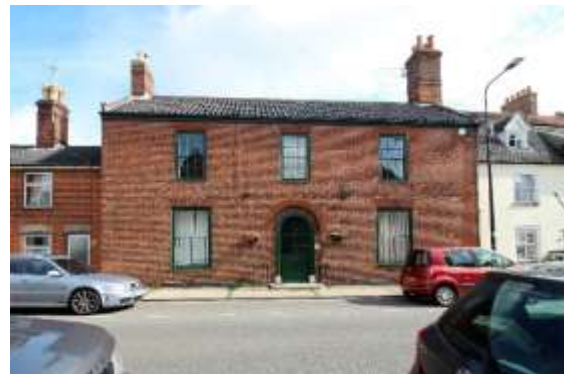
*Cransford, No.20 Broad Street* (grade II). An early to mid-nineteenth century dwelling with a symmetrical classical façade of two storeys and three bays. Faced in red brick, with a black pan tile roof. At the first-floor level are three flush frame twelve-light sash windows with wedge-shaped brick lintels. The ground floor windows are now plate-glass sashes with narrow margin lights. Central six-panelled arched front door recessed within a double brick arch. Reeded wooden architrave with roundels at the arch's springing point, surmounted by double arch, inner set back 4½ ins. Iron segmental fanlight window, to staircase at back, with radial bars. Seventeenth century wing to the east of two storeys and an attic, rendered, with a pan tile roof. Flush frame sash window at each floor now with centre and margin bars only, four-panel door with glazed upper panels. Later twentieth century two storey rear addition.

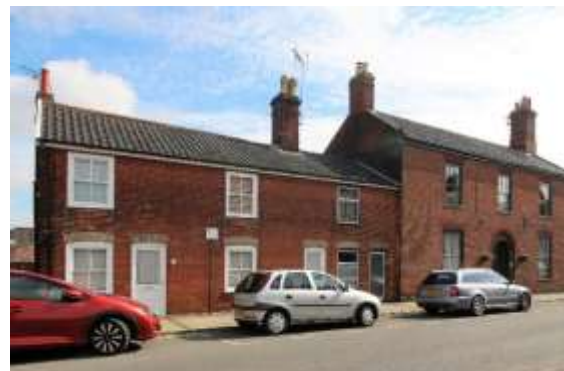
*Nos.22, and 24 Broad Street*

*Nos.22-24 (even) Broad Street.* A terrace of three two storey cottages, now two. Faced in red brick with gault brick lintels to door and window openings. Late twentieth century black pan tile roof covering. Red brick ridge stack to spine wall between cottages. A further ridge stack has probably been removed. No.22 has metal casements within original window openings and a glazed metal door. No.24 with four light horned sashes in heavy moulded frames. Return elevation has red brick lintels to openings and plain bargeboards. This short terrace forms an important part of the setting of the grade II listed Nos.20 and No.18.

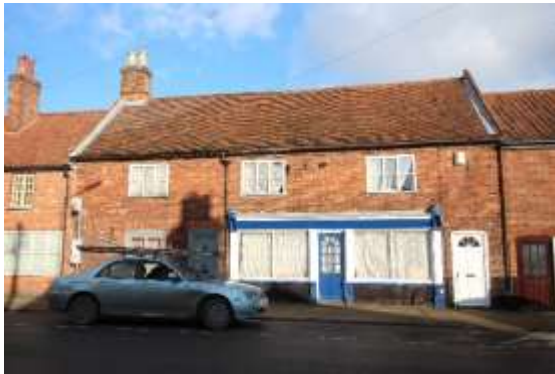
*No.30 and 30a Broad Street*

*No.30 and 30A Broad Street (grade II).* Eighteenth century house with nineteenth century shop fascia. Of two storeys, with a fairly steep red plain tile roof. Red brick, toothed eaves band. Red brick chimney stacks with drip-bands and capping to gable ends. At first floor level there are three, flush-framed, three-light wooden casement windows. A plinth and diaper of dark headers survive on the left-hand section. A single window opening with a twentieth century horned sash and a wedge-shaped lintel survives at ground floor level and a twentieth century six panelled door to No.30. No.30a has a partially glazed door of c1990. Late nineteenth century wide former shop front with pilasters and a central entrance. Door again of c1990. Two iron scroll brackets of former hanging signs at first floor level. Honeywood F, Morrow P & Reeve C, *The Town Recorder, A History of Bungay in Photographs* (Bungay, 1994) p152.

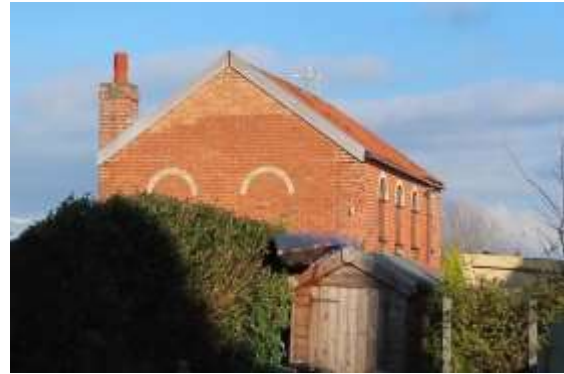
*No.38 Broad Street*

*No.38 Broad Street.* A mid to late nineteenth century red brick two storey structure standing to the rear of No.40 Broad Street, also visible from Nethergate Street. Possibly built as a workshop. Four bay principal elevation with gault brick lintels to arched casement windows. Single storey red pan tile roofed projecting range. Return elevation to Broad Street has blocked arched window openings at first floor level and a larger blocked arched opening to the ground floor. Return elevation to Nethergate Street rendered. Red pan tile roof, red brick stack to rear. Good tall red brick boundary wall attached to rear gable. A building is shown on this site on the 1885 1:2,500 Ordnance Survey map.

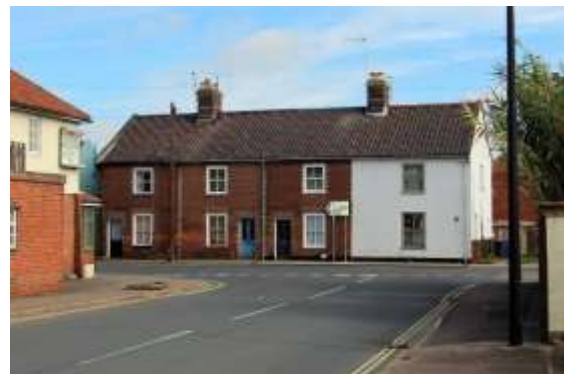
*Nos.40-46 (even) Broad Street*

*Nos.40-46 (even) Broad Street including boundary wall of No.46 to Stone Alley.* A terrace of four later nineteenth century cottages. Red brick with gault brick embellishments. No.40 now painted. Roof covering partially red and blue pan tiles in a geometric design and partially replaced with red pan tiles. Two shared red brick ridge stacks. Four-pane, horned, plate-glass sashes. Gault brick quoins separating cottages, and alternate gault and red bricks to wedge shaped lintels for both doors and windows. Sides of window and door openings also have gault brick embellishments. Partially glazed front doors. No.40's front door has been moved to the return elevation. No.46 has a good series of early nineteenth century or earlier boundary walls of brick and rubble to Stone Alley.

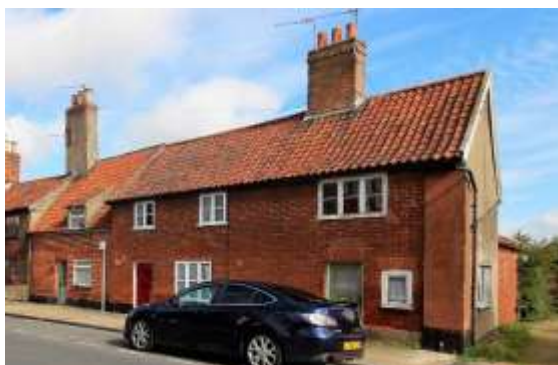
*Nos.54 & 56 Broad Street* A pair of cottages with early nineteenth century facades and steeply pitched red pan tile roofs. Shared central ridge stack. Possibly a re-fronting of an earlier structure. Casement windows. Those to No.56 are of late twentieth century date, however the first-floor window of No.54 may be earlier. Twentieth century front doors. Wedge shaped lintels to door and window openings. No.54 has a single storey late twentieth century addition to the rear and a rendered return elevation.

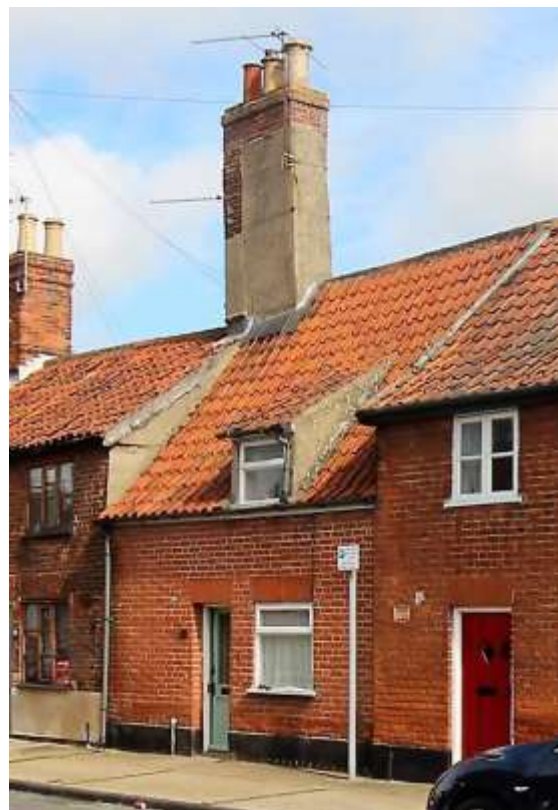
*No.58 Broad Street*

*No.58 Broad Street.* A single storey cottage with a red brick façade and a red pan tile roof. Probably of mid to late eighteenth century date. The external joinery is now largely of late twentieth century date. Wedge-shaped lintels to door and window. Central rendered dormer with late twentieth century casement lighting attic. Massive red brick chimney stack.

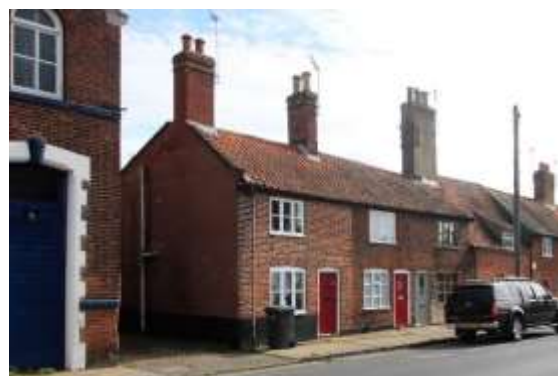
*Nos.60-64 (even) Broad Street*

*Nos.60-64 (even) Broad Street.* A row of three early nineteenth century red brick cottages, with a red pan tile roof and three tall red brick ridge stacks. Six-light casement windows, those to the ground floor beneath shallow arched brick lintels. The first-floor windows rise to eaves height. Twentieth century doors beneath shallow arched brick lintels.

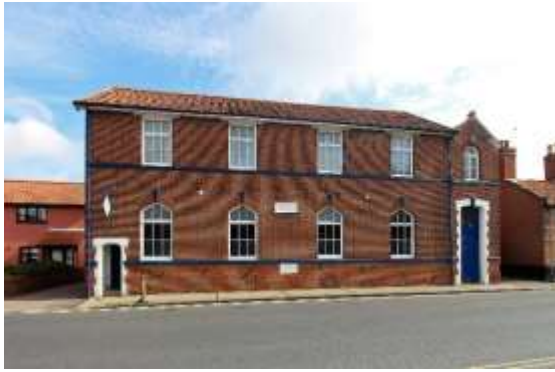
*Former Saint Mary's Parish Rooms, Broad Street*

*Former Saint Mary's Parish Rooms, Broad Street.* Former parish rooms and Sunday School built in 1882, but in a highly conservative style. Formerly with a Church of England Sunday School to the ground floor, and a mission hall above. Reputedly used as a soup kitchen in the two World Wars. Red brick with a shallow pitched red pan tile roof with blue tile stripes. Overhanging eaves with bargeboards to return elevations. Five bay, two storey, principal façade in a restrained gothic style. Painted stone dressings. Cambered brick arched windows to ground floor with painted stone rusticated keystones. Casement windows replaced with PVCu. Principal entrance in gabled bay to right with arched window at first floor level. Painted stone sill bands, with date stone below that to the ground floor. Closed c1939 and later a store and retail premises. Marked as a shoe factory on the 1969 Ordnance Survey map. Saint Mary's Church itself was declared redundant in 1977. Honeywood F, Morrow P & Reeve C, *The Town Recorder, A History of Bungay in Photographs* (Bungay, 1994) p14.

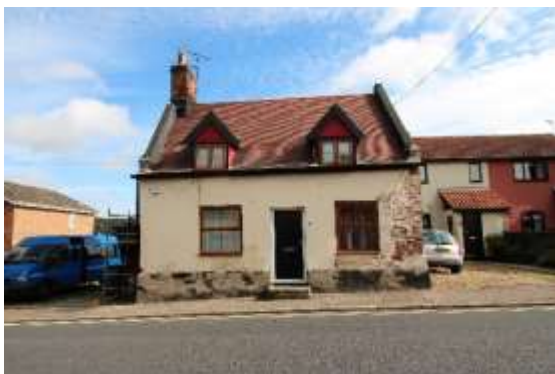
*No.86 Broad Street*

*No.86 Broad Street.* A small detached cottage, probably of mid eighteenth century date. Of a single storey with attics. Red brick with a three-bay rendered façade. Central doorway flanked by two casement windows. Late twentieth century red plain tile roof with two gabled dormers. Windows

now late twentieth century casements. Red brick stack to left-hand gable.

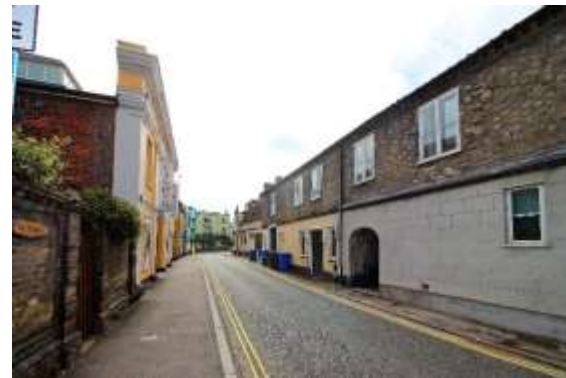
*Nos. 1 & 2 Bigod Flats, Broad Street*

*Nos. 1 & 2 Bigod Flats, Broad Street.* Probably of early to mid-nineteenth century date and built as stabling and outbuildings for properties on Earsham Street. White brick with a black pan tile roof and a rendered ground floor. Restrained neo-Tudor detailing including hood mould to doorway and flanking window. Casement windows, decorative eaves cornice and dentilled string course.

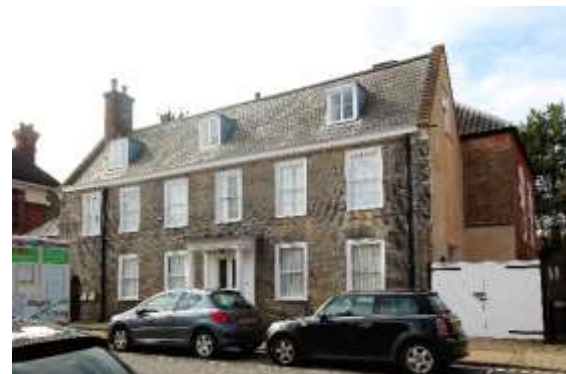
*Charlotte House, Broad Street*

*Charlotte House, No.1 Broad Street (grade II).* Early nineteenth century, of two storeys and an attic which is lit by three flat roofed casement dormers, Welsh slates. Formerly known as Broad Street House. Six bay principal façade of Suffolk white brick with a painted wooden cornice. The first-floor sash windows are twelve-light hornless sashes, the ground floor windows are now without glazing bars and sit beneath wedge-shaped lintels. Four-panelled door with panelled linings within a porch with Doric columns and an enriched entablature.

Panelled door in arched surround to far left-hand bay. Substantial red brick rear range visible from Saxon Place (now a separate dwelling). This has a hipped black pan tile roof and two large horned twelve light sash windows to the first floor. Row of arched openings to the ground floor. This range this possibly of an earlier date. Roughcast faced single storey garage wing to the left with boarded doors and a Welsh slate roof, probably of early to mid-nineteenth century date. Formerly with a small forecourt enclosed by railings and brick piers which are shown on Edwardian photographs.

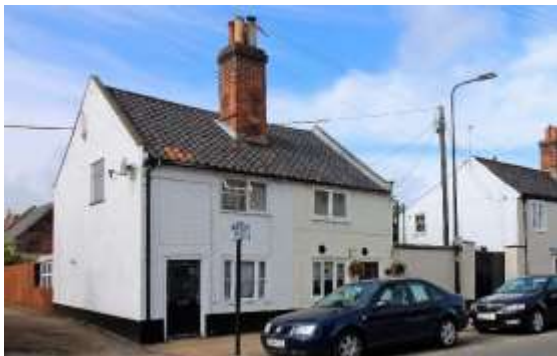
*Nos.11-13 (odd) Broad Street* Semi-detached pair of two storey cottages of c1800 date. Black pan-tiled roof covering, patched with red pan tiles. Large central red brick chimneystack rising from spine wall between the cottages. Dentilled brick eaves cornice. Late twentieth century casements to first floor and sashes below. Front doors both late twentieth century. Attached to the rear of No.13 is a substantial two storey red brick outbuilding of probably early nineteenth century date. This pair of cottages make a strong positive contribution to the setting of the grade II listed Nos.17-19 (Odd).

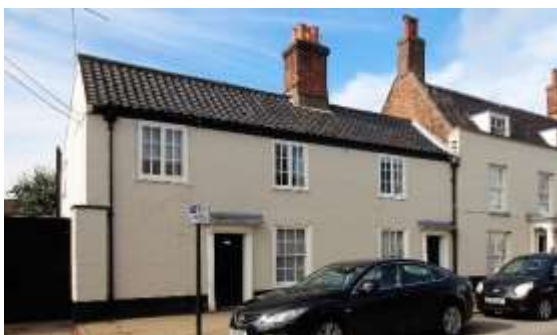
*Nos.15-17 (odd) Broad Street* (grade II). A later eighteenth century semi-detached pair of cottages of two storeys brick, lime-washed, pantiles. Three

small-paned casements in flush frames to the first floor. Twelve-light hornless sashes in flush frames to the ground floor, with flat arches. Two entrances with six-panelled doors, reeded pilasters and mutular cornices. Nos.15-19 form a group.

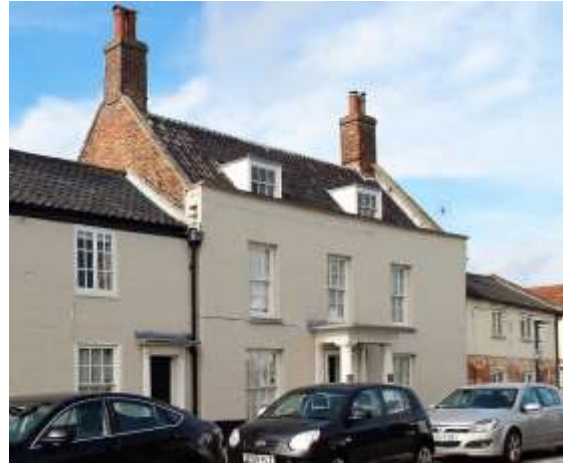
*Cambridge House, No.19 Broad Street* (grade II). Later eighteenth century façade of two storeys and three bays, with an attic lit by twin flat roofed dormers with sashes. Black pan tile roof covering with red brick stacks rising from the gable ends. Symmetrical classical façade of painted red brick with a high parapet. Three twelve light hornless sashes at first floor level beneath wedge shaped lintels. Centrally placed six-panelled front door with a wooden architrave and panelled reveals. Wooden Doric porch with an enriched entablature. Nos.15-19 form a group.

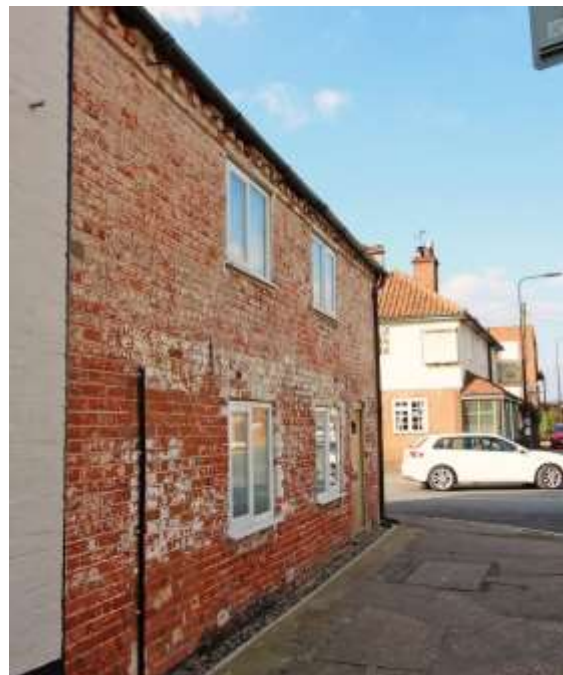
*No.21 Broad Street*

*No.21 Broad Street.* Formerly a pair of early nineteenth century cottages, now a single dwelling. Red brick with a dentilled eaves cornice and a black pan tiled roof. Boarded door at northern end and a blocked door opening at the southern end. Twentieth century casement windows. Despite alteration this dwelling contributes positively to the adjoining grade II listed Nos.15-19 (odd).
