#### Appendix 4: Structures that make a positive contribution to the Conservation Area

The character and appearance of the Conservation Area are shaped by the structures and spaces within it. This appendix contains a list of the built structures which have been identified as making a positive contribution to the Conservation Area (as per section 4. *Positive Contributors* of the CAAMP). The list contains designated as well as undesignated structures. The list is illustrated on maps in the CAAMP.

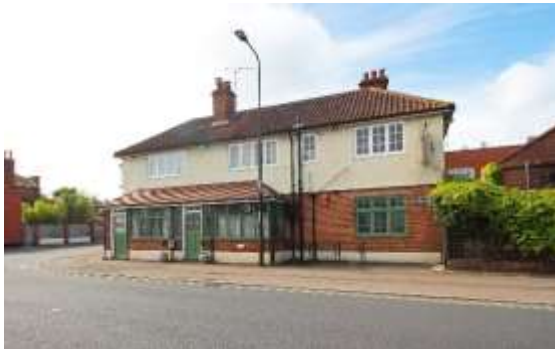
*The Green Dragon Public House, No.29 Broad Street*

*The Green Dragon Public House and outbuildings to rear, No.29 Broad Street and Popson Street.* A purpose-built public house of c1926, replacing an earlier inn. Formerly known as the Horse and Groom. Restrained 'arts and crafts' vernacular style. Much of the building's original external detailing has survived including its external joinery and leaded windows. The pub is faced in red brick with pebble dashed first floor, and a hipped red pan tile roof. Wooden casement windows divided by mullions and a transom and with small leaded panes to the ground floor. The first-floor windows are similar but do not have a transom. Fine decorative rainwater heads. *Subsidiary Structures* To the rear are two much earlier outbuildings. Fronting Popson Street is a single storey red brick outbuilding of c1800 with a red pan tile roof and a dentilled brick eaves cornice. This is a survival from a range of out buildings shown on late nineteenth century Ordnance Survey maps. To the rear of the yard a two-storey red brick stable range with boarded doors and a red pan tile roof. Probably of early nineteenth century date, its ground floor openings show signs of alteration and a number of the original brick lintels have been replaced.

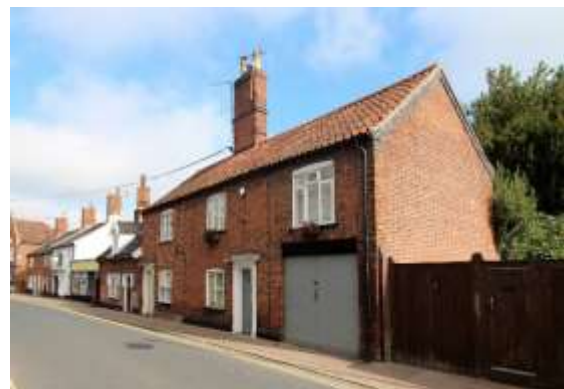
*Nos.2 & 4 (even) Chaucer Street*

*Nos.2 & 4 (even) Chaucer Street.* Semi-detached pair of red brick cottages with red pan tile roof. Originally a two storey two bay mirrored pair with a massive central ridge stack of c1820. Single casement window to each floor beneath a shallow arched brick lintel. Doorcases to outer bays with fluted pilasters and roundels. Six panelled doors. Window frames largely replaced in the late twentieth century. Dentilled brick eaves cornice. No.2 has early twentieth century single bay addition with boarded garage doors to the ground floor, and a single six-light casement window above.

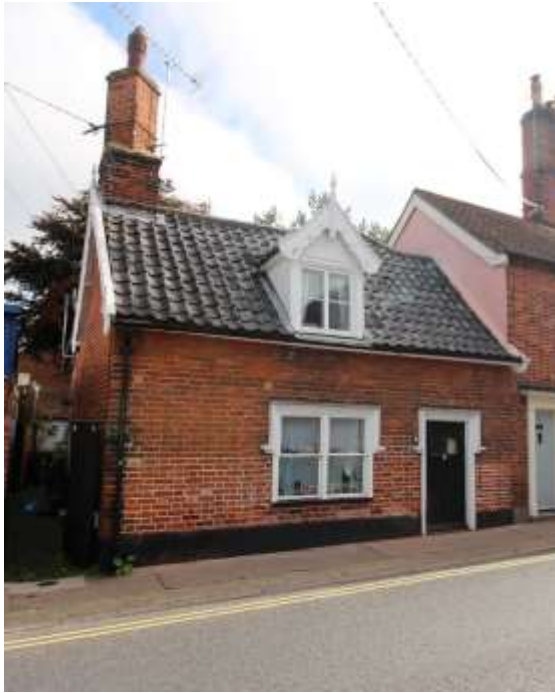
*No.6 Chaucer Street*

*No.6 Chaucer Street.* A small red brick structure externally of early to mid-nineteenth century appearance but possibly a re-casing of an earlier structure. Red brick with painted stone dressings and a black pan tile roof. Street frontage range of a single storey and attics, substantial largely nineteenth century rear range of two storeys. Hood moulds to window and door openings, gabled dormer to attic with elaborate bargeboards. External joinery largely replaced. Tall brick chimneystack to left-hand gable. In the nineteenth century the Two Brewers Public House.

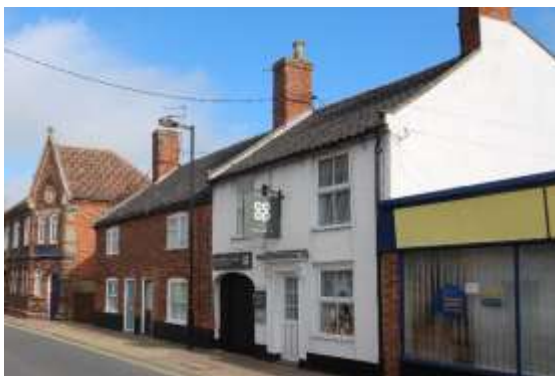
*No.12 Chaucer Street*

*No.12 Chaucer Street.* A mid nineteenth century dwelling, now (2017) offices. Painted red brick with a black pan tile roof. Two storeys and two bays with a cart entrance to the rear yard in the left-hand bay. Window joinery replaced in the early twenty first century. Doorcase with panelled pilasters and scrolled corbels. Door within a later twentieth century partially glazed one.

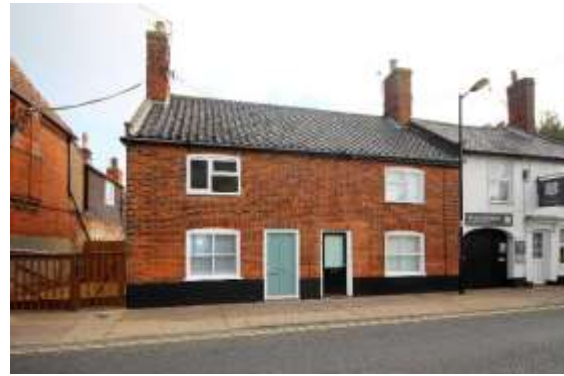
*Nos. 14 & 16 Chaucer Street*

*Nos. 14 & 16 Chaucer Street.* An early to mid-nineteenth century semi-detached pair of cottages. Of red brick with a shallow pitched black pan tile roof. Red brick stacks rising from gable ends. Replacement casement windows beneath shallow arched brick lintels. Brick lintels to doors possibly replaced. Four-panelled door to No.16. No.14 has a late twentieth century partially glazed front door.

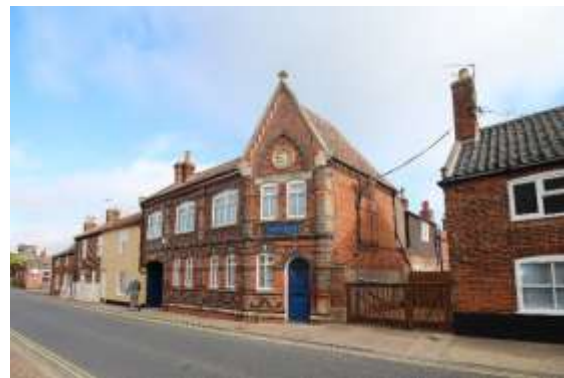
*Masonic Rooms, Nos.18-22 Chaucer Street*

*Masonic Rooms, Nos.18-22 Chaucer Street and Forester's Court Chaucer Street.* Former Oddfellows Hall reputedly of c1910 but in a very conservative style. Now flats. Its Chaucer Street façade in an elaborate Venetian gothic style. Red brick with elaborate blue and gault brick embellishments. Carved stone dressings and blue and red tiled roof covering in geometric design. Four bay two storey principal façade, the right-hand bay splayed and gabled. Its steeply pitched gable has a stone coping and is surmounted by a damaged carved stone fleur-de-lis. Decorative stone corbels and roundel within blue brick pointed arch. Gault brick quoins and stone sills and lintels to first floor window within splay. The rest of the windows have decorative red and blue brick pointed arches above with stone keystones. Arched panel door with circular light. The ground floor window frames are mullioned and transomed casements with leaded lights. Elaborate corbelled eaves cornice. Projecting

stack on return elevation of a highly decorative design. Left hand bay has cart entrance into a central courtyard. Lower late twentieth century rear range faced in red brick with a weatherboarded first floor. Bettley, J, and Pevsner, N, *The Buildings of England, Suffolk: East* (London, 2015) p.155. Honeywood F, Morrow P & Reeve C, *The Town Recorder, A History of Bungay in Photographs* (Bungay, 1994) p149.

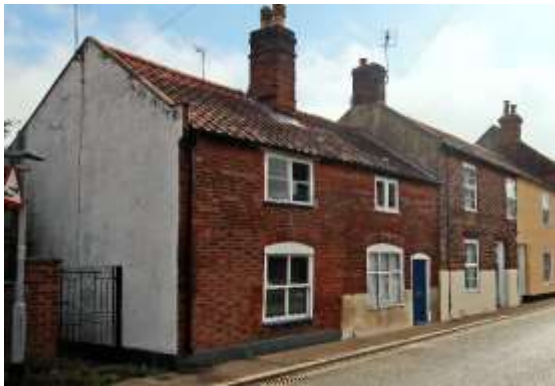
*No.28 Chaucer Street*

*No.28 Chaucer Street.* An early nineteenth century semi-detached pair of houses, now a single dwelling. Red brick with a red pan tile roof and a red brick ridge stack rising from the former spine wall. Dentilled brick eaves cornice. Replacement casement windows beneath shallow arched brick lintels. Left-hand return elevation rendered, Reeve C, *Bungay Through Time* (Stroud, 2009) p52.

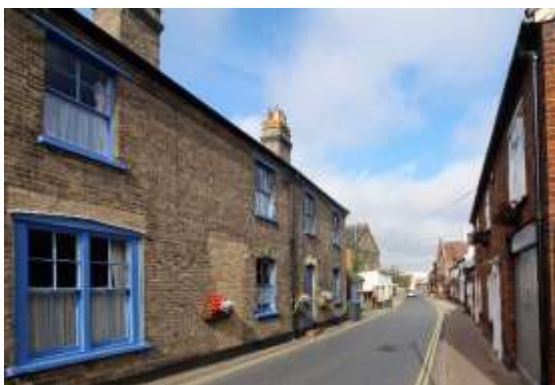
*No.1 Chaucer Street*

*No.1 Chaucer Street.* Attached to the rear of the grade II listed No.24 Earsham Street and shown as part of that structure on early Ordnance Survey maps. By 1969 it was shown on maps as a separate dwelling. It was possibly built as the postmaster's house for the former town post office at No.24 Earsham Street 1880. Gault brick façade to an

otherwise red brick structure; Welsh slate roof. Bay window to left hand house now removed and original front door opening blocked. Present front door formed from a former window. Otherwise late nineteenth century joinery largely intact. An important part of the setting and history of the GII listed No.24 Earsham Street. Reeve C, *Bungay Through Time* (Stroud, 2009) p53. Honeywood F, Morrow P & Reeve C, *The Town Recorder, A History of Bungay in Photographs* (Bungay, 1994) p149.

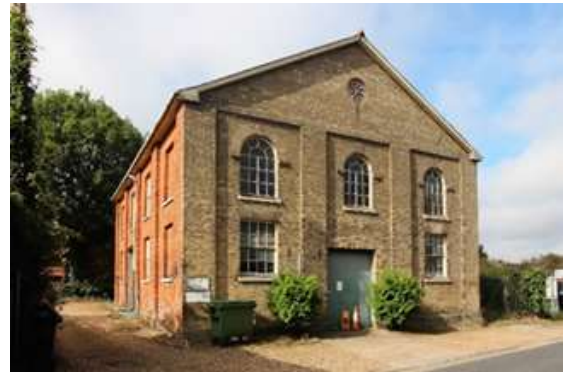
*The Old Chapel (Former Bethesda Chapel)*

*Former Bethesda Chapel, Chaucer Street.* Former Strict Baptist Chapel built 1851 to the designs of Samuel Matthew of Lindsey (Pevsner). Closed c1960 and latterly a workshop. Symmetrical classical gault brick façade to an otherwise red brick structure. Pedimented entrance façade with pilasters without capitals rising from a plinth. Arched first floor casement windows lighting the former gallery and sixteen light hornless sashes with wedge shaped lintels to the ground floor. Decorative ventilator roundel with building date in centre of pediment. Original window frames largely retained although the building presently has a twentieth century workshop entrance. Four bay return elevations with pilasters and overhanging eaves. Welsh slate roof with decorative red tile ridge pieces. Bettley, J, and Pevsner, N, *The Buildings of England, Suffolk: East* (London, 2015) p.155. Honeywood F, Morrow P & Reeve C, *The Town Recorder, A History of Bungay in Photographs* (Bungay, 1994) p16.

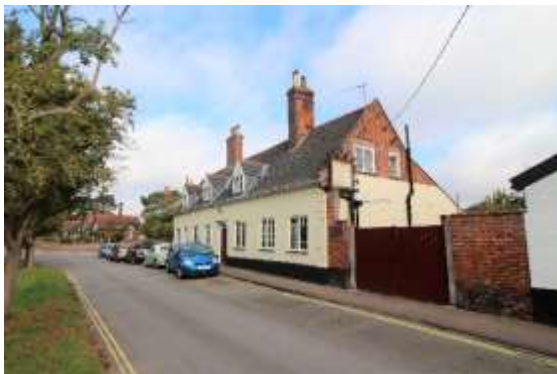
*Cherry Tree House, Outney Road*

*Cherry Tree House, No.4 Outney Road and red brick boundary wall.* A former public house, which was in use as such from at least the beginning of the nineteenth century, it closed in the mid twentieth century. Probably of mid eighteenth century date altered c1930. Single storey with attics, rendered red brick façade with quoins and a black pan tile roof. Eight bay street frontage with two doorways and six small paned metal casement windows set back beneath flat lintels. The window openings to the right of the central doorway are not shown on late nineteenth century photographs. Three gabled dormers with late twentieth century casements. Two substantial red brick ridge stacks. Good red brick wall to Outney Road frontage. Reeve C, *Bungay Through Time* (Stroud, 2009) p49.

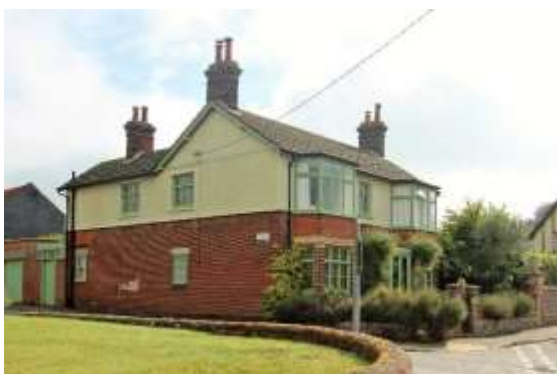
*No.6 Outney Road*

*No.6 Outney Road and boundary wall* (local list) A detached house of c1910 on the corner of Webster Street and Outney Road it replaces an earlier structure which faced onto Webster Street. (Not shown on the 1906 Ordnance Survey map). Red brick and render with mullioned and transomed timber casement windows. Although architecturally modest this is a well preserved and characterful dwelling which contributes strongly to the setting of the adjoining almshouses. *Subsidiary Structures* Low early twentieth century boundary wall to Outney Road with square section piers and

well-designed late twentieth century iron railings. Twentieth century flat roofed garage facing Webster Street not included.

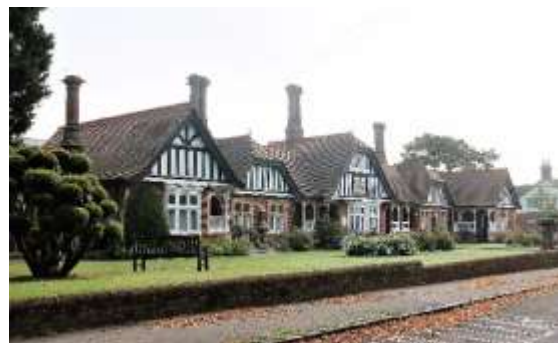
*St Edmund's Homes, Outney Road*

*St Edmund's Homes, gate piers and boundary walls, Nos.8-22 (even) Outney Road.* Alms houses of 1895 designed by F.E. Banham and donated by Frederic Smith. Set back from the road within mature landscaped grounds. Symmetrical, vernacular revival style with applied timber framing to the otherwise red brick shell. Of a single story with a plain tile roof and tall paired octagonal shafts to the red brick chimney stacks. Five barge-boarded gables the middle three half-hipped. Windows either two-light stone hood moulded mullions, with casements within, or mullioned and transomed wooden frames. Individual front doors set back within decorative painted wooden verandas with balustrades. Stone quoins to corners. Gabled return elevation of a single bay to Webster Street. Rear elevations significantly altered c1960 possibly by Raymond Erith. Low red brick wall to Outney Road and Webster Street with octagonal gate piers and semi-circular cap. Tall red brick wall to the rear. Bettley, J, and Pevsner, N, *The Buildings of England, Suffolk: East* (London, 2015) p.155. Archer L, *Raymond Erith Architect* (Burford, 1985) p151.

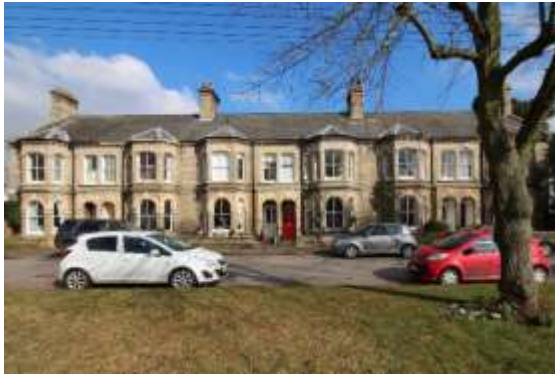
*Waveney Terrace, Nos.24-34 Outney Road*

*Waveney Terrace, Nos.24-34 (even). Outney Road with boundary walls.* A terrace of six substantial houses in three mirrored pairs of c1881. Shown on the 1885 1:2,500 Ordnance Survey map. Red brick with a gault brick façade and stone dressings. Welsh slate roof and corbelled eaves cornice. Each house is of two bays, one with a full height canted bay window. The other containing an arched porch with a pronounced key stone. Four-light plate glass sash above. Four panelled doors with glazed arched upper lights. Horned plate glass sashes. Late nineteenth century low gault brick boundary wall with square section gault brick gate piers. Decorative iron railings and gates now removed. Glazed tile paths to front doors of a geometric design. Red brick rear boundary walls and rear elevation. A good example of a speculatively built later nineteenth century terrace retaining the bulk of its original features and joinery. Honeywood F, Morrow P & Reeve C, *The Town Recorder, A History of Bungay in Photographs* (Bungay, 1994) p143.

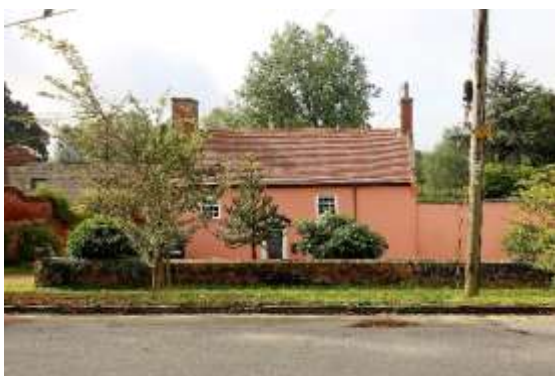
*Waveney Cottage, Outney Road*

*Waveney Cottage and Outbuilding No.7 Outney Road (grade II).* Of sixteenth century date, but largely remodelled in the eighteenth century. Two storeys. Two late twentieth century casement windows in flush frames. Stucco, colour-washed. Later twentieth century red tile roof with red brick ridge stacks. Later twentieth century six-panelled

door in wooden case with reeded pilasters, fluted caps, radial bar fanlight and dentilled pediment. Lower range to rear at a right-angle with pan tiled roof. To its west a high rendered red brick wall, which is now painted linking the house to a contemporary stable or cart shed with a central arched opening and a hay loft at attic level. Single gabled bay to Outney Road with boarded taking-in door. Black pan tiled roof. Good red brick wall enclosing front courtyard.

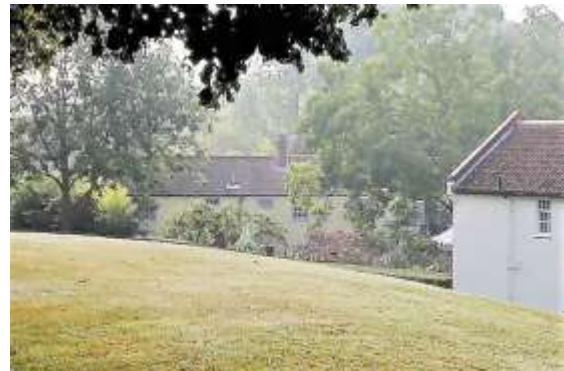
*No.9 Outney Road*

No.9 Outney Road. A later eighteenth century cottage of two storeys and three bays with a red pan tile roof, massively extended in the mid to late twentieth century on site of single storey range of outbuildings. Rendered façades, and external joinery largely replaced. The section between Outney Road and the central ridge brick ridge stack is all an addition to the original cottage. A further small cottage once stood immediately in front. Honeywood F, Morrow P, & Reeve C, *The Town Recorder, A History of Bungay in Photographs* (Bungay, 1994) p142.

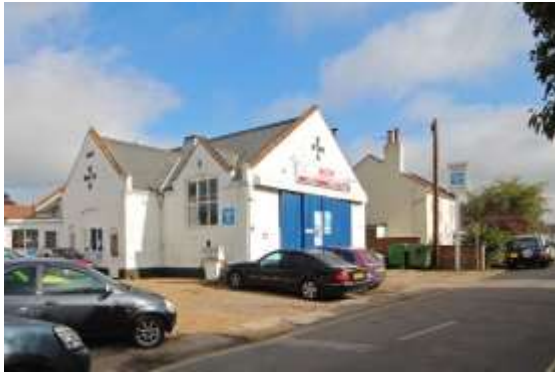
*No.12 Scales Street*

*No.12 Scales Street.* Former drill hall now car repair workshop. Probably designed and built by John Doe architect and builder of Bungay and dated 1906. Used primarily by the 2nd Volunteer Battalion Norfolk and 5<sup>th</sup> Battalion Suffolk Regiments. Single storey red brick with Welsh slate roof formerly with tall leaded ventilator on ridge. Iron roof with tie rods. Gabled elevation to Scales Street with central circular former window with stone decoration in the form of four keystones. Mullioned and transomed wooden casement windows.

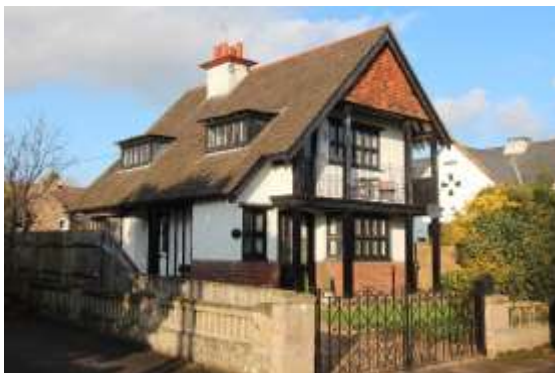
*No.14 Scales Street*

*Bedford House No.14 Scales Street and front garden wall* (local list). Early twentieth century detached villa designed and built by John Doe. Inventive free Arts and Crafts Tudor vernacular style. Red brick and rough cast elevations. Wooden mullioned and transomed windows with leaded lights. Scales Street elevation gabled with plain tile hung apex which projects and is supported on a full height wooden veranda. Late twentieth century pan tiled roof with original flat roofed dormers. *Subsidiary Structures* Low contemporary concrete garden wall to Street frontage with balustrade. Bettley, J, and Pevsner, N, *The Buildings of England, Suffolk: East* (London, 2015) p.155.

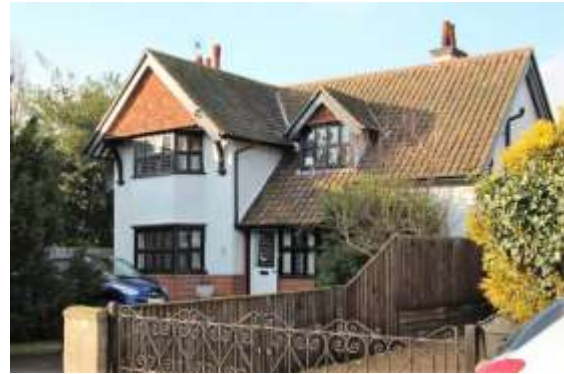
*No.16 Scales Street*

*No.16 Scales Street and front garden wall.* Early twentieth century detached villa designed and built by John Doe. Tudor vernacular with red brick and roughcast elevations. Plain tiled gable apex supported on carved wooden brackets with two storey can bay window below. Wooden mullioned and transomed windows. Late twentieth century pan tiled roof with original gabled dormer with bargeboards. *Subsidiary Structures* Low contemporary concrete garden wall with balustrade to Street frontage continued between Nos.14 & 16. Bettley, J, and Pevsner, N, *The Buildings of England, Suffolk: East* (London, 2015) p.155.

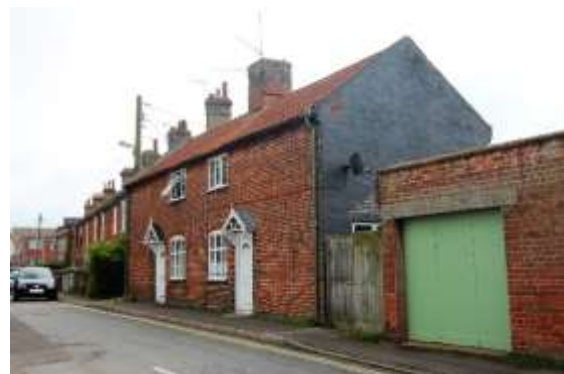
*Nos.2-4 (even) Webster Street*

*Nos.2-4 (even) Webster Street.* A semi-detached pair of cottages of red brick, with a red pan tile roof covering. Probably of late eighteenth century date. Twentieth century porches. Casement windows to ground floor beneath shallow brick arched lintels, those above rise to eaves height. Window joinery replaced. The last survivors of a group of similar cottages which stood in the Scales Street and Webster Street area until the later twentieth century. A similar pair in Scales Street were

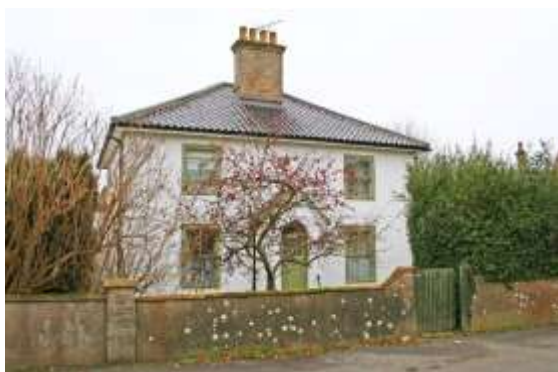
*No.2 Bardolph Road*

*Henham Villa, No.2 Bardolph Road, boundary walls, and outbuilding.* Early nineteenth century villa with later additions. Stuccoed with a hipped black pan tiled roof. Large gault brick central stack. Symmetrical façade with four-light, horned, plate-glass sashes. Central gabled c1900 porch. Large late twentieth century rear addition. Flanking walls to either side that to Laburnum Road concealing a single storey outbuilding. Subsidiary Structures Low partially rendered gault brick nineteenth century wall to Bardolph Road and red brick wall to Laburnum Road. Nineteenth century outbuilding with red brick rear wall, single storey with chimneystack to Bardolph Road elevation. Map evidence suggests this is a c1900 heated greenhouse. Honeywood F, Morrow P, & Reeve C, *The Town Recorder, A History of Bungay in Photographs* (Bungay, 1994) p188.

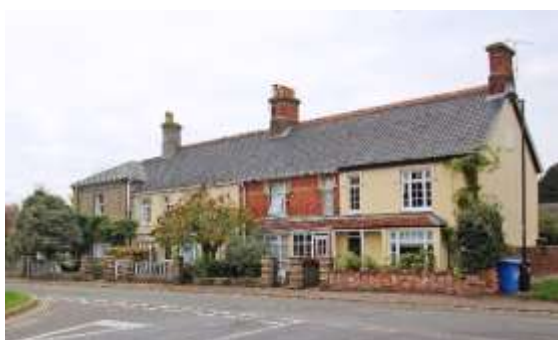
*Nos.2-6 (even) Flixton Road*

*Nos.2-6 (even) Flixton Road and boundary walls.* Terrace of three substantial houses c1900, attached to the rear of the larger and slightly earlier No.8. Red brick with stone dressings. Black pan tile roof

with decorative ridge pieces. Mullioned and transomed timber casements with stone hood moulds. Bay window to ground floor of each house with a tile roof continued over door to form a porch. Wooden pillars flanking doors. *Subsidiary Structures.* Good boundary wall and gate piers of alternate gault and red brick layers c1900. Nos. 4 & 6 with decorative iron railings. The wall to No.2 has been rebuilt but the original piers are preserved. No.2 has a good red brick boundary wall to Rose Hall Gardens. The terrace occupies the site of the medieval chapel of St Mary Magdalene and is thus likely to be of archaeological value.

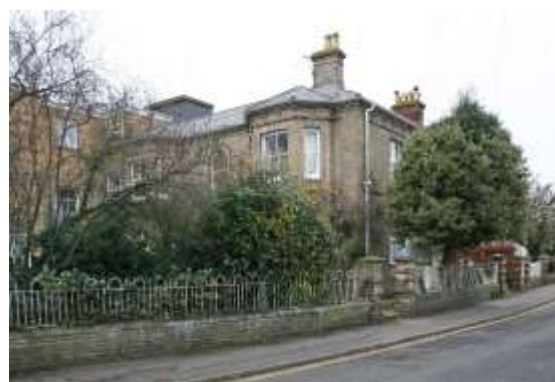
*No.8 Flixton Road*

*Cherrington Lodge, No.8 Flixton Road and boundary wall and outbuildings.* A gault brick villa of c1870 (shown on the 1885 1:2,500 Ordnance survey map). Substantial late twentieth century additions. No.8 faces south and has a return elevation of a single bay to Flixton Road. Principal façade of three bays with full height canted bay windows flanking a central pedimented porch. Arched window with heavy moulded brick frame above door. The bulk of the house's original horned plate glass sashes have been preserved. Welsh slate roof. Decorative eaves cornice. Gault brick chimney stack. Return elevation to Flixton Road with altered ground floor window opening. Twentieth century additions not of interest. *Subsidiary structures.* Low gault brick wall with decorative piers and hooped iron railings. Further red brick section to south. To south west of house a range of nineteenth century outbuildings. Single storey gault brick with a red pan tile roof.

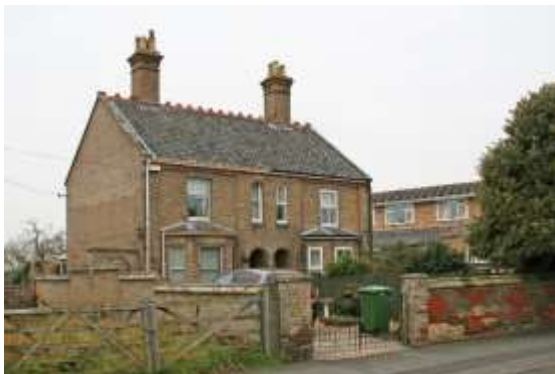
*Nos.10 & 12 Flixton Road*

*Nos.10 & 12 Flixton Road and boundary walls.* A semi-detached pair of late nineteenth century gault brick villas. Map evidence suggests that they were constructed between 1885 and 1905. Black pan tiled roof with decorative ridge pieces. Single storey canted bay windows to ground floor. Doors within arched recessed porches. No.12 has its original plate glass horned sashes. The windows to No.10 have been replaced with casements. *Subsidiary Structures* Notable stepped gault brick wall of c1890 to south side of No.12. Similar though less decorative wall to north of No.10. red brick wall with gault brick piers to Flixton Road. Gault brick gateway with arched door opening to north side of No.10. red brick garden walls to rear.

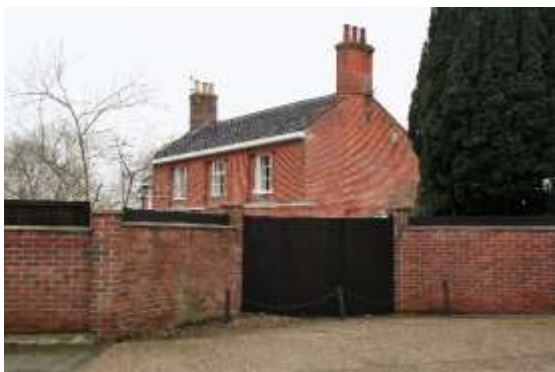
*No.14 Flixton Road*

*The Red House, No.14 Flixton Road, stable and boundary walls.* (grade II). Late-eighteenth century villa, facing south with return elevation to Flixton Road. Two storeys, red brick with an enriched wood cornice. First floor band, plinth, black pan tiles. Symmetrical three bay façade with sash windows beneath cambered flat arches. Louvred and panelled shutters. Sash windows, with glazing bars, set back in recesses to take shutters at first floor level with arches over the recesses. Three-light windows with glazing bars at ground floor level of the same width as the recesses over. Four-panelled door in wood case with panelled reveals. Formerly with porch. *Subsidiary structures.* Good nineteenth century stable range to rear. Red brick with a black pan tiled roof. Two storeys, the outer bays breaking forward and with gables. Boarded doors to ground and first floors and an oculus within each gable. Good red brick boundary wall to Flixton Road frontage of rear yard. The southern part of the wall fronting the garden appears to have been rebuilt. Nineteenth century red brick wall to northern return boundary.

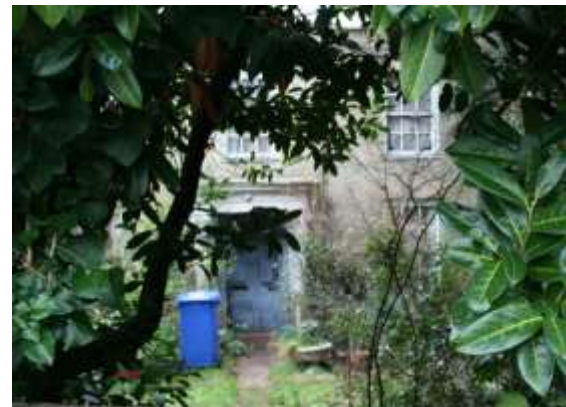
*No.16 Flixton Road*

*No.16 Flixton Road and outbuildings* (grade II). Early nineteenth century villa of Suffolk white brick built as the miller's house for a now demolished smock mill. Two storeys with a Welsh slate roof. Band below, parapet with a stone cope. Symmetrical

three bay façade with twelve-light hornless sash windows within exposed frames; flat arched lintels. Six-panelled door with ornamental arched fanlight. Ionic porch. *Subsidiary Structures* Large group of nineteenth century outbuildings to rear possibly originally associated with the smock mill. Honeywood F, Morrow P & Reeve C, *The Town Recorder, A History of Bungay in Photographs* (Bungay, 1994) p51.

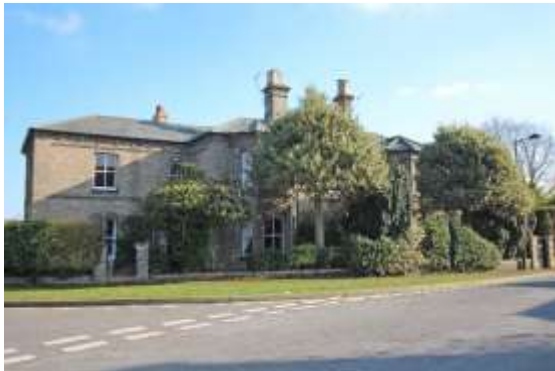
*Nos.1 & 3 Flixton Road*

*Nos.1 & 3 Flixton Road, walls and gate piers.* A semi-detached pair of houses prominently located at the junction of Bardolph and Flixton Roads. Also visible from Laburnum Road. Shown on the 1885 Ordnance survey map and probably dating from c1870. Gault brick with a Welsh slate roof. Decorative corbelled eaves cornice, pilasters, and two storey canted bay windows. Original plate glass sashes largely preserved. *Subsidiary Structures* Good contemporary gault brick gate piers and low boundary wall. Tall nineteenth century red brick wall to Laburnum Road.

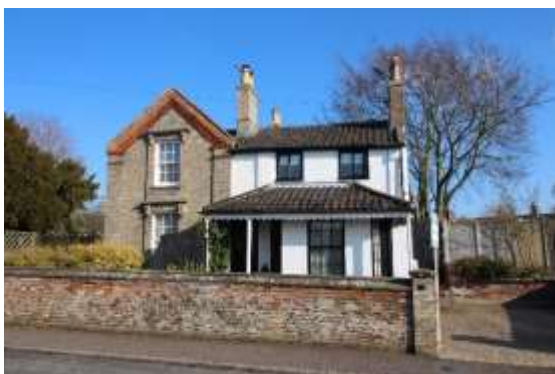
*No.5-7 Flixton Road*

*No.5-7 Flixton Road and boundary wall.* Mid nineteenth century with later nineteenth century alterations. No.5 of gault brick with a Welsh slate

roof and decorative tile ridge pieces. Entrance façade to north of three bays with central gabled porch and hornless sash windows. Flixton Road elevation with corner pilasters and pediment with a terracotta raking cornice. Hornless twelve-light sash windows with moulded brick surrounds with pilasters and stone corbels. No.7 of painted brick with a pan tiled roof. Casement windows to first floor. Wooden veranda with hipped pan tiled roof and fretwork frieze containing a canted bay window with sashes and shutters. *Subsidiary Structures.* Low nineteenth century red brick wall with a moulded gault brick cap and gault brick piers.

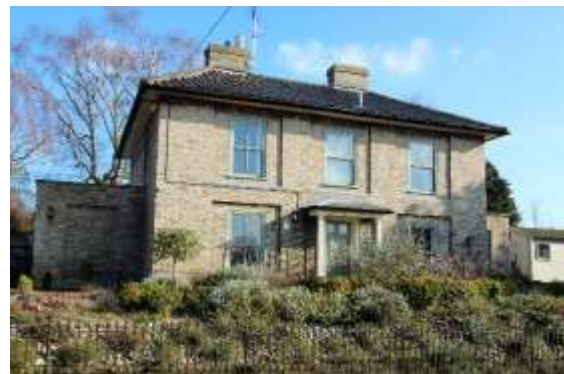
*No.9 Flixton Road*

*No.9 Flixton Road (grade II).* Early nineteenth century villa of two storeys. Faced in Suffolk yellow brick, with a hipped black pan tiled roof with wide overhanging eaves. Symmetrical façade divided into three bays with wide shallow brick panels and with wide connecting horizontal band at first floor level. Each panel has a horned plate-glass sash at its centre with a margin to take louvred and panelled shutters, now removed. Sashes, in flush frames, with glazing bars and small border panes at sides, flat arches. Single storey wings with blank panels. Six-panelled door with frieze and cornice, Wooden porch with square-section panelled columns, trellis screen either side. Nos.9 to 13 (odd) form a group.

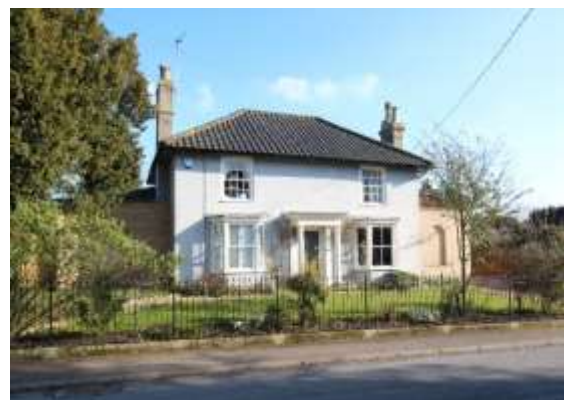
*No.11 Flixton Road* (grade II). An early nineteenth century two storey, Suffolk yellow brick, villa, grey-washed. Hipped black pan tiled roof and wide eaves. Two sixteen-light hornless sash windows with flush frames, at first floor level. Two canted and sashed bays to ground floor. Small wings with blank arched panels. Six-panelled door. Wooden Doric porch. Nos.9 to 13 (odd) form a group.

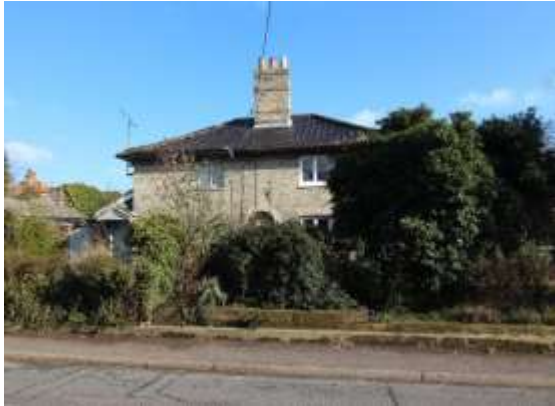
*Autumn Cottage, No.13 Flixton Road* (grade II). A pair of semi-detached cottages; now converted to a single dwelling. Early nineteenth century. Symmetrical two storey, and three-bay principal façade with a hipped black pan tile roof. Central white brick stack rising from former spine wall and façades of Suffolk white brick. Eaves soffit. Two windows, casements in reveals with flat- arches. Plain door, left, in reveals with flat arch. Central arched blank panel at ground floor. Former entrance (to former No.15) filled in. Nos.9 to 13 (odd) form a group.

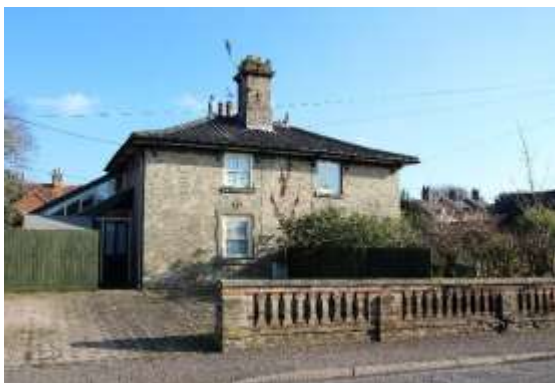
*Nos.17 & 19 Flixton Road*

*Nos.17 & 19 Flixton Road and boundary wall.* A semi-detached pair of cottages of probably mid-nineteenth century date. Faced in white brick with a hipped black pan tiled roof and overhanging eaves. Elaborate surrounds to windows on ground floor. Decorative ridge pieces and finials. Decorative central white brick stack rising from

former spine wall. No.17 retains four-pane plate glass sashes, the window joinery to No.19 has however been replaced with casements. Late twentieth century glazed addition. Lean-to side porch to No.19. Subsidiary Structures: Low mid-nineteenth century white brick wall with red brick bands and brick balustrade. Honeywood F, Morrow P, & Reeve C, *The Town Recorder, A History of Bungay in Photographs* (Bungay, 1994) p190.

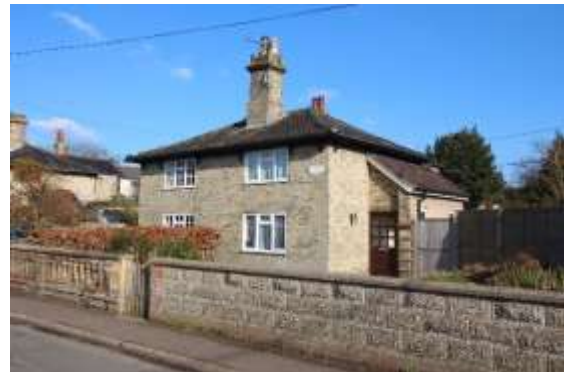
*Nos.21 & 23 Flixton Road*

*Nos.21 & 23 Flixton Road.* A semi-detached pair of cottages of probably mid-nineteenth century date. Faced in gault brick with a hipped black pan tiled roof and overhanging eaves. Central brick stack rising from former spine wall. Window openings remodelled to hold casements in late twentieth century. Included here primarily for its group value. *Subsidiary Structures* Low mid-nineteenth century white brick wall with red brick bands and brick balustrade. Wall to side of No.21 rebuilt in later twentieth century and not of interest. Single storey nineteenth century red brick outbuilding to rear.

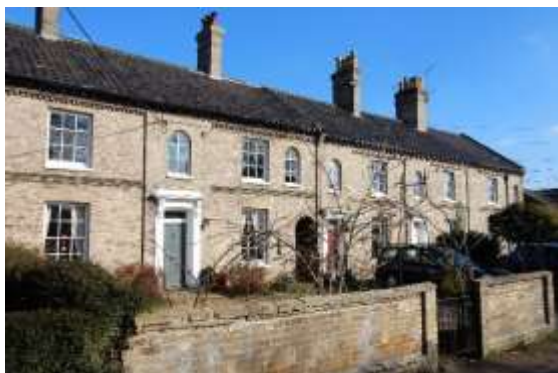
*Nos.1-9 (Odd) Laburnum Road*

*Nos.1-9 (Odd) Laburnum Road and boundary wall . A distinguished late nineteenth century gault brick terrace. Shown on the 1885 Ordnance Survey map. Nos.3-9 remarkably intact, No.1 sadly now rendered and altered. Shallow pitched black pan tiled roof with overhanging eaves. Corbelled eaves cornice with dentilled frieze below. Entrance bay to each house in a shallow breakfront with an arched casement window at first floor level and a pilastered doorcase below. Rectangular fanlights and four panelled nineteenth century doors. The other windows are twelve-light hornless sashes. No.1 has altered fenestration. *Subsidiary Structures.* Nineteenth century gault brick wall to Laburnum Road altered to form drive entrances. Red brick nineteenth century wall with gault brick pier to side of No.9.*

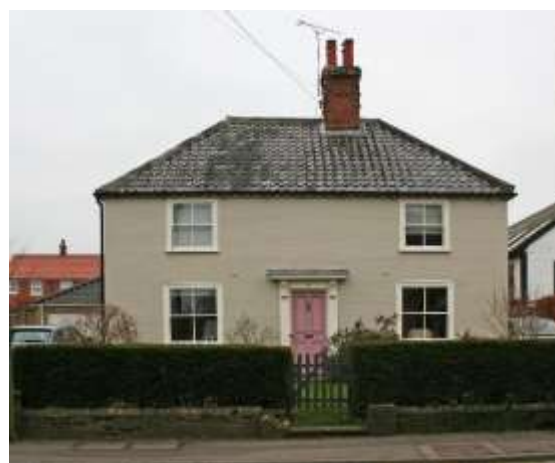
*No.4 St John's Road*

*No.4 St John's Road (grade II)* An early nineteenth century cottage with a symmetrical two storey façade of limewashed brick. Hipped black pan tiled roof and dentilled eaves cornice. Red brick ridge stack. Horned four-light plate-glass sashes within flush frames, cambered flat arches at ground floor, four-panelled door in case with console brackets and an enriched cornice. *Subsidiary structures.* Low red brick wall to front with the plinths of former gate piers. Probably later nineteenth century.

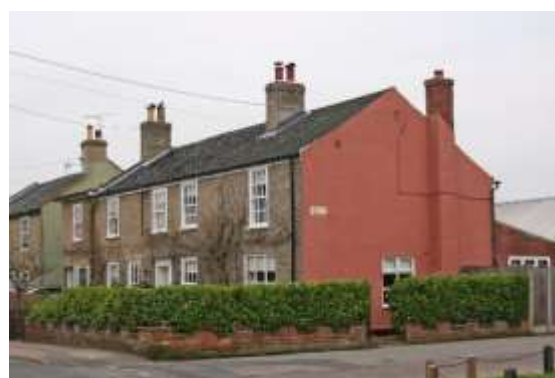
*Nos. 10 & 12 St John's Road*

*Nos. 10 & 12 St John's Road.* An early to mid-nineteenth century semi-detached pair of houses. St John's Road elevation of Suffolk white brick with a black pan tiled roof. Twelve-light hornless sashes, those to No.12 part of an early twenty first century restoration scheme. No. 10 with a single large mullioned and transomed casement to northern corner of ground floor. No.10 also has a simple doorcase with pilasters, No.12 a later twentieth century doorcase. No.10 with a rendered return elevation to Southend Road. Red brick rear elevation with single storey late Twentieth century lean-to additions. Southern return elevation of No.12 of red brick with stone rubble to lower courses. *Subsidiary Structures.* No.10 has a

crenelated early twentieth century red brick boundary wall to the street. All other walls appear to be of late twentieth century date.

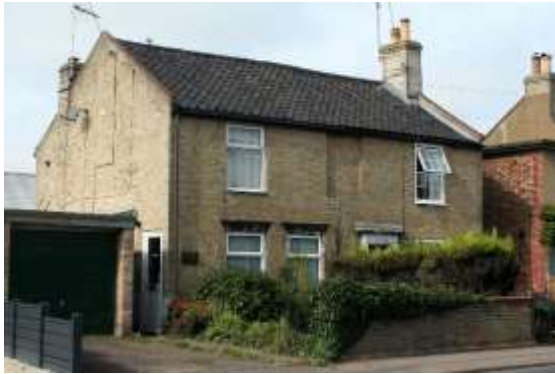
*Nos.14 & 16 St John's Road*

*Nos.14 & 16 St John's Road.* An early to mid-nineteenth century semi-detached pair of cottages. Suffolk white brick façade with a black pan tiled roof. Formerly symmetrical façade, No.16 now altered. No.14 retains a wooden doorcase with pilasters and a dentilled cornice. Late twentieth century partially glazed front door. Blind panel above doorcase. Late twentieth century casements within original openings. No.16 has had its front door replaced by a window and again has late twentieth century casements. *Subsidiary Structures* Low red brick boundary wall with glazed cap probably of early twentieth century date. Garage to No.16 not included.

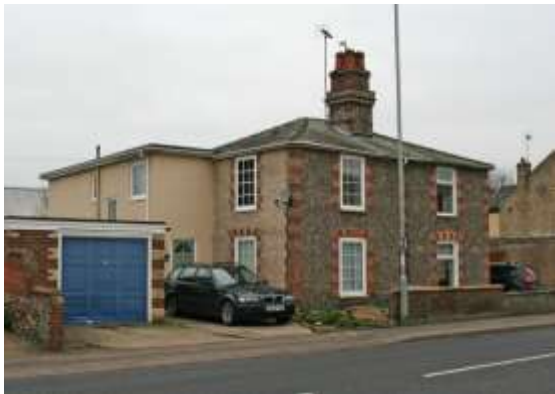
*Nos.18 & 20 St John's Road*

*Nos.18 & 20 St John's Road.* Semi-detached pair of later nineteenth century dwellings, faced in stone rubble with red and gault brick quoins and dressings. Hipped Welsh slate roof. Large central stack rising from spine wall again of rubble with brick dressings. Most external joinery now replaced within original window and door openings. No.20 with a rendered twentieth century addition to the rear. *Subsidiary Structures* Low gault brick boundary wall to No.18. Red brick nineteenth century wall to rear courtyard. Front wall to No.20

recently rebuilt. Stone rubble wall with red brick dressings separating Nos. 20 & 22, rear section of red brick. Late twentieth century garage to No.20 not included.

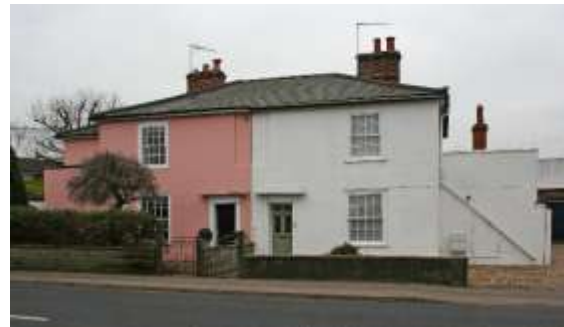
*Nos.22 & 24 St John's Road* (grade II). Early nineteenth century semi-detached pair of dwellings. Symmetrical, cement rendered and lined façade of two storeys. Hipped Welsh slate roof. Eaves soffit, brown brick chimneys. Two flush framed sixteen-light hornless sash windows to each floor flanking a central blind panel at first floor level. Entrances paired at centre with six-panelled doors and wooden cases with mutular cornices. Blind faced single storey wings to each side, slightly recessed with a parapet. Return elevation to No.22 of red brick. Return to No.24 has rendered two storey wing with sixteen-light sashes. *Subsidiary Structures* Stone rubble wall with brick dressings to No.24 with red brick return section. Other walls appear to be low and of twentieth century date. Nos 10 to 24 (even) form a group.

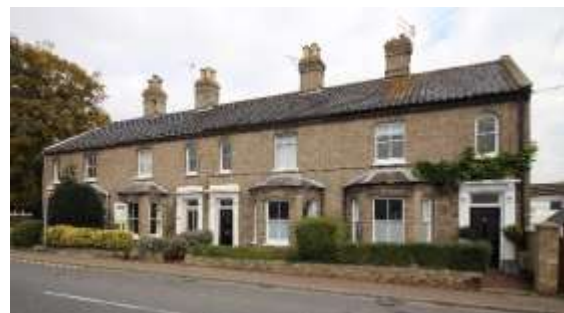
*Nos.1-7 (Odd) St John's Road*

*Southend Terrace, Nos.1-7 (odd) St John's Road .* A well-preserved gault brick terrace of 1893. Black pan tiled roof. Each house has a pilastered doorcase and a canted bay to the ground floor and at first floor level a strong course and two sash windows. The window above each doorcase is a narrow arched one. Original horned glass sashes

preserved to first floor. The sashes to the canted bays also appear to be original. Partially glazed four panelled doors and doorcases with decorative corbels. *Subsidiary Features* Low gault brick boundary wall to street formerly with cast iron spear type railings and hooped cast iron gates.

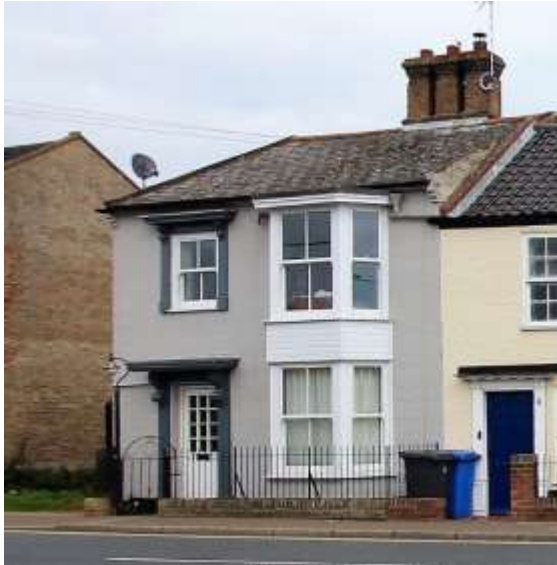
*No.9 St John's Road*

*No.9 St John's Road.* House of early to mid-nineteenth century date. Of painted red brick. Black pan tiled roof. Red brick stack of three linked grouped shafts to ridge. Two storey wooden canted bay window with four-pane plate-glass sashes. Doorcase with corbels. Twentieth century partially glazed door. Window above door with corbelled hood and pilastered frame.

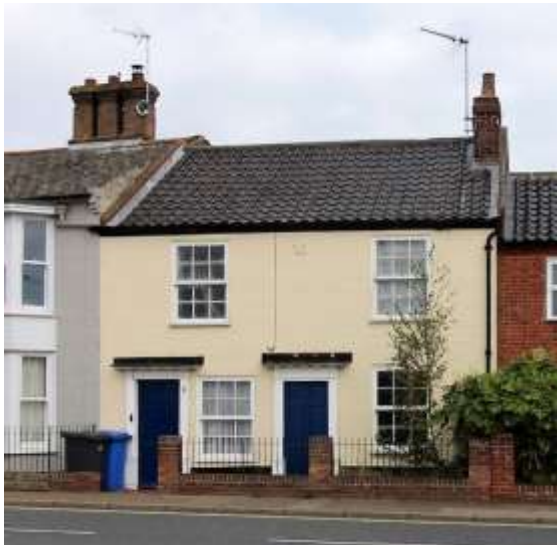
*No.11 St John's Road*

*No.11 St John's Road.* Pair of small cottages now a single dwelling, dated 1829 on façade. Painted red brick with a black pan tiled roof. Doorcase with

pilasters and six panelled doors. Late twentieth century casement windows within original openings with flat-arched lintels. Red brick stack to southern gable.

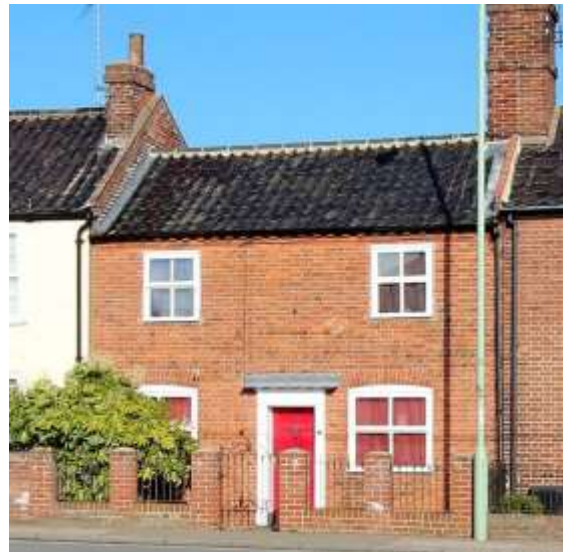
*No.13 St John's Road*

*No.13 St John's Road.* A red brick early to mid-nineteenth century cottage with a black pan tiled roof. Three bay two storey façade with central door. Doorcase with pilasters. Late twentieth century casement windows in original openings. Late twentieth century boundary wall to street not included. Prominently located at the termination of Bardolph Road.

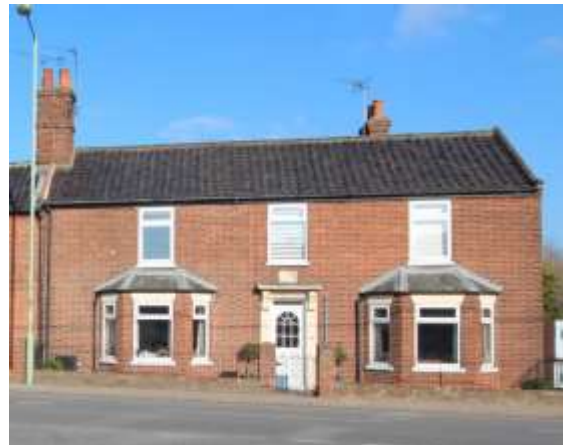
*No.15 St John's Road*

*No.15 St John's Road.* Late nineteenth century detached villa in a prominent location at the head of Bardolph Road. Red brick with stone dressings and a black pan tiled roof. Symmetrical façade with central doorcase flanked by single storey canted bay windows. Late twentieth century casements in original openings. *Subsidiary Structures.* Low red

brick wall with square-section piers and decorative early twentieth century railings.

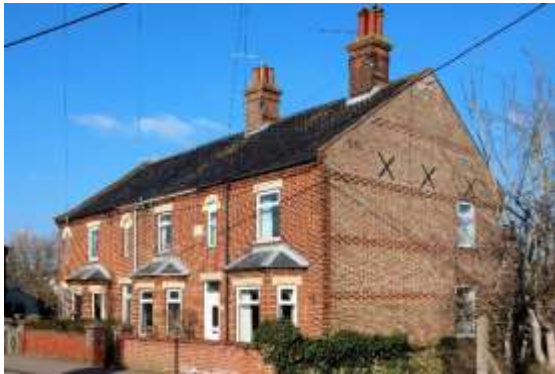
*Nos.17-21 odd St John's Road*

*Belle Vue Villas Nos.17-21 odd St John's Road.* Terrace dated 1909, of red brick within stone dressings. Black pan tiled roof. Canted bay windows to ground floor. Narrow arched windows above door openings. Twentieth century casements within original window openings. Partially glazed front doors. No.17 has late twentieth century porch on return elevation which is faced in Fletton brick with decorative red brick bands. *Subsidiary Structures.* Low red brick garden walls with stone capped square section piers and decorative iron gates.

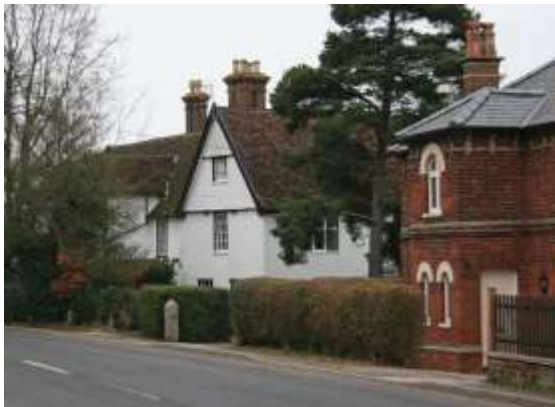
*'The Ollands' No.51, & 'The Gables' No.53 St John's Road*

*'The Ollands' No.51, and 'The Gables' No.53 St John's Road (grade II\*).* Dated 1654 on a stone tablet on a chimney. Large detached house formerly known as Ollands House, now two dwellings. Probably subdivided c1900. The 1654 date appears consistent with the oldest surviving fabric. Later eighteenth, or early nineteenth century work to rear and late twentieth century flat roofed additions. No.51, is of two storeys and an attic, timber-framed and plastered. Plain tiled roof to front, black and red pan tiles to rear. Twelve-light flush-framed hornless sash windows to first

floor. The full height gabled and jettied porch projection has a similar first floor window and a small sash in the gable. The oak door is in original condition, divided into ten panels by moulded battens, in heavy moulded frame with enriched stop-chamfer. Original wooden case lock, bolts and fittings remain. Twentieth century multiple splayed bay window to ground floor, right. The stair is a fine example of the period in oak with turned balusters, moulded rail, strings, and newels. No. 53, has its entrance on the south-eastern face, it is of two storeys and an attic which is lit by a window within the gable. Timber-framed and plastered, mullioned and transomed casements, (one blocked but showing frame). The St John's Road façade has hornless sash windows in flush frames in the gabled wing. Six-panelled door with an arched radial bar fanlight. Twentieth century bay window ground floor. Good Adam type mantel. Bettley, J, and Pevsner, N, *The Buildings of England, Suffolk: East* (London, 2015) p.158.

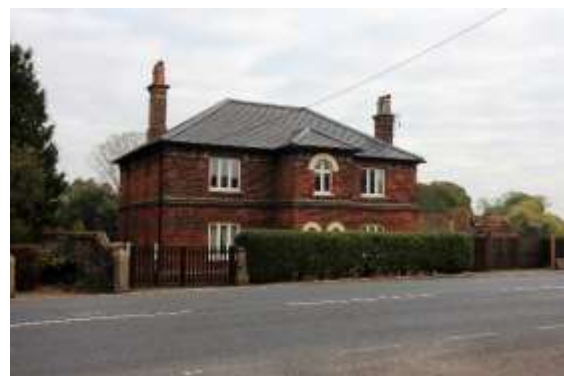
*No.55 St John's Road*

*No.55 St John's Road.* Mid nineteenth century farmhouse Formerly part of Ollands Farm, of red brick with gault brick dressings and a hipped black pan tiled roof. Three bay façade with central projecting two storey porch. Projecting eaves and elaborate corbelled gault brick eaves cornice. Moulded gault brick platt band. Mullioned timber casement windows and mullioned and transomed arched casements to porch. Door in return elevation of porch. An important building within the setting of the GII\* Nos. 51 & 53 and at the entrance to the Conservation Area from the south. *Subsidiary Structures.* Good stone rubble wall with gault brick dressings separating No.55 and the GII\* No.53.

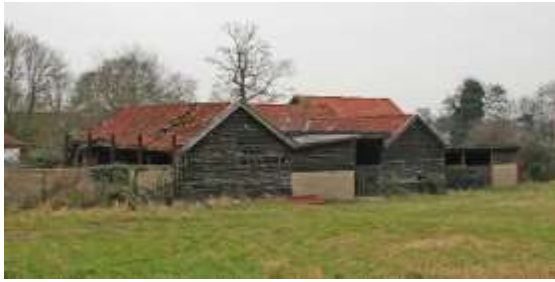
*Farm buildings at No.55 St John's Road*

*Farm buildings, St John's Road.* A weather boarded single storey group of farm buildings with red pan tile roofs. Grouped around the north, east, and west sides of a formerly open courtyard and located to the south of No.55 St John's Road. Including an open-fronted cart or implement shed. A key group of buildings at the southern entrance to the Conservation Area. Red brick nineteenth century structure with a red pan tiled roof to rear of two storeys. Shown on the 1885 1:2,500 Ordnance Survey map and at that time part of Ollands Farm. Late twentieth century breeze block additions and infill to courtyard not of interest.

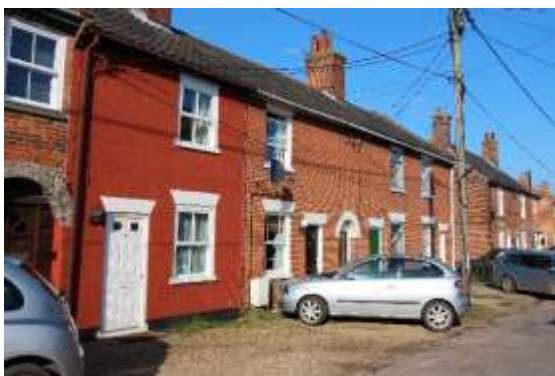
*Nos.6-10 (even) Southend Road*

*Nos.6-10 (even) Southend Road.* Mid to late nineteenth century red brick terrace with a black pan tiled roof. Central arched entrance to rear gardens. Nos.6 and 8 retain original horned sashes with margin lights. No.8 also retains a four-paneled

front door. Other external joinery replaced but original openings preserved.

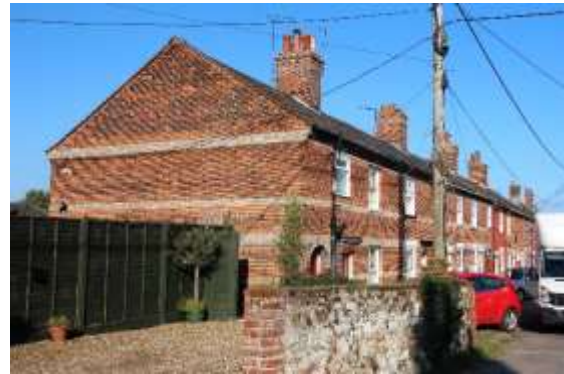
*Nos.12-20 (even) Southend Road*

*Nos.12-20 (even) Southend Road.* Terrace of mid to late nineteenth century cottages. Red brick with gault and blue brick dressings and a black pan tiled roof. Central arched opening leading to passage way to rear gardens and further passage entrances within end bays. Decorative gault brick corbelled eaves cornice. Blue brick diaper work between first floor windows. Gault brick sill band to first floor and lintel band to ground floor windows, with between further blue brick diapering. Further gault brick bands below. Dentilled gault brick frieze above doorcase lintels. External joinery largely replaced but original openings preserved.

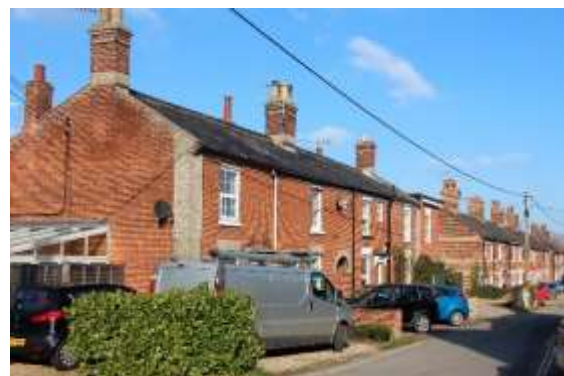
*Nos.22-28 (even) Southend Road*

*Southend Cottages, Nos.22-28 (even) Southend Road.* A terrace of cottages dated 1867. Built of red brick with gault brick dressings and pilasters. Black pan tiled roof. Central arched entrance to rear gardens with date stone over. Gault brick lintels, eaves cornice, and decorative bands to chimneystacks. Hoods over doors supported on decorative corbels. Window joinery largely replaced but original openings preserved. Twentieth century two-storey side addition to No.22. Small inserted window above door to No.24. Return elevation of No.28 to Laburnum Road largely blind but with decorative gault brick pilaster

to front corner. *Subsidiary Structures* No.26 retains its original red brick front garden walls. Good stretch of stone rubble walling to garden of No.22 possibly of a much earlier date than the terrace.

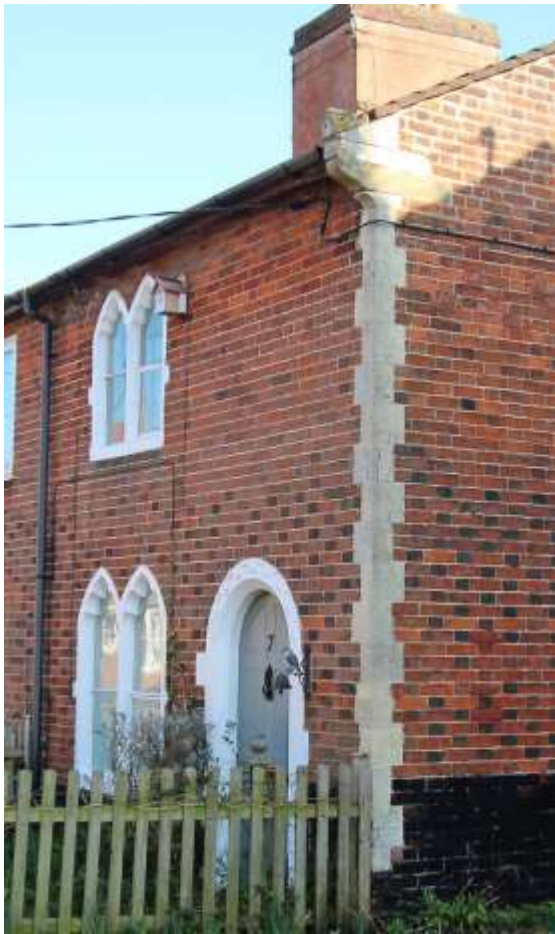
*No.7 Southend Road*

*No.7 Southend Road.* A mid-nineteenth century cottage which forms part of a semi-detached pair with the much altered No.5 (not included). Red and blue brick with painted stone dressings and quoins. Shallow pitched Welsh slate roof with deep overhang to eaves. Neo-Norman arched doorcase. Six-paneled door. Pointed arched windows divided by central splayed mullion.
