#### Appendix 4: Structures that make a positive contribution to the Conservation Area

The character and appearance of the Conservation Area are shaped by the structures and spaces within it. This appendix contains a list of the built structures which have been identified as making a positive contribution to the Conservation Area (as per section 4. *Positive Contributors* of the CAAMP). The list contains designated as well as undesignated structures. The list is illustrated on maps in the CAAMP.

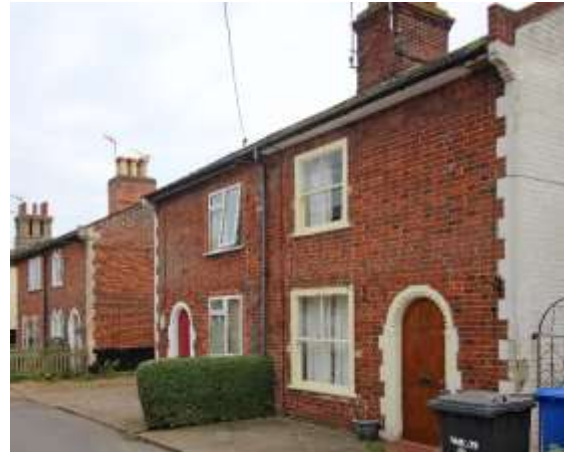
*Nos.9 & 11 Southend Road*

*Nos.9 & 11 Southend Road.* A semi-detached pair of mid-nineteenth century houses. Principal façade of red and blue brick with painted stone dressings and quoins. Shallow pitched Welsh slate roof with deep overhang to eaves. Neo-Norman arched doorcases with quarter pilasters and dog tooth frieze. Original arched six-paneled doors. No.11 retains its four-pane horned sashes. No.9 with casement windows and shutters. Substantial twentieth century additions to the rear.

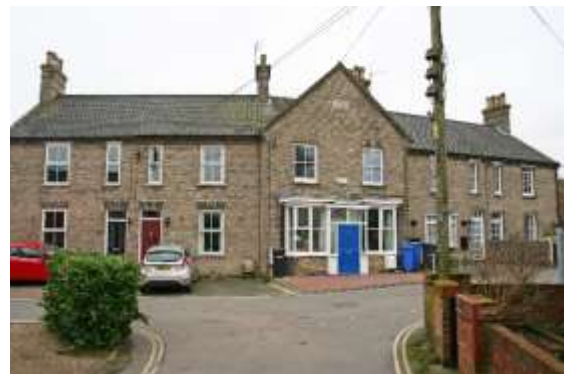
*Nos.33-41 (Odd) Southend Road*

*Windsor Terrace Nos.33-41 (Odd) Southend Road.* A terrace of 1896 faced in gault brick with black pan tiles to the front roof slope and red to the rear. Decorative eaves cornice. The central section, a former shop, breaks forward slightly and is gabled; it terminates views along Laburnum Road. The original shop windows to either side of the entrance have been partially preserved. Late twentieth century glazed porch added between former shop windows. Within the flanking wings are mirrored pairs of cottages. Many of the sash windows to these have been replaced with casements. Honeywood F, Morrow P, & Reeve C, *The Town Recorder, A History of Bungay in Photographs* (Bungay, 1994) p180.

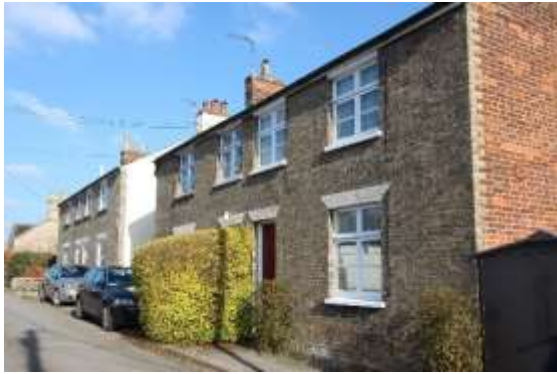
*Nos.47-53 (Odd) Southend Road*

*Nos.47-53 (Odd) Southend Road.* Two semi-detached pairs of cottages. Gault brick facades to otherwise red brick structures. Symmetrical façades with centrally placed doors flanked by casement windows. Doors set back beneath flat arched lintels. Nos. 51 & 53 appear to retain their original casement windows. Shown on the 1885 1:2,500 Ordnance Survey map. No.47 has a later twentieth century flat roofed garage addition.

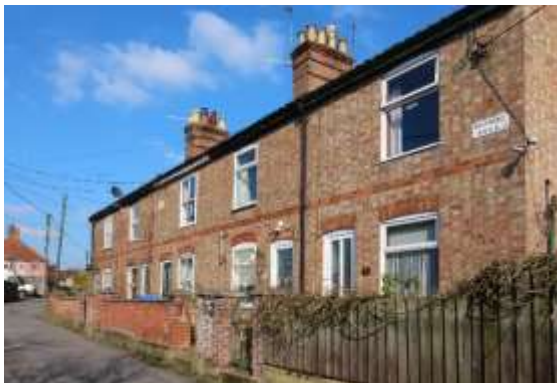
*Sunnyside Cottages, Nos.55-63 (odd) Southend Road*

*Sunnyside Cottages, Nos.55-63 (odd) Southend Road.* Fletton brick terrace with red brick dressings dated 1907. Black pan tiled roof. External joinery largely replaced within original openings. An important part of the setting of the adjoining grade II listed former windmill.

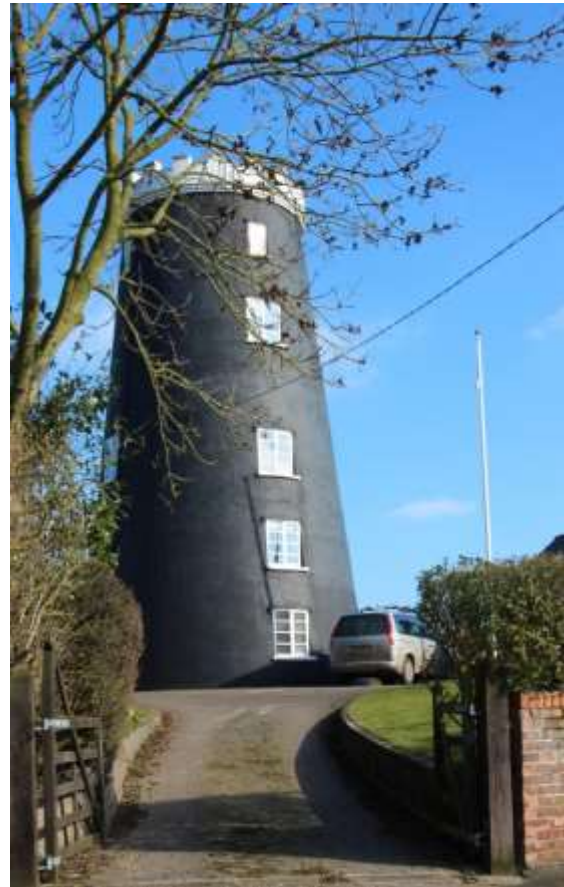
*Tower Mill, Tower Mill Road*

*Tower Mill, Tower Mill Road (grade II).* A former wind powered corn mill of c1830. The mill was in use until c1918 but its boat shaped cap, sails, fantail, and top storey were reputedly removed soon after. Now converted into a dwelling. Now a five-storey circular tower with c1924 crenellations, painted brown brick. Formerly linked to the adjoining single storey red brick engine house by a drive belt enclosed in a boarded wooden frame. *Subsidiary Structures* Later nineteenth century single storey red brick engine house now converted to a dwelling. This provided auxiliary power to the mill.

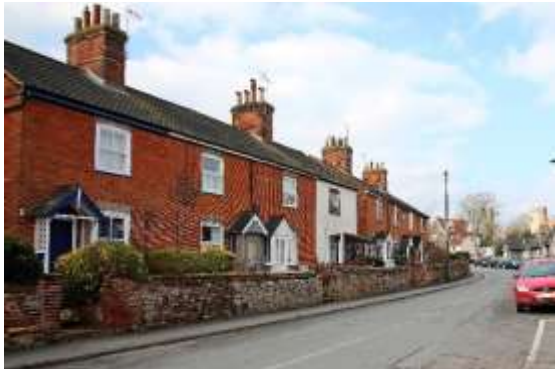
*Nos.12-28 (even) Staithe Road*

*Kimberley Terrace Nos.12-28 (even) Staithe Road .* Two terraces of red brick cottages of c1902. Gault brick cambered lintels to ground floor windows. Black pan tiled roof. Most external joinery replaced but original openings preserved. Contemporary red brick boundary wall to Staithe Road.

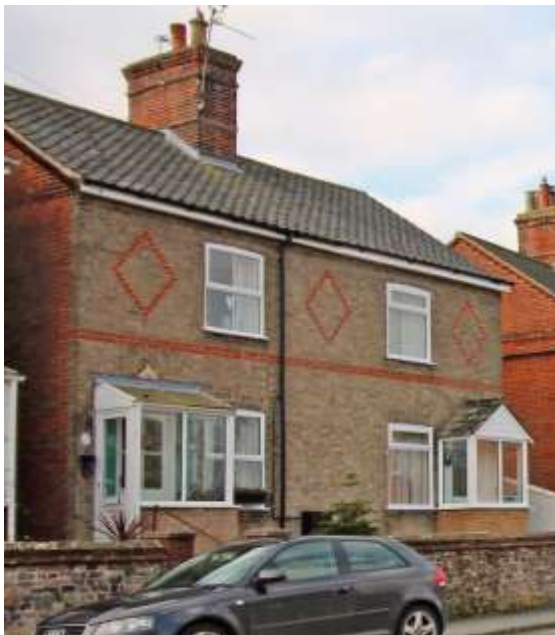
*Nos.30-32 (even) Staithe Road*

*Nos.30-32 (even) Staithe Road.* Semi-detached pair of houses constructed between 1892 and 1905. Gault brick façade with red brick dressings to otherwise red brick structure. Replacement windows in original openings. Black pan tiled roof. Nineteenth century red brick boundary wall to Staithe Rd.

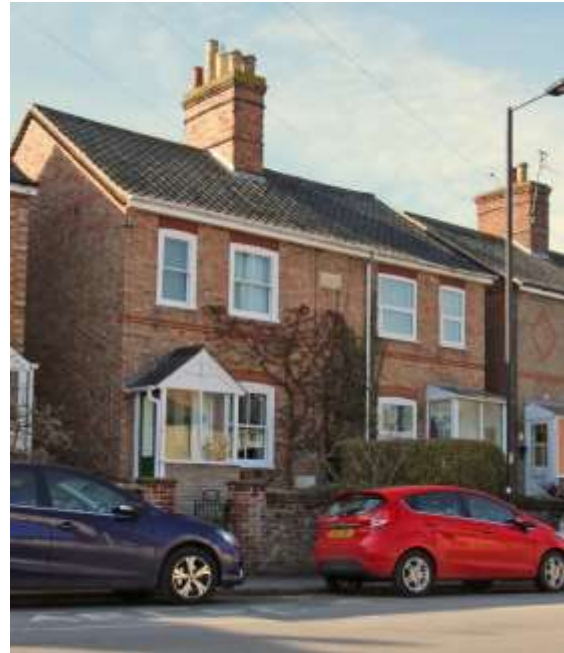
*Alexandra Cottages, Nos.34-36 (even) Staithe Road*

*Alexandra Cottages, Nos.34-36 (even) Staithe Road .* A semi-detached pair of houses of 1901. Alternate Fletton and red brick façade with elaborate red brick dressings. Black pan tiled roof and central ridge stack to spine wall. Replacement windows in original openings. Twentieth century porches. A relatively early use of Fletton brick. Nineteenth century red brick boundary wall to Staithe Rd.

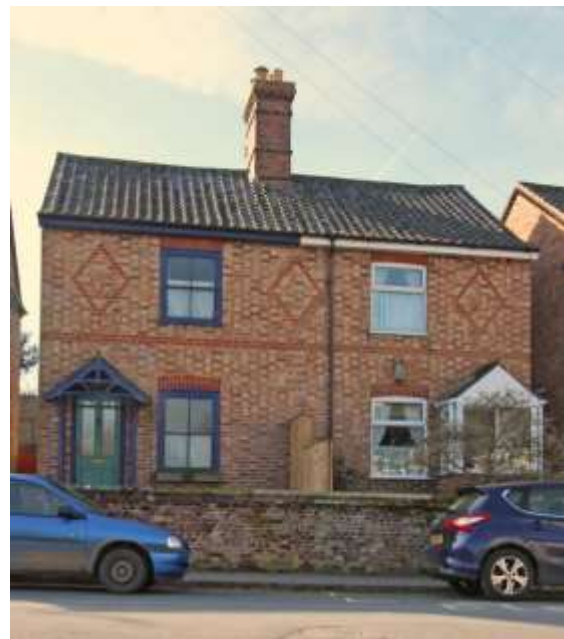
*Nos.38-40 (even) Staithe Road*

*Nos.38-40 (even) Staithe Road.* A semi-detached pair of houses constructed between 1892 and 1905. Their Staithe Road façade is faced in Fletton and red brick with elaborate red brick dressings. Black

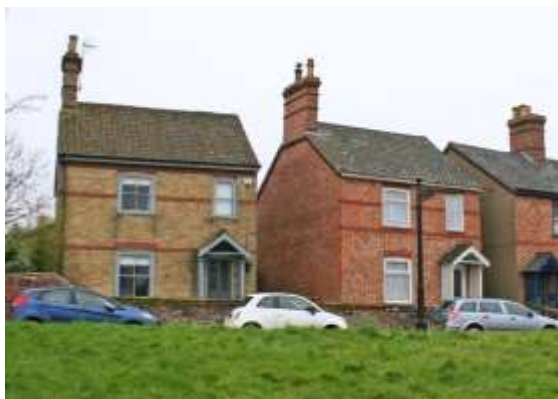
*Nos.42-44 (even) Staithe Road*

*Nos.42-44 (even) Staithe Road.* A pair of detached houses of Fletton brick c1904-10. No.42 has a Fletton and red brick façade to Staithe Road, red brick dressings, and replacement casement windows within original openings. A relatively early use of Fletton brick. No.44 with a gault brick elevation to Staithe Road with red brick dressings. Horned sash windows, and a partially glazed four-panelled front door. Gabled wooden lattice porch. Gault brick chimney stack with red brick dressings. Fletton brick gable end. Good quality late twentieth century addition to rear. Replaced pan tile roof coverings. C1900 red brick boundary wall to Staithe Road.

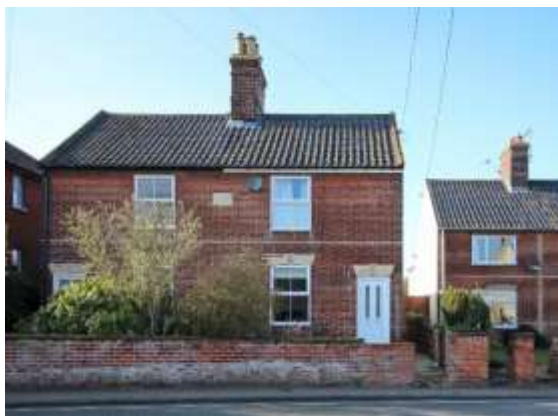
*Nos.48-52 (even) Staithe Road*

*Nos.48-52 (even) Staithe Road (local list)* A semi-detached pair of late nineteenth century cottages faced in red brick, and with a black pan tiled roof. Decorative stone lintels with pronounced keystones to ground floor windows and doors. White brick band below first floor windows. Windows now late twentieth century casements in imitation of sashes. Red brick stack rising from spine wall. Single storey twentieth century rear addition not of significance.

*Subsidiary Structures* Low red brick boundary wall of probably c1900 date.

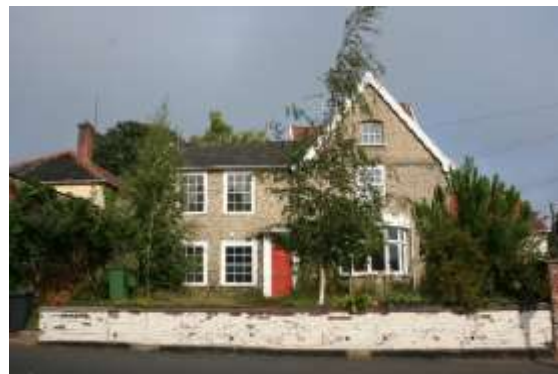
*No.3 Staithe Road*

*No.3 Staithe Road (grade II).* A detached house of later eighteenth, or early nineteenth century date. Of two storeys with a gabled attic lit by later windows. Suffolk yellow brick. Black pan tiled roof. Of three bays, the right-hand bay projecting slightly and having a gable. Twelve-light hornless flush-framed sash windows. Those to the ground floor having segmental arched lintels. Five-sided canted bay window with casements to ground floor of gabled bay. Six-panelled door with wooden case. Elliptical fanlight Side door in wing wall with elliptical arch. *Subsidiary structures* to the right, now separated from No.3 by the entrance to a housing development, a red brick boundary wall of nineteenth century date with stone capped square-section piers. Lower twentieth century section directly by street. Low painted brick retaining wall to front.

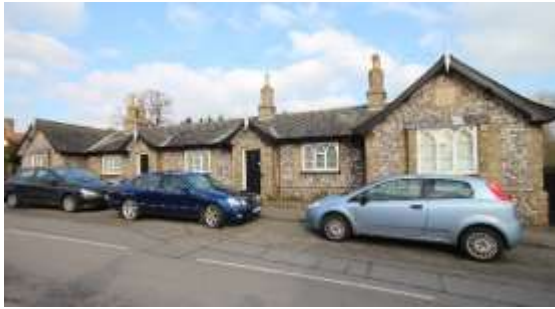
*Dreyers Almshouses, Nos.9-17 (odd) Staithe Road* (grade II). Single storey alms house block of 1848 faced in square knapped flint with gault brick dressings. Endowed by Eliza Dreyer for the widows of poor tradesmen. Seven-bay façade with gabled porches, outer bays gabled and slightly projecting. Gothic casement windows with three pointed lights. Octagonal shafts to chimneys with capping and drip moulded bases. Plinth. Near-flush-frame doors with cambered arches. Inscribed stone tablets in flank gables with date. Roof of octagonal Welsh slates, bargeboards with spear finials. Further gabled porches to return elevations.

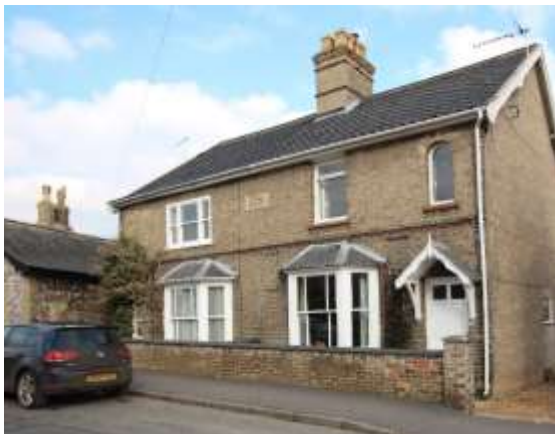
*Pretoria Villas, Nos.19-21 (odd) Staithe Road*

*Pretoria Villas, Nos.19-21 (odd) Staithe Road*. Semi-detached pair of dwellings faced in white brick dated 1901. Canted wooden bay windows to the ground floor. Tripartite casement sash to first floor of No.19, first floor window to No.21 recently replaced. Dentilled plat band. Black pan tiled roof with substantial ridge stack to spine wall. No.21 has a gabled porch with bargeboards and a spear finial. *Subsidiary Structures* low nineteenth century wall to front and to side of No.21 the front wall being of gault brick the side wall of red.

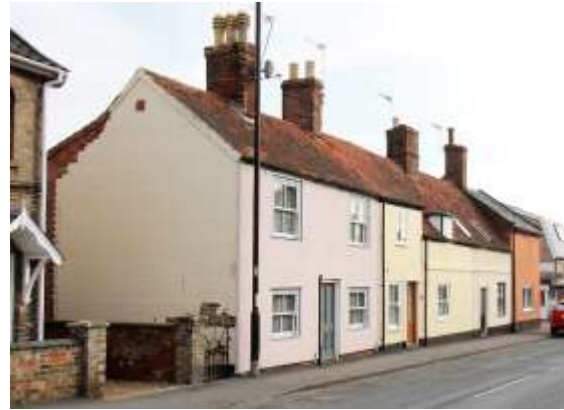
*Nos.23-25 (odd) Staithe Road*

*Nos.23-25 (odd) Staithe Road*. Small rendered pair of cottages of c1800 forming an important part of the setting of the grade II listed. No.23 with central four-panelled door flanked by horned sashes. No.25. Horned sash to ground floor and twentieth century top-lit boarded front door. Twentieth century casement above in earlier opening. Red pan tiled roof. No.23 extended to rear.

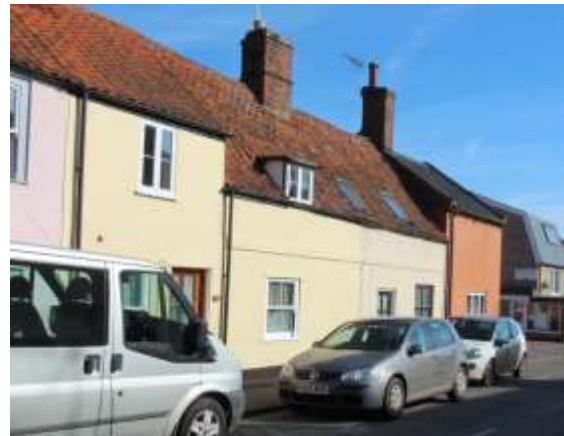
*Nos.27 -29 (odd) Staithe Road*

*No.27 Staithe Road* (grade II). A late seventeenth, or early eighteenth century cottage of a single storey and an attic. Converted into two cottages in the nineteenth century, and now again a single dwelling. Red pan tiled roof with a single casement dormer and two rooflights. Stippled rendering, painted. Plinth, platt band. Plate-glass sashes and a two-panelled door in a near-flush-frame.

*No.29 Staithe Road*. Probably of early nineteenth century date, a small painted red brick cottage with a black pan-tiled roof. Principal façade within return elevation which is gabled and contains twentieth century casement windows (nineteenth century photos show horned plate-glass sashes) Staithe Road elevation largely blind save for one casement window at ground floor level. Dentilled brick eaves cornice. No.29 forms an important part of the

setting of the grade II listed No.27. *Subsidiary Structures* Twentieth century garage not included.

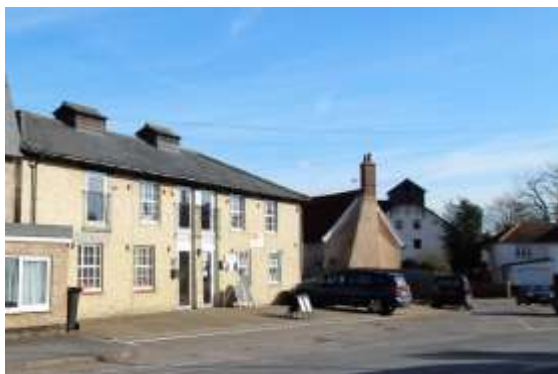
*Staithe Business Suite, Staithe Road*

*Staithe Business Suite, Staithe Road.* A later nineteenth century gault brick faced industrial structure which is now converted to offices. Shown on the 1885 Ordnance Survey map. Rendered return elevation. Hipped Welsh slate roof with overhanging eaves. Two louvered ventilators to ridge. Largely symmetrical façade with late twentieth century casement windows within original openings. Twin central doors with former taking-in doors above. Late twentieth century industrial structure to rear not of interest. Blocked doorway to left-hand outer bay. An important part of the setting of the grade II listed No.45 Staithe Road. Twentieth century addition to left not of interest.

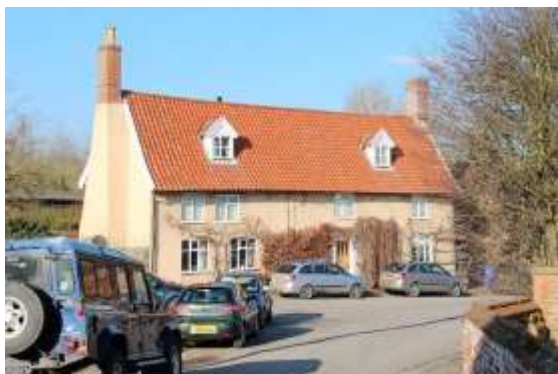
*No.45 Staithe Road* (grade II). Former White Horse Inn (closed 1978), of late sixteenth or early seventeenth century date. Two storeys with an attic lit by two gabled dormers. Timber-framed, roughcast, late twentieth century red pan tiles. Four wide bays with casement windows, original mullion transom casements, wood drip mould over ground floor windows. Exposed shaped rafter, feet at eaves. Interior: original staircase with shaped flat balusters, moulded handrail, cut and shaped newels of primitive but characteristic

workmanship, and in general the Inn is free from modernisation. Seventeenth century bolecion moulded mantel. Honeywood F, Reeve C, & Reeve T, *The Town Recorder, Five Centuries of Bungay at Play* (Bungay, 2008) p104-106 & 168-169.

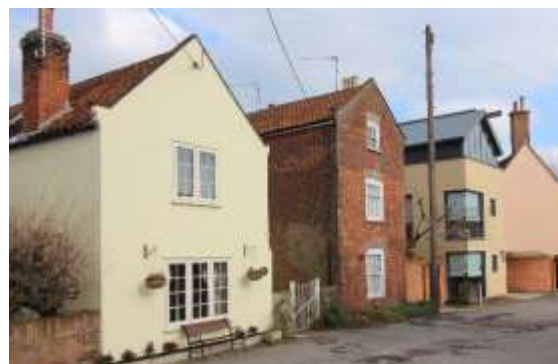
*No.47 Staithe Road*

*Millers Cottage, No.47 Staithe Road.* Detached dwelling with gable end to street probably dating from c1800. Two storeys. Rendered façade and red pan tiled roof. Late twentieth century casement windows. Red brick stack to western roof slope. Ground floor casement in gable replaces a door and a small sash window.

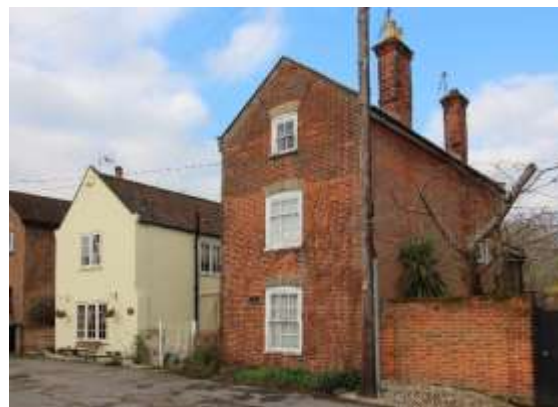
*No.49 Staithe Road*

*Heron House, No.49 Staithe Road.* Detached dwelling of red brick with gable end to street. Probably of early nineteenth century date. Red pan tiled roof with tall red brick stacks. Two storeys and an attic. Gault brick cambered lintels to windows. Eastern façade largely blind at first at first floor level, door to ground floor.

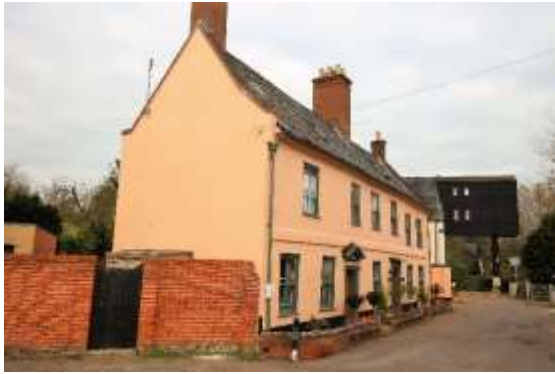
*Nos.51 & 53 Staithe Road*

*Nos.51 & 53 Staithe Road.* (grade II). Originally one early eighteenth century dwelling. Two storey, six bay façade, pebble dash on red brick. Platt band below first floor windows, plinth, and a coved cornice. Black pan tiled roof of steep pitch with overhanging eaves. Four-light sashes in flush frames, rendered flat arched lintels to ground floor windows. No.51, six-panelled door, with an eared architrave and a pediment. No.53, six-panelled door in a wood case with slender pilasters and a cornice. red brick chimney stacks. *Subsidiary structures.* Boundary walls appear to be later twentieth century red brick.

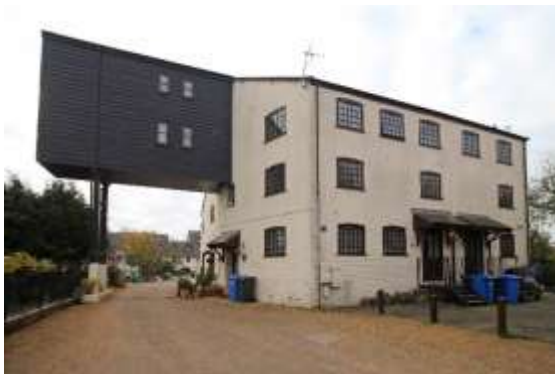
*Nos.1-5 The Watermill, Staithe Road*

*Nos.1-5 The Watermill, Staithe Road.* Former provinder (or animal feed) mill of 1902 built for the Marston family, closed c1956 and now converted to apartments. Wheel and machinery removed. Its watercourses have been partially filled in and turfed over. Painted brick and weatherboarding. Twentieth century wooden casement windows. The site has long been occupied by water powered mills, the previous one being destroyed by fire c1900.

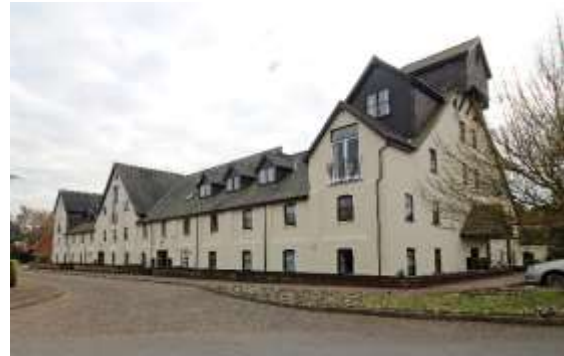
*Nos.1-23 (cons) The Maltings, Staithe Road*

*Nos.1-23 (cons) The Maltings, Staithe Road.* Former maltings of c1902 now apartments. Site shown as gardens on the 1892 Ordnance Survey map. Faced in painted red brick with an impressive asymmetrical fourteen bay principal façade divided by plain pilasters at first floor level. End bays gabled, and further three-bay section gabled towards centre. Steeply pitched Welsh slate roof with late twentieth century gabled dormers and roof lights. Late twentieth century window joinery of uniform design. Former taking-in doors to gables now balconied window openings. Low late twentieth century boundary wall.

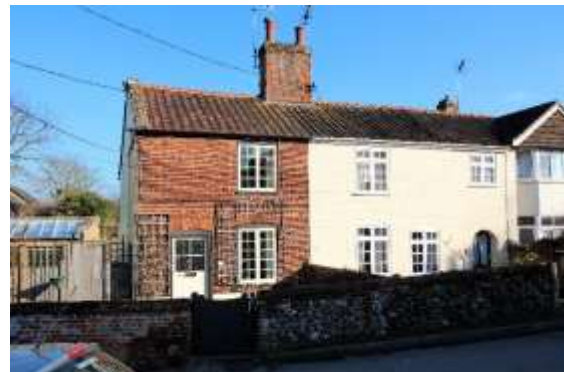
*Nos.61-63 (odd) Staithe Road*

*Nos.61-63 (odd) Staithe Road, outbuilding and boundary wall.* A pair of early nineteenth century red brick cottages. No.63 now painted. Red pan tile roof. Original windows to No.61, late twentieth century casement windows to No.63. Cambered arched lintels to ground floor openings. Rendered return elevation to No.61. *Subsidiary structures* Good low boundary wall to Staithe Road of flint and stone rubble with brick dressings and a tile cap. Single storey painted brick outbuilding of nineteenth century date to rear with red pan tiled roof.

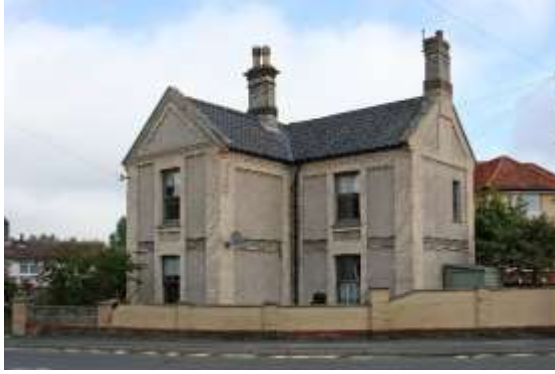
*No. 71 Staithe Road*

*No. 71 Staithe Road.* A substantial mid- nineteenth century classical villa of a bold and inventive design.
